**Westport Public Schools**  
**Coleytown Elementary School – 23-008-RFP**  
***Request for Proposal for Renovation Status Evaluation***

**5.0 Existing Facility Survey**  
Master Plan Facility Study for Westport Public Schools  
**COLEYTOWN ELEMENTARY SCHOOL**  
**5.1.1 Architectural Conditions Analysis**

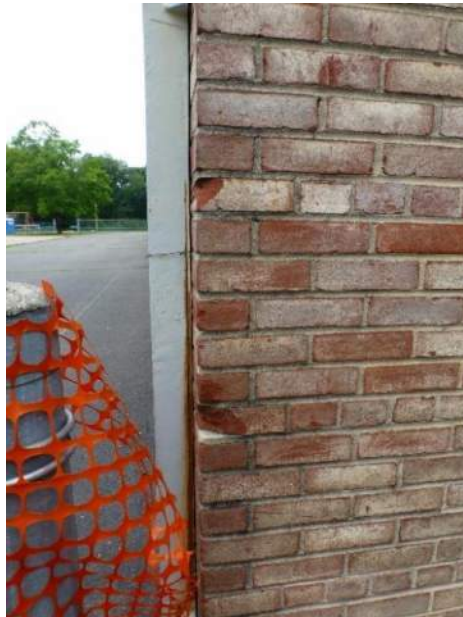
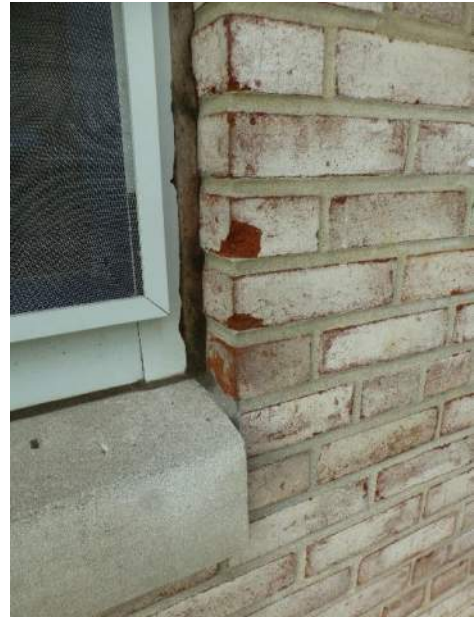
Overall, there were no obvious cracks in the brick veneer, and it appears to be in good condition. There are several locations of minor damage to masonry, mostly located at building corners and at window jambs.

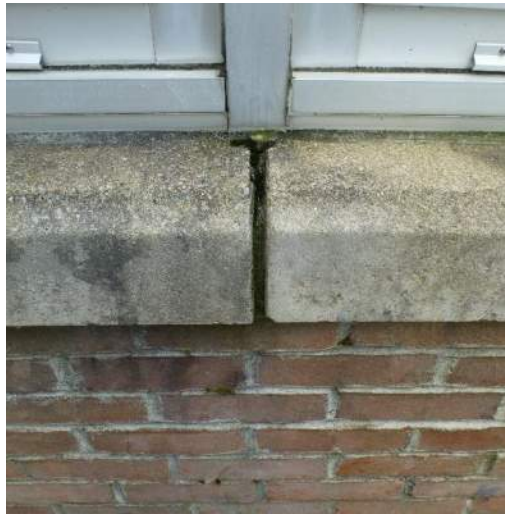
Mortar joints and caulk joints also appear to be in sound shape except for the window sills at the connecting corridor to the 1993/97 Addition. These should be scraped clean and completely re-grouted.

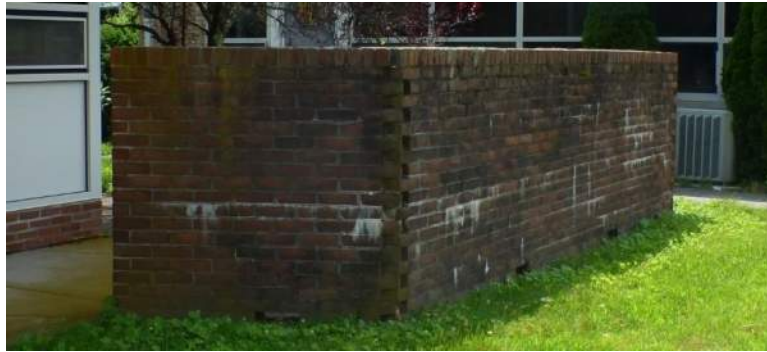
This staining also occurs at the low brick walls at the north and south 1974 Additions.

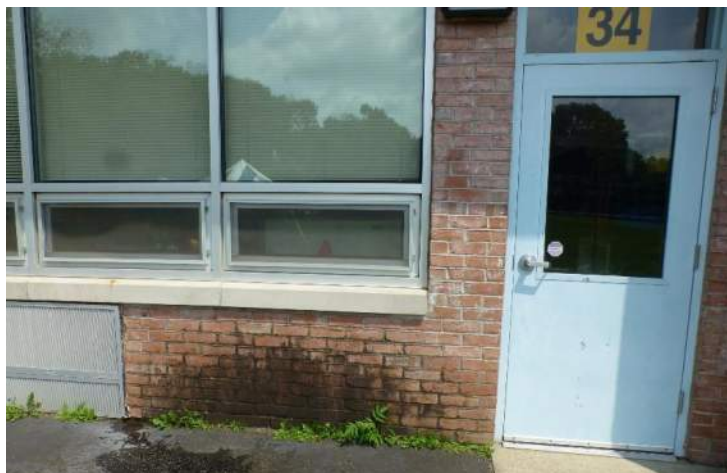
There are several areas about the perimeter of the structure that show signs of black staining. These areas should be investigated to determine the source of the issue, repaired and cleaned. Examples of this can be found near Doors 7, 26, 34, and 62.

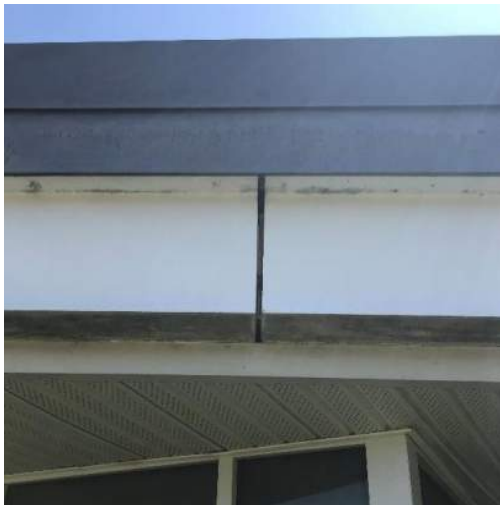
Structural steel columns, fascias, and metal trim work / louvers are in need of scraping, priming, and repainting.

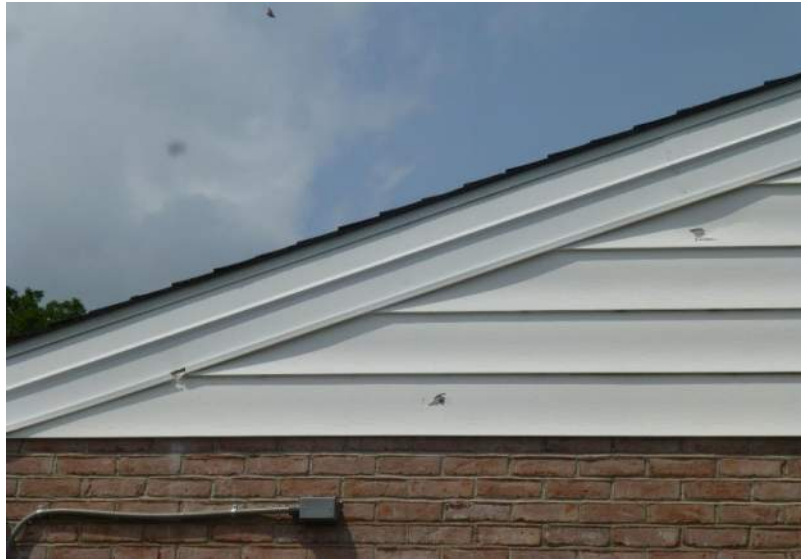
Vinyl siding, overall, is in good condition, but there were several punctures located at gable ends that are in need of replacement.

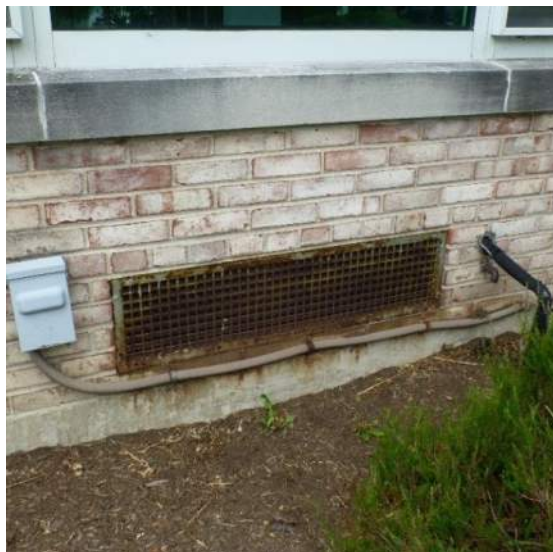
There are multiple areas of rust that are in need of scraping, priming, and repainting. Evidence of rust can be found at the grille vents near Doors #3 and #7 and also at the handrails at these locations. Steel lintels at many window openings are in need of the same treatment, as are some of the gutter leaders.

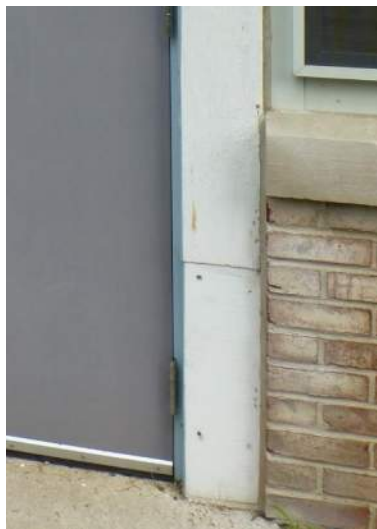
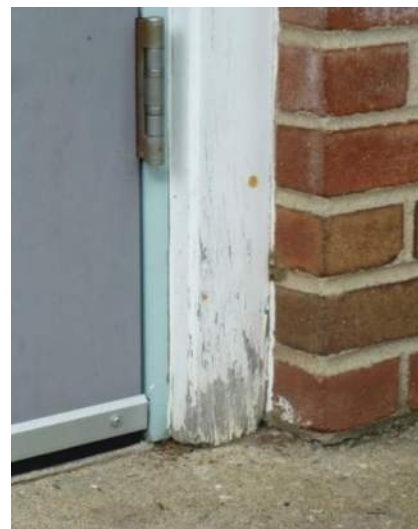
Many of the exterior doors to the classrooms of the older portions of the school still have wood trim. There is evidence that repair work has been done in the past to repair rotting wood at the base of the side jamb by splicing in new pieces. Some doors have not yet received this repair-work. It is recommended that the wood trim be removed entirely and replaced with new PVC trim.

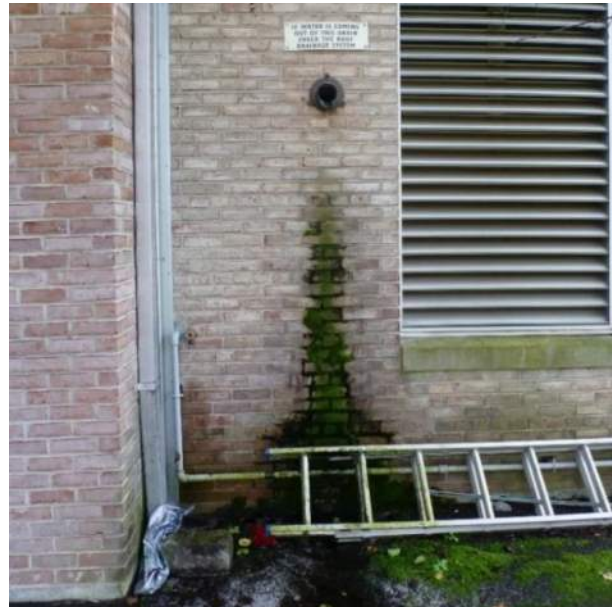
Roof drains and gutters appeared clear and in relatively good condition, but should be regularly inspected for any blockages and clogs. It was noted that at least one overflow scupper near Door #24 was free flowing, indicating a possible clogged drain or another problem such as the scupper being located too low relative to roof level.

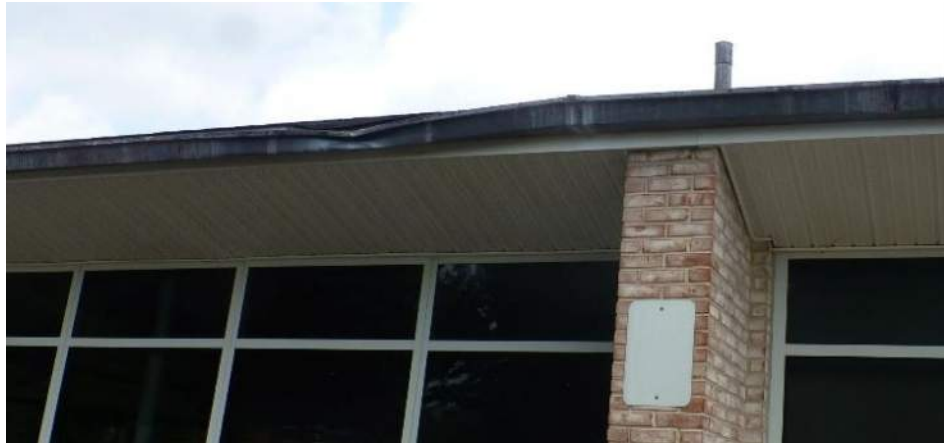
The gutter near Door #43 was noted to be dented and should be repaired or replaced if necessary.

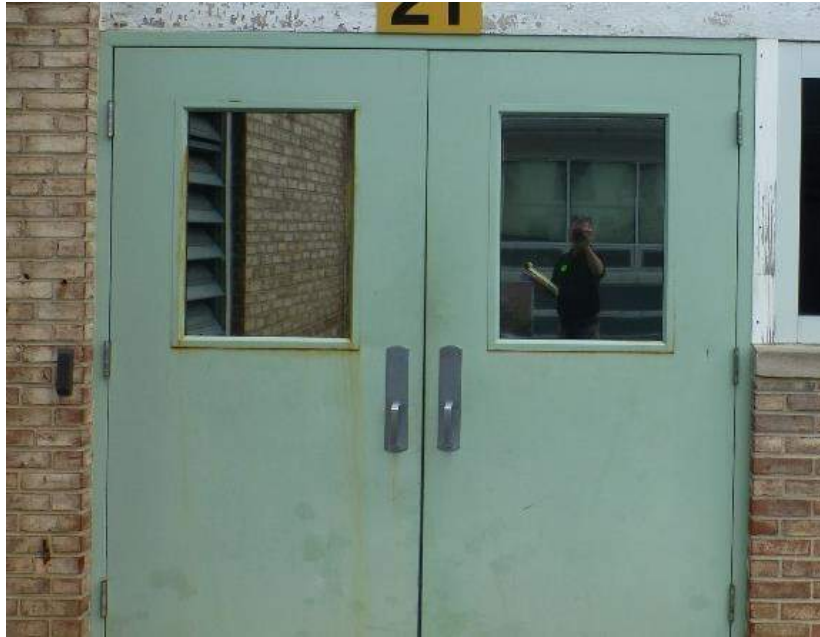
Doors to the gym and also to the exterior storage closets near the boiler room are showing signs of rust.

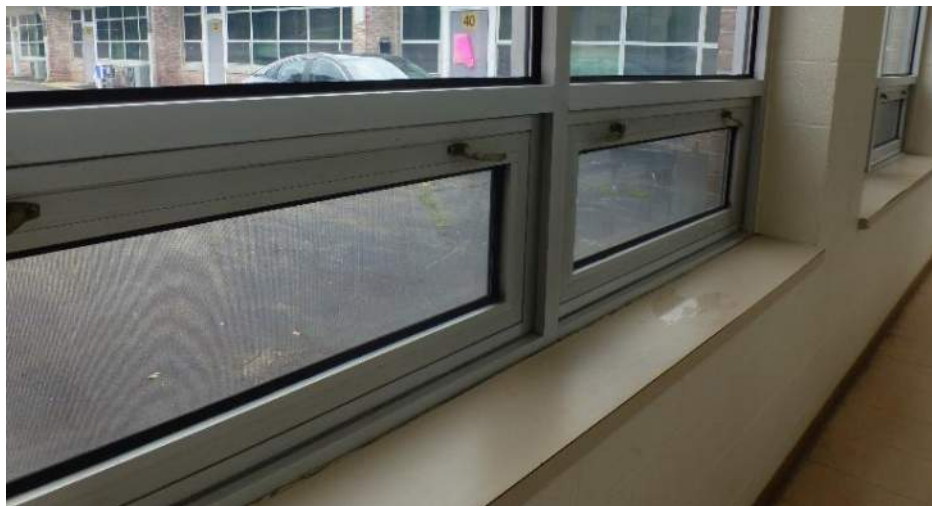
The windows for the 1994/1997 Additions also have aluminum frames with fixed glazing and hoppers. They are typically in good operational condition, but there was evidence of possible water infiltration in several areas (for example, water visible on window stool as shown below along the north wall of the main connector corridor).

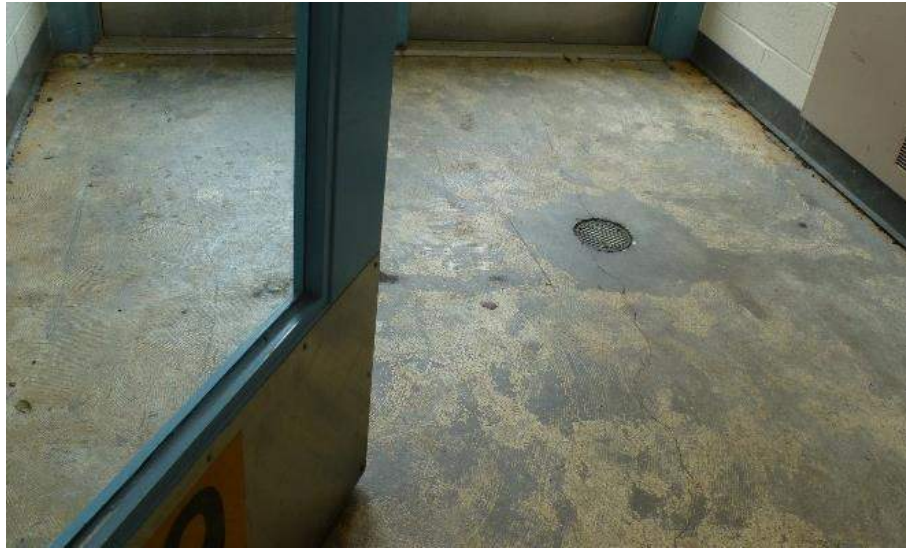
It was noted that there was no flooring material at the northwest vestibule near Door #39.

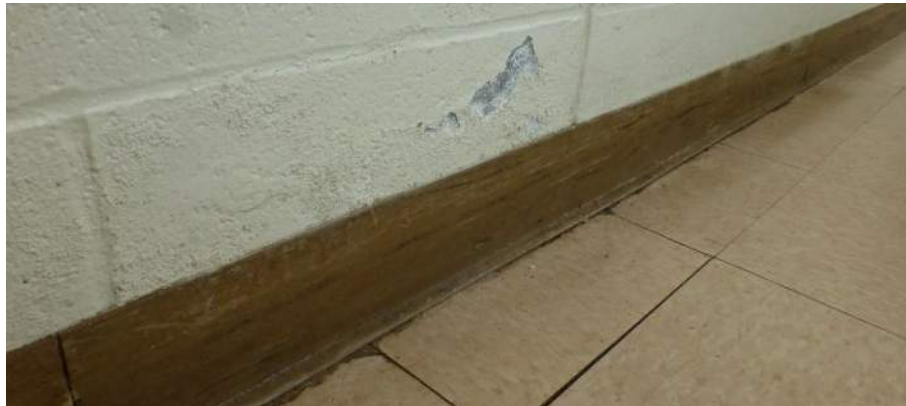
Rubber base molding throughout the entire school is showing signs of significant wear and tear.

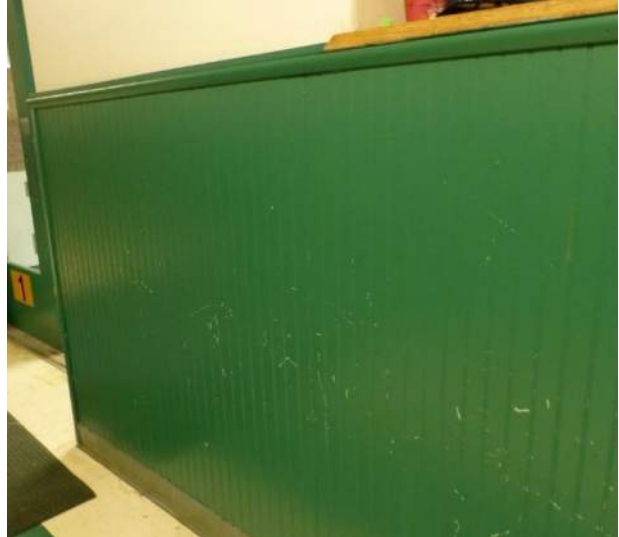
The interior walls are a mixture of painted CMU, brick, and painted gypsum board. Overall, walls are in good condition, but it was observed that there are some minor scuffs and dings on the lower paneling of the main corridor. Typical touch ups for these walls should be expected; patch and paint.

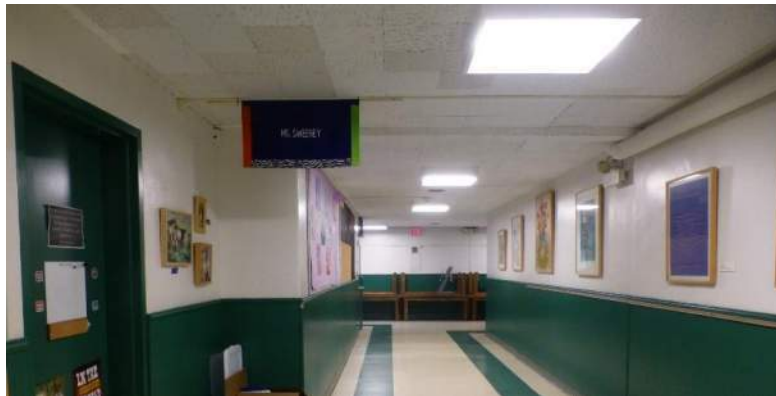
In general, the ceilings of the original 1953 building tend to be the 12"x12" tiles. Although a very dated look, these appear to be in fair to good condition except for some areas of unsightly color variation where tiles have been replaced. Per WPS Facilities, the z-spline ceiling tiles are typically adhered to sheetrock above. Sagging is occurring in many locations due to failure of the fastening of the sheetrock to structure, such as along exterior walls at Classrooms 16 and 23. Classroom 27, appears to have water damage at the ceiling and the corner of the interior wall adjacent to the window. Replacing all the z-spline ceilings should be considered.

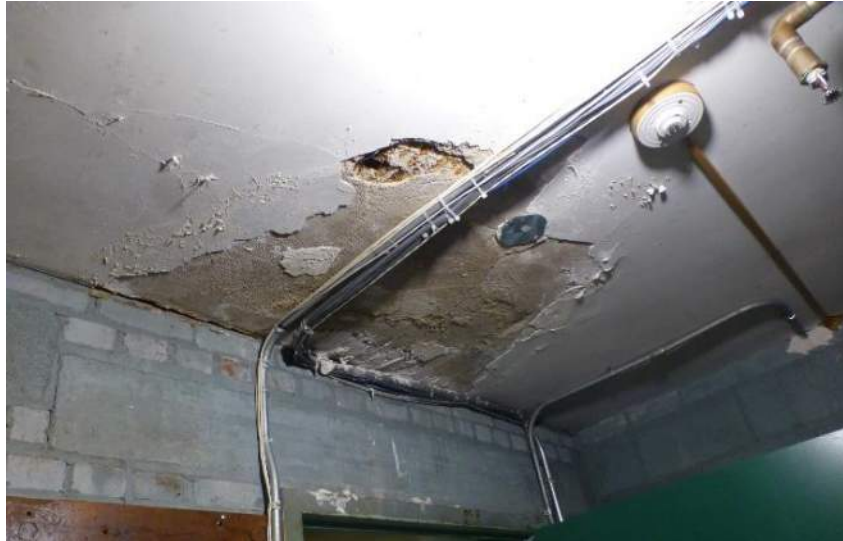
The ceiling of the Janitor's Closet was found to have damage, potentially from water. If this has not already been addressed, this should be further investigated to determine the source. Once the source of the damage has been resolved, the ceiling should be scraped, cleaned and repainted.

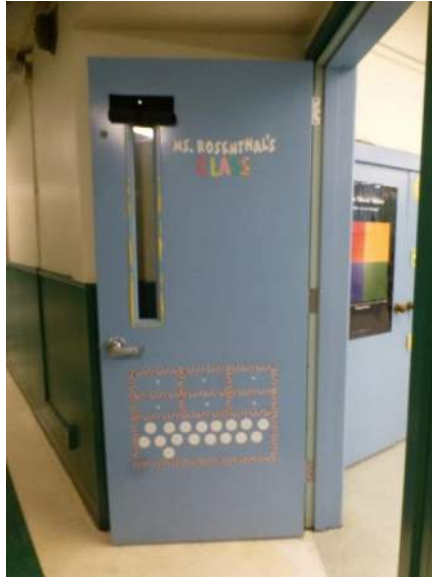
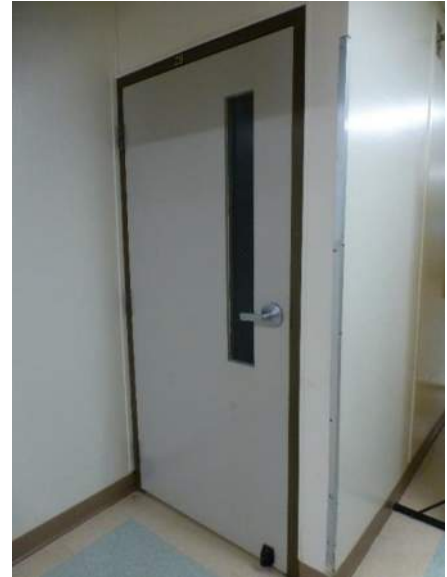
In the original 1953 building, entry doors to classrooms are either solid core wood or metal doors with a vision panel. Some door frames are still wood, although several have been changed out to hollow metal. The doors in the rest of the school are metal with hollow metal frames, also with a vision panel. Typically, door leafs are 36” wide and are generally in good condition, although some are in need of a new coat of paint for both door and frame. Entry doors have lever-type hardware for accessibility to persons with disabilities.

It was noted that closets in the older classrooms have standard knobs which do not comply with current accessibility codes.

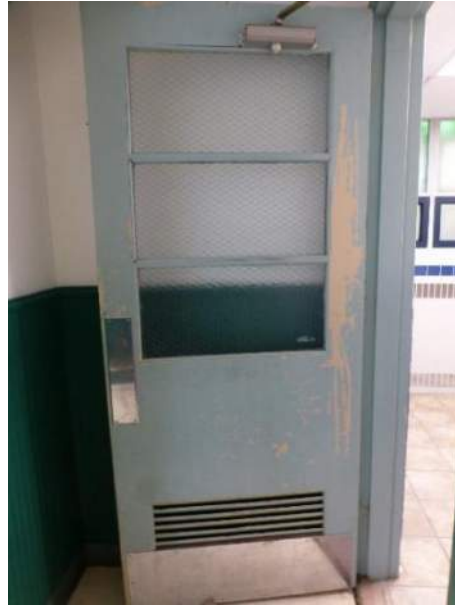
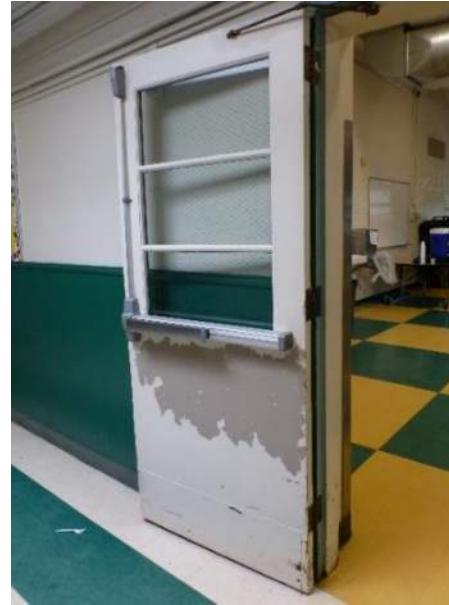
Doors to the Cafeteria and to several of the toilet rooms in the older portion of the building appear to be original with three panes of glass. If these doors are to be kept, they need to be scraped, cleaned, and repainted. The panes of glass to the toilet rooms should be removed and replaced with frosted, tempered safety glass.

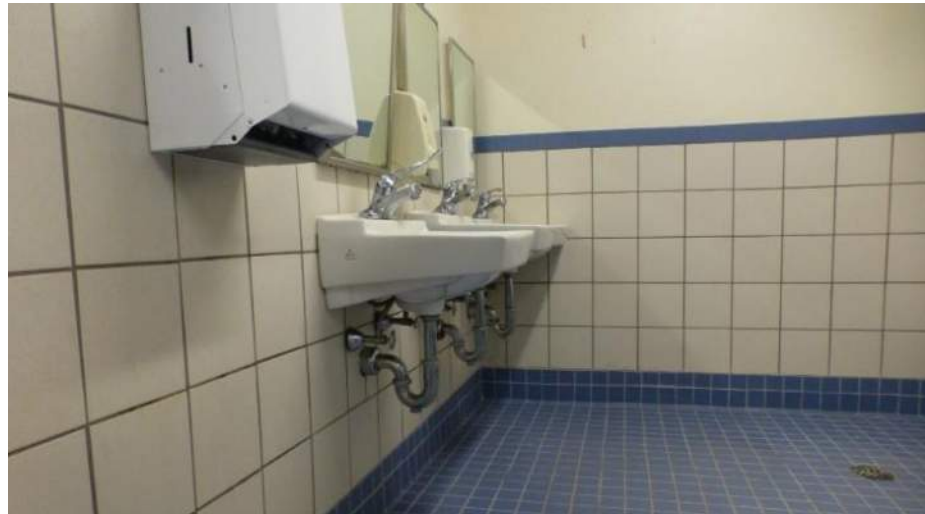
Plumbing fixtures appear to be in fairly good condition. However, it was noted that not all sinks have proper knee protection covers at the pipes.

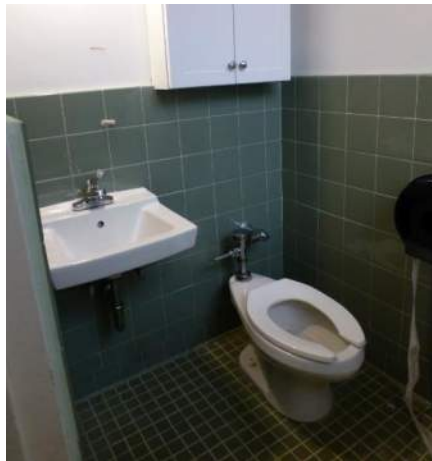
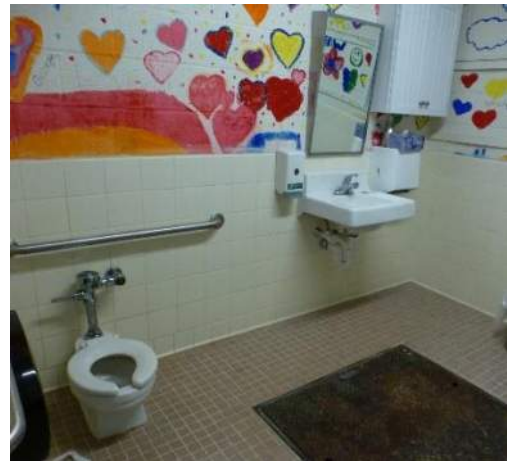
Several classrooms are equipped with their own individual toilet rooms. These toilet rooms, in general, appear to be in good condition, although not all are accessible.

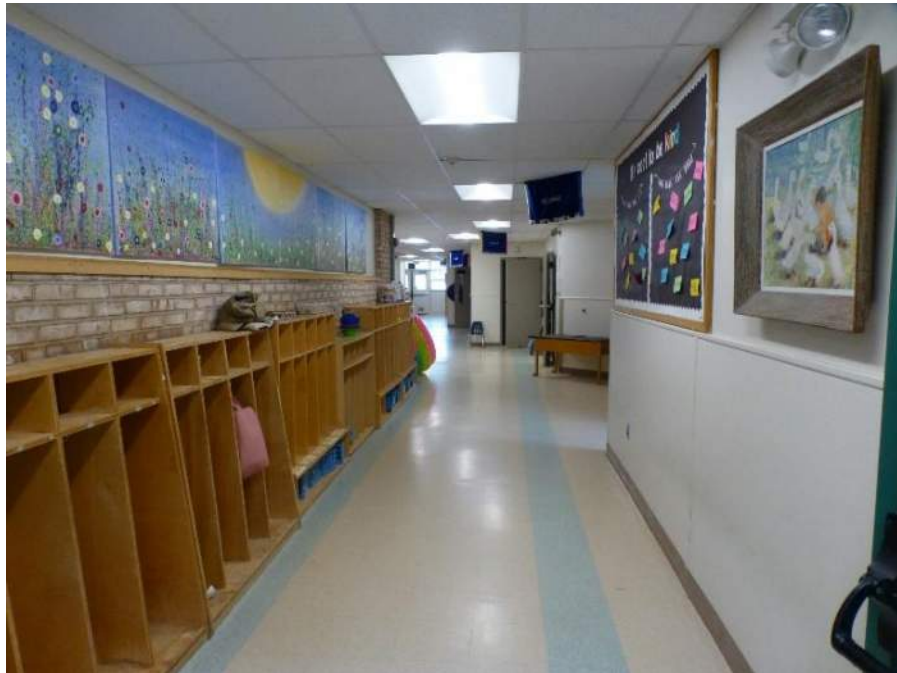
The southwest addition built in the 70's is used as a Preschool, equipped with its own classrooms and offices. Overall, this wing is in good condition, although it was noted that some of the 24"x48" ceiling tiles are showing slight signs of sagging and the walls below the chair-rails are in need of cleaning.

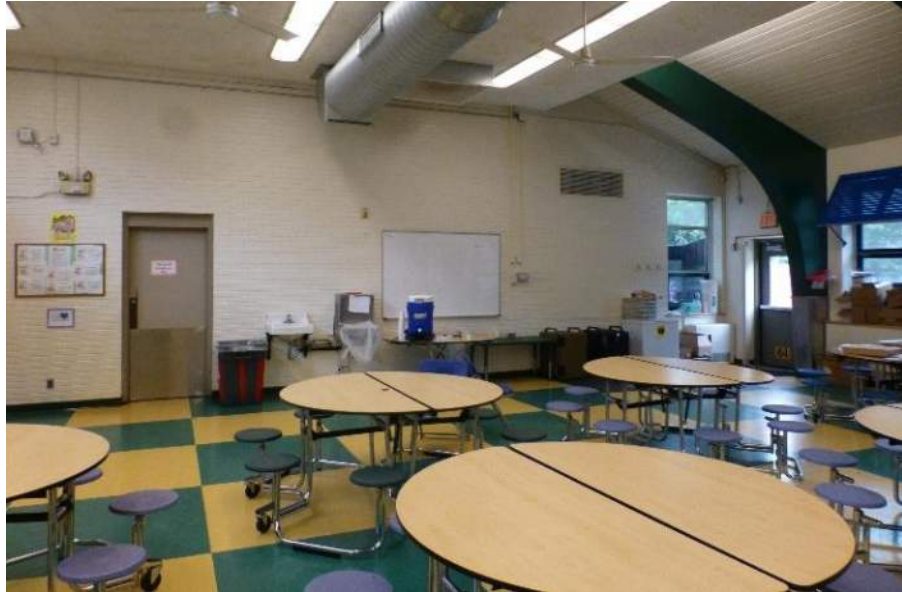
The Cafeteria is approximately 2,220 square feet in size and centrally located off the east side of the main corridor. In general, it is in good condition, but the VCT floors are scuffed and worn in many places. Walls and ceilings are also dull and dated.

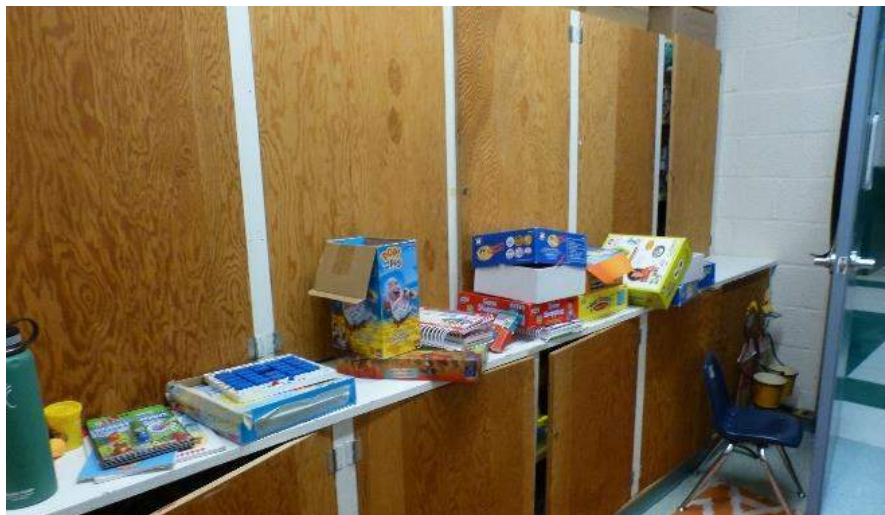
The office space located near Classroom 13 was noted to have storage cabinets constructed with plywood doors. It is recommended that these be replaced with appropriate cabinet doors with accessible hardware.

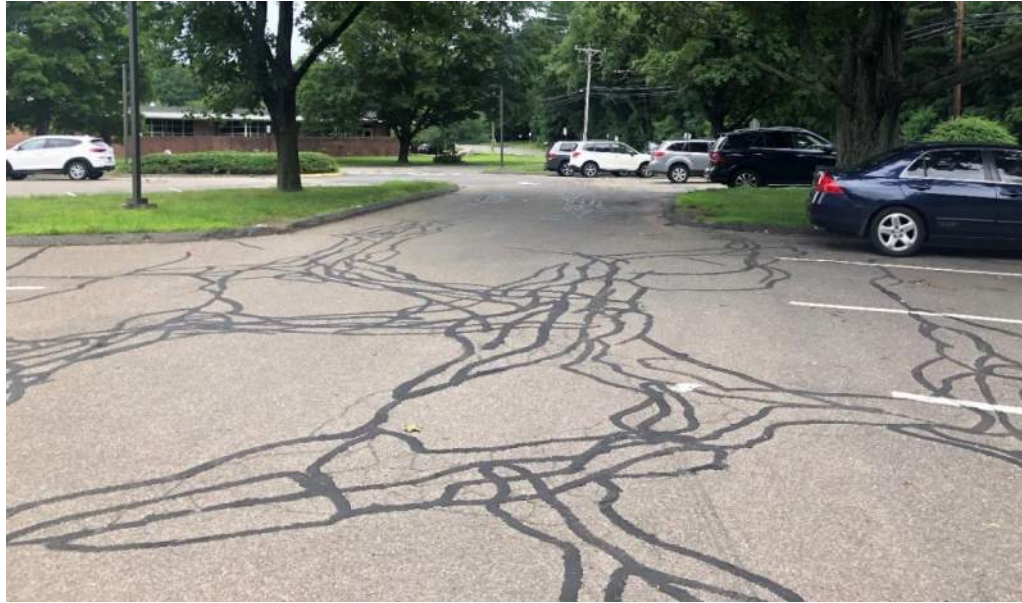
PHOTO #1:

Cracking along pavement. Future pavement repair 5+ years.

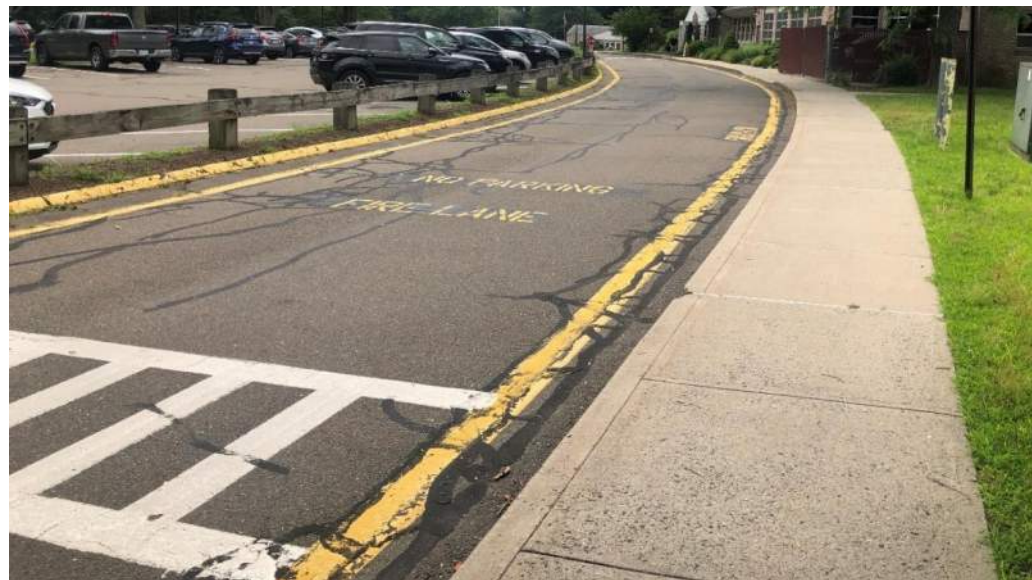
PHOTO #2:

Cracking along pavement. Future pavement repair 5+ years with re-stripping.

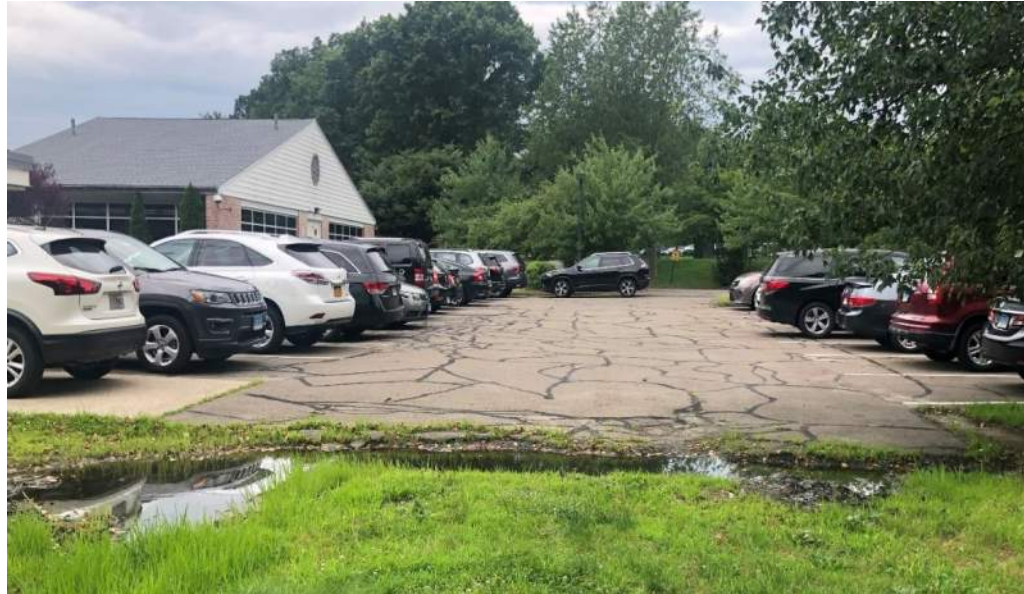
PHOTO #3:

Cracking along pavement and drainage improvements. Future pavement repair 2+ years with re-striping.  
Drainage improvements immediate.

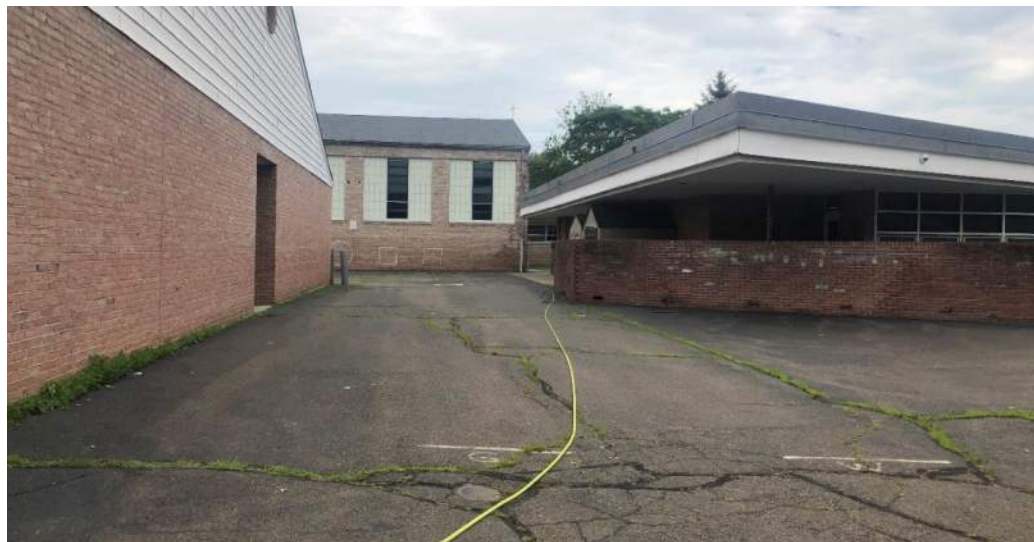
PHOTO #4:

Limit pavement along back side of school.

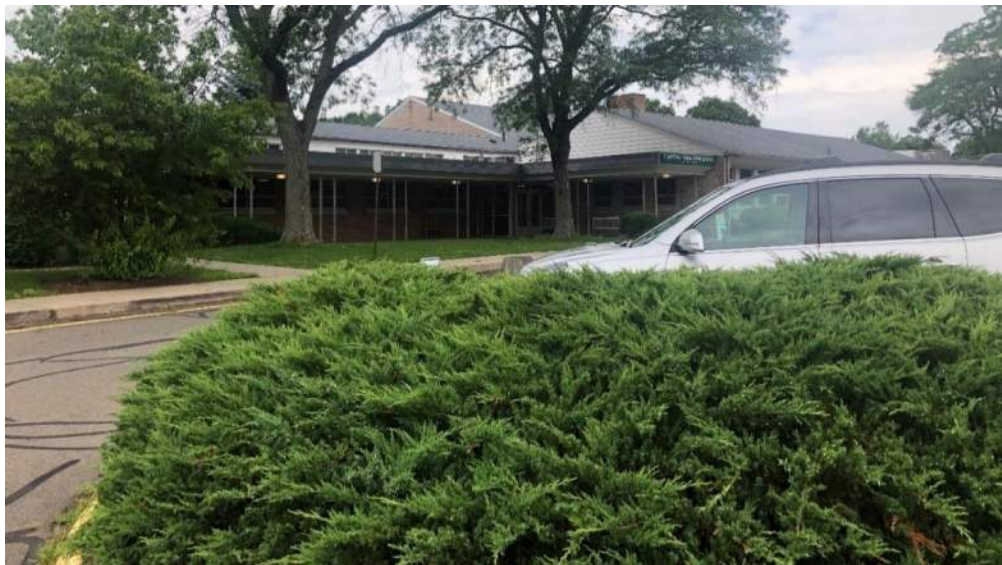
Improve internal sight lines exiting front parking lot. Immediate Need.

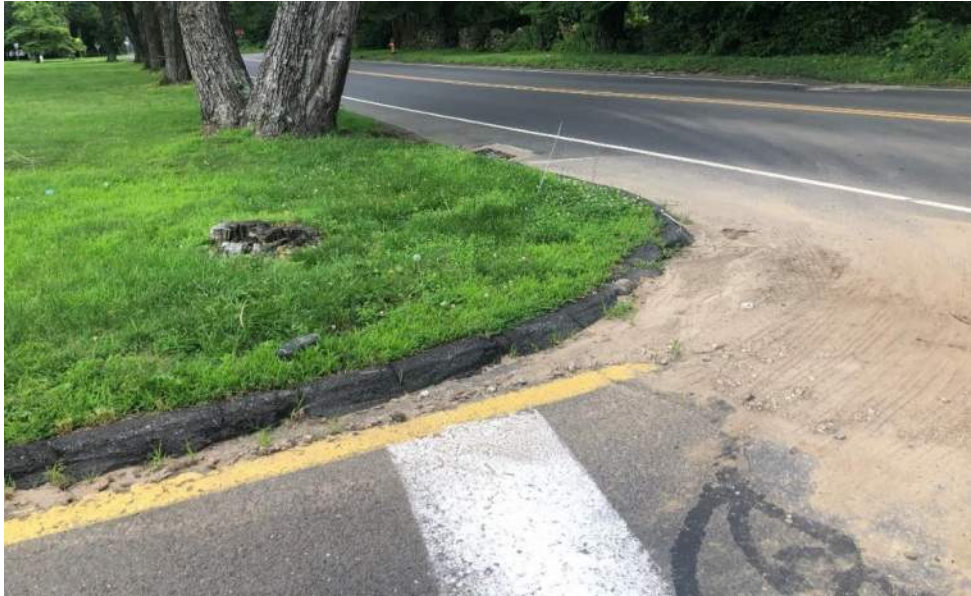
Improve sight lines at exit onto Easton Road. Immediate need.
