WESTPORT BOARD OF EDUCATION

Subject: *Recommended 5-year Capital Improvement Plan FY23 through FY27*

PROPERTY CONDITION ASSESSMENT Long Lots Elementary School

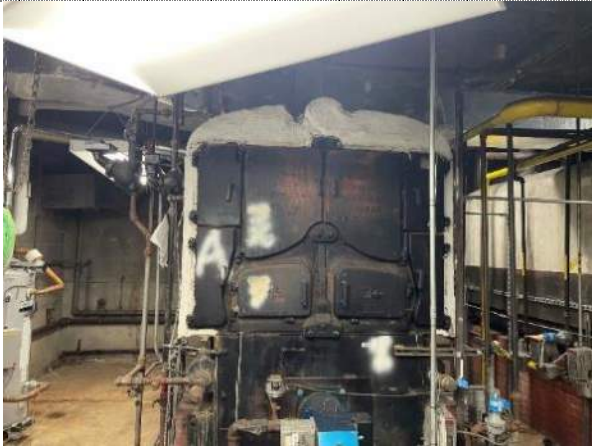
Figure 3: Steam boilers original to the building (cr 1953).

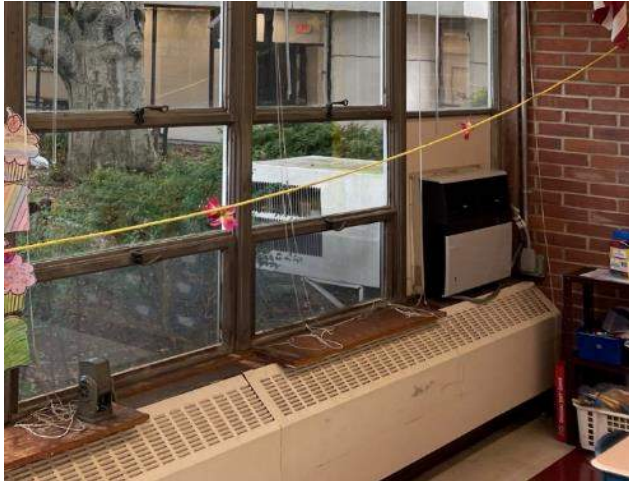
Figure 7: Steam radiation and window AC unit in the original building

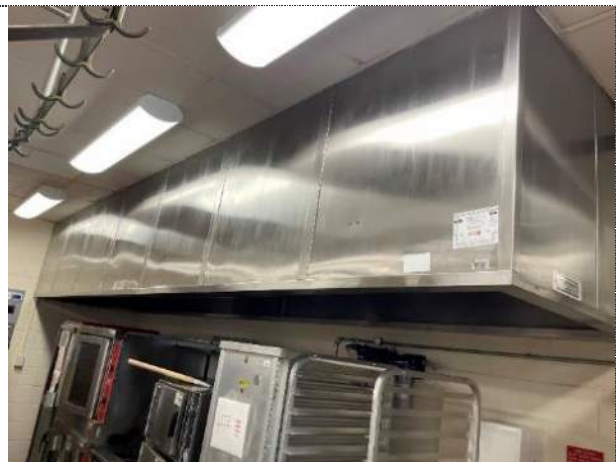
Figure 11: Kitchen exhaust hood.

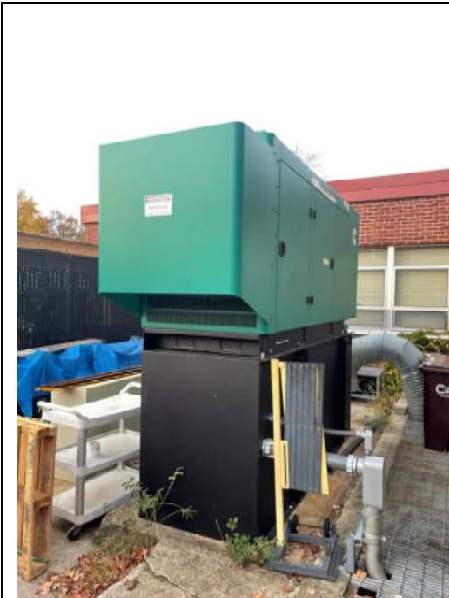
Figure 21: New 125kW Cummins emergency generator

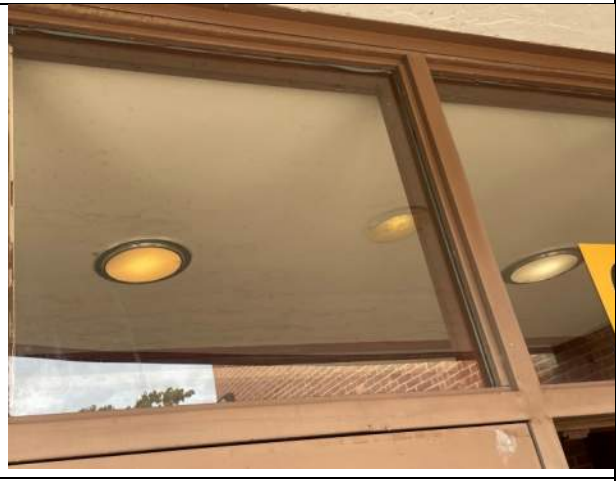
Figure 26: Can light fixtures by rear doorway canopy

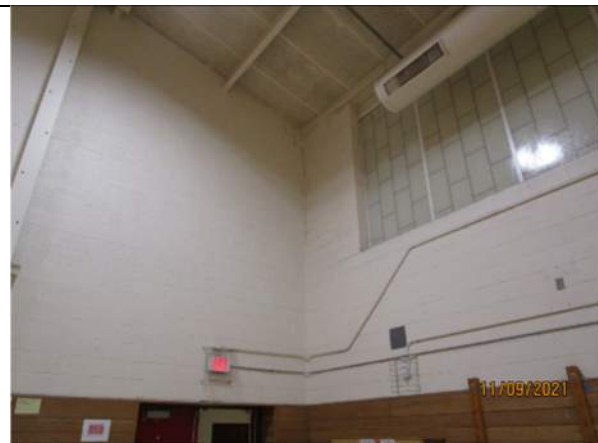
Cracks observed in the block wall of the gym at the common wall to the building chimney.

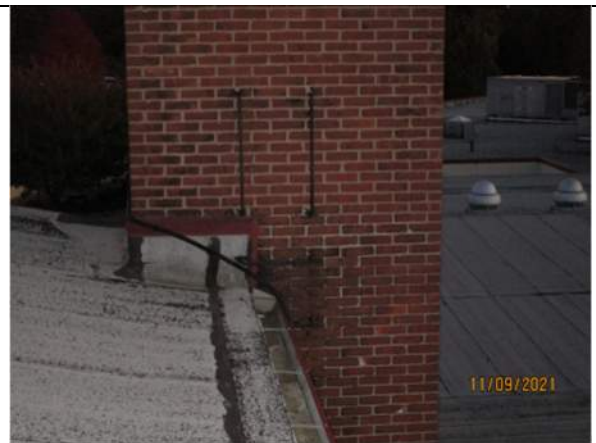
Building chimney at the roof intersection. No sign of water infiltration in the roof.

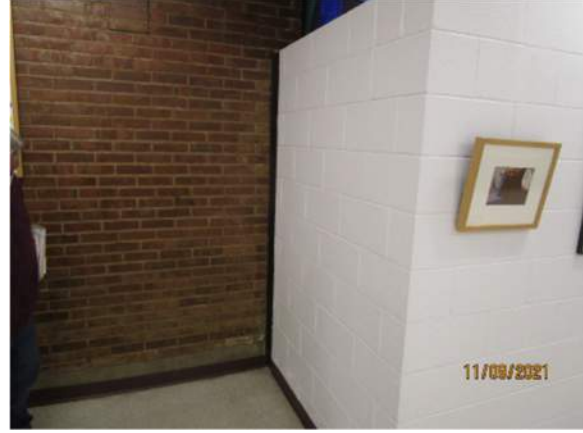
This corner near the ramp is where the water was actively observed entering the building.

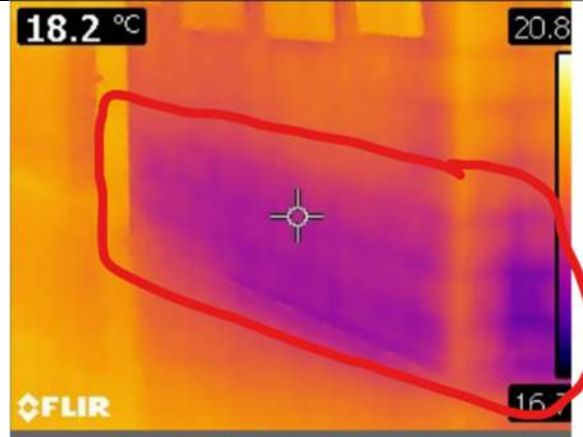
Thermal patterns show cooler temperatures at the foundation wall. This thermal pattern is consistent with missing foundation insulation, wet block, condensation.

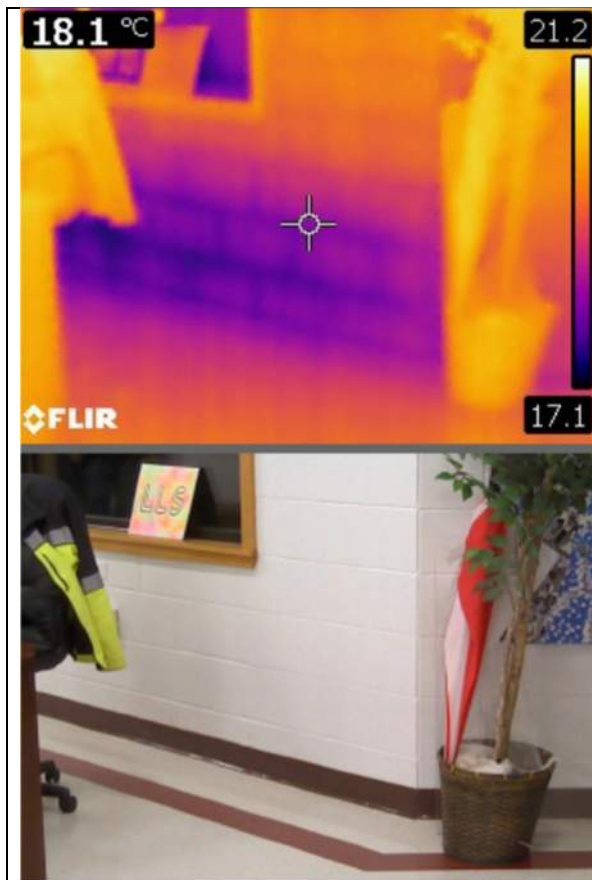
Thermal patterns show cooler temperatures at the foundation wall. This thermal pattern is consistent with missing foundation insulation, wet block, condensation.

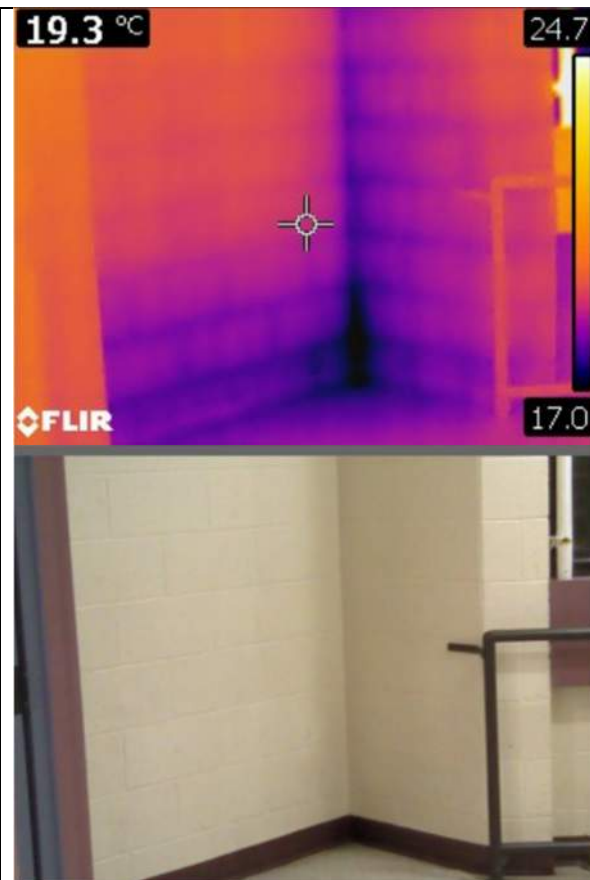
Thermal patterns show cooler temperatures at the foundation wall. This thermal pattern is consistent with missing foundation insulation, wet block, condensation.

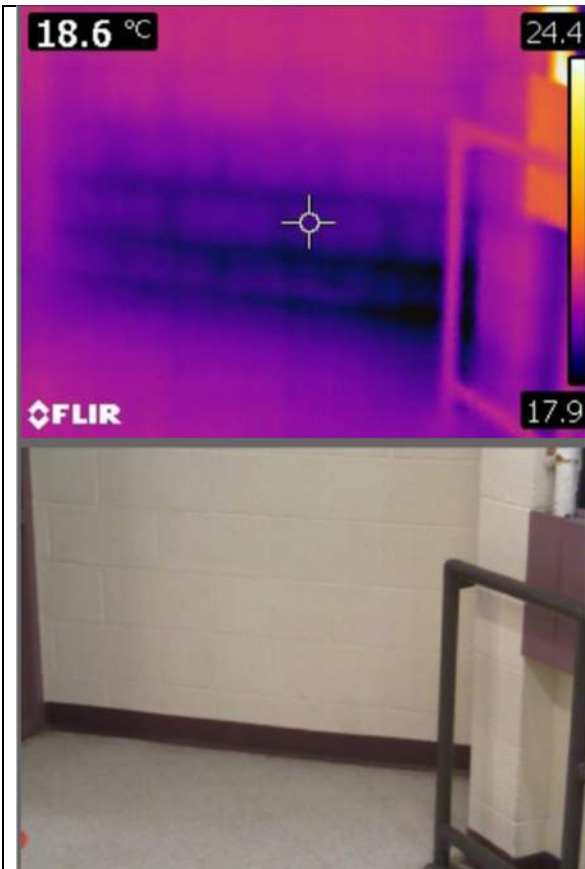
Thermal patterns show cooler temperatures at the foundation wall. This thermal pattern is consistent with missing foundation insulation, wet block, condensation.

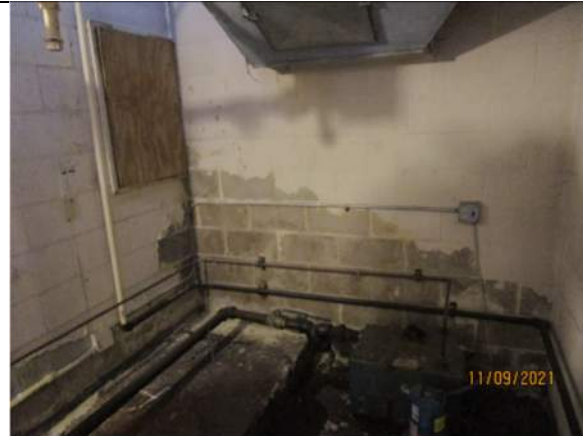
Evidence of hydraulic water pressure against the below grade wall and water infiltration into the building.

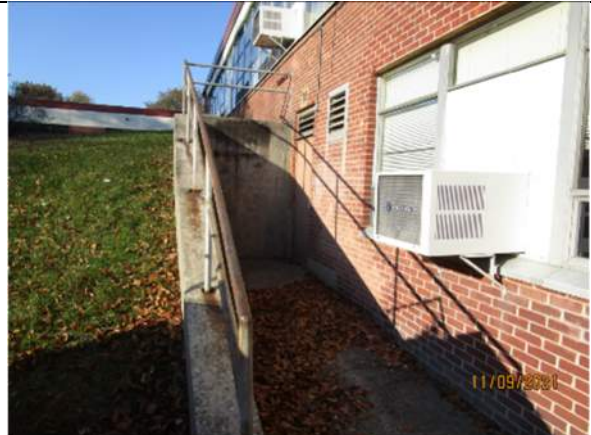
Access to room 19 with a door into the utility tunnels under the building.

Suspect insulation materials on pipes are deteriorating so the tunnels were not investigated.

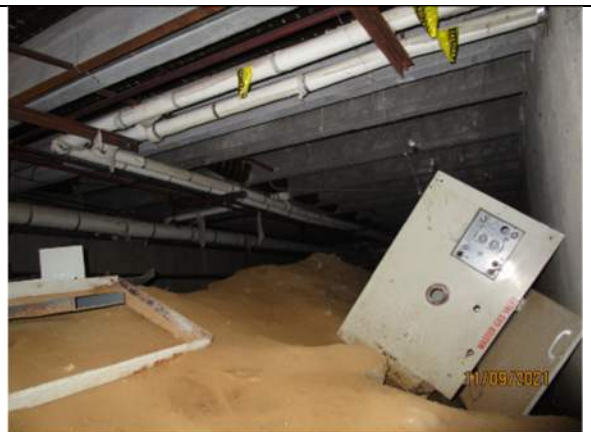
Soils with no vapor barrier allow moisture vapor from the ground into the building.

Observed the unexcavated soil condition through the room 9 hatch.

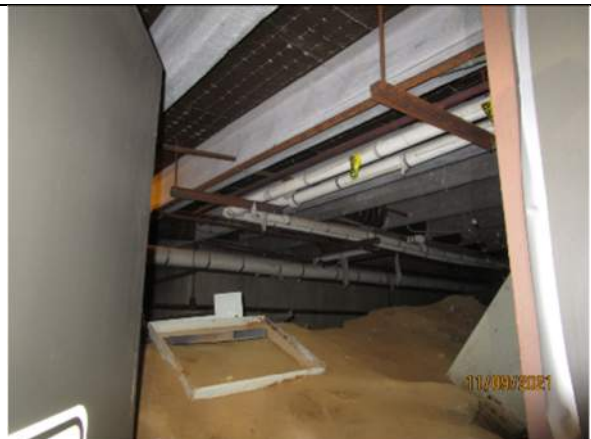
Sandbags observed in place to prevent surface water from infiltration the building. Site grading changes will be needed to correct water infiltration plus the addition of area drains.

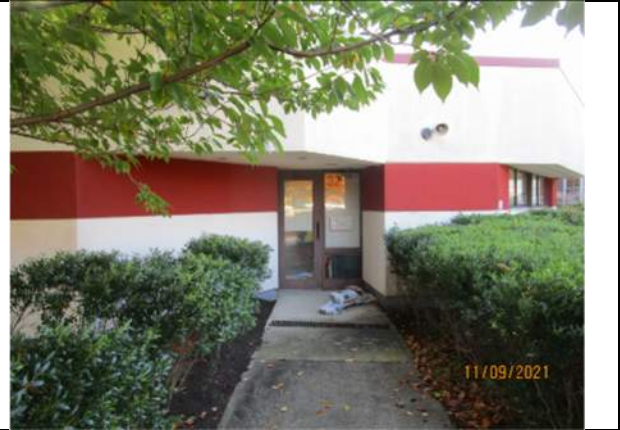
Courtyard 24" beech tree canopy overlaps the building. This has the potential to cause multiple issues. The root system extends as far as the canopy of the tree and will impact the building foundation, the tree branches are in contact with the roof and will cause damage to the roof membrane and flashing, the leaves from the tree are collecting on the roof and will impact the function of the roof drains.

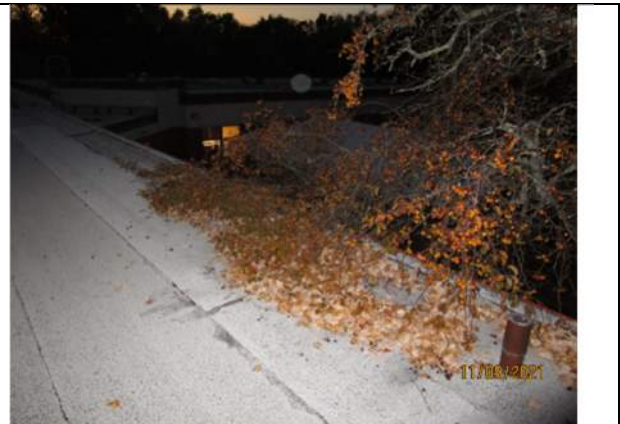
Additional trees overgrow the roof line and should be removed to prevent roof and foundation damage.

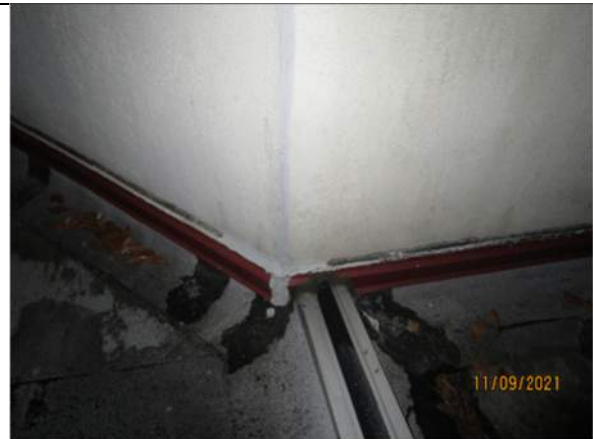
<p>Roofing cap sheet is delaminated from the lower plies of roofing.</p> <p>The roof blisters are causing water infiltration to the lower plies of roofing both through cracks in the cap sheet and condensation building up in the blisters. The moisture trapped in the blisters will deteriorate the roof at an accelerated rate.</p>

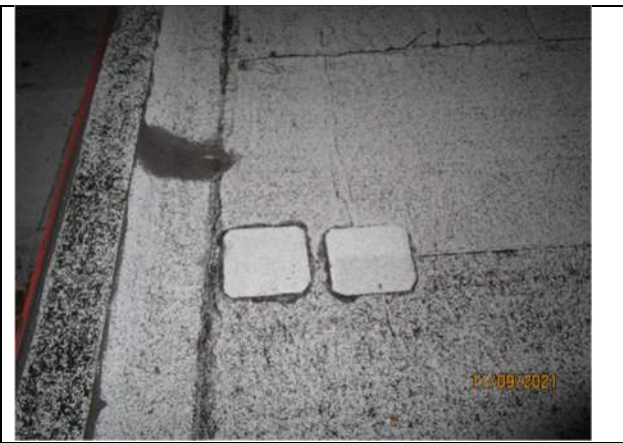
<p>Annual and semi-annual roof inspections are performed on Long Lots. The maintenance of the roof is evident. Leaks have been chased for years with new sealant observed at cracks, joints, pitch boxes and repairs.</p>

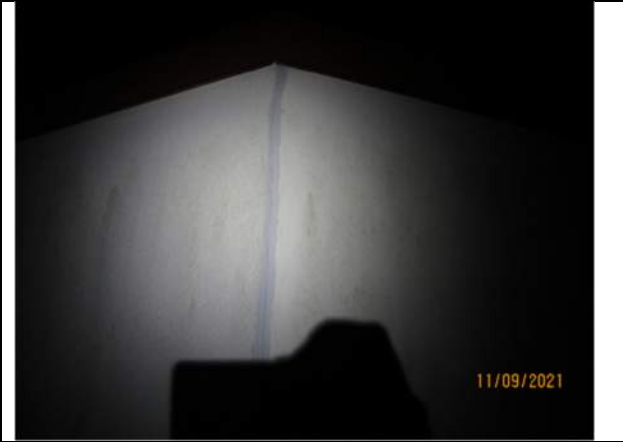
<p>The roof is very fragile. The blister spots are easy to damage if walked on especially in the colder temperatures in addition the bitumen is getting cracked and brittle.</p> <p>The life expectancy of this roof is 10 – 20 years and it is showing signs of wear.</p>

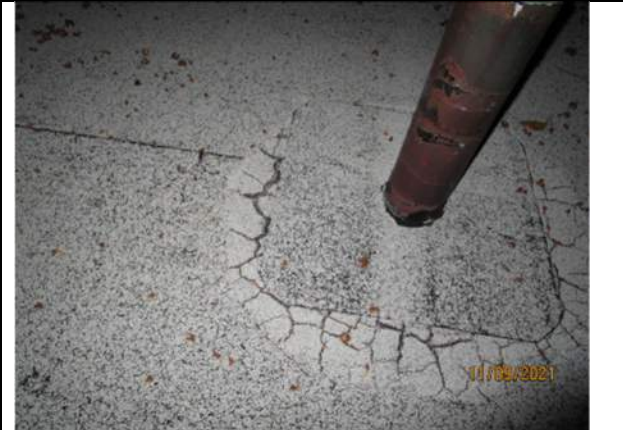
This roof is not impact resistant to falling branches. As mentioned above some trees overhang this building and should be removed.

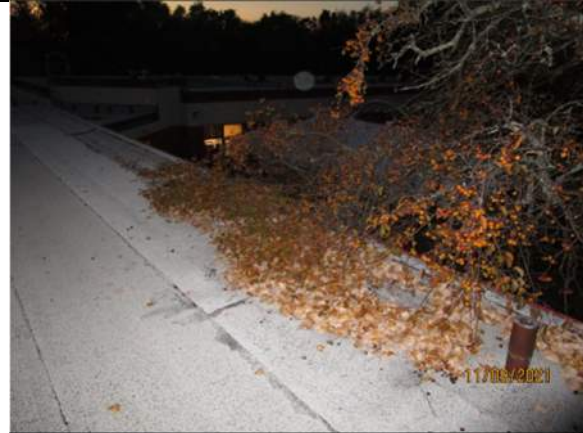
Puddling will cause a modified bitumen roof to wear down faster. The building maintenance team is doing an excellent job of preventing puddling by keeping the roof drains clean. No leaf clogged roof drains were observed during the site visit despite leaves actively falling on the roof from overhang trees.

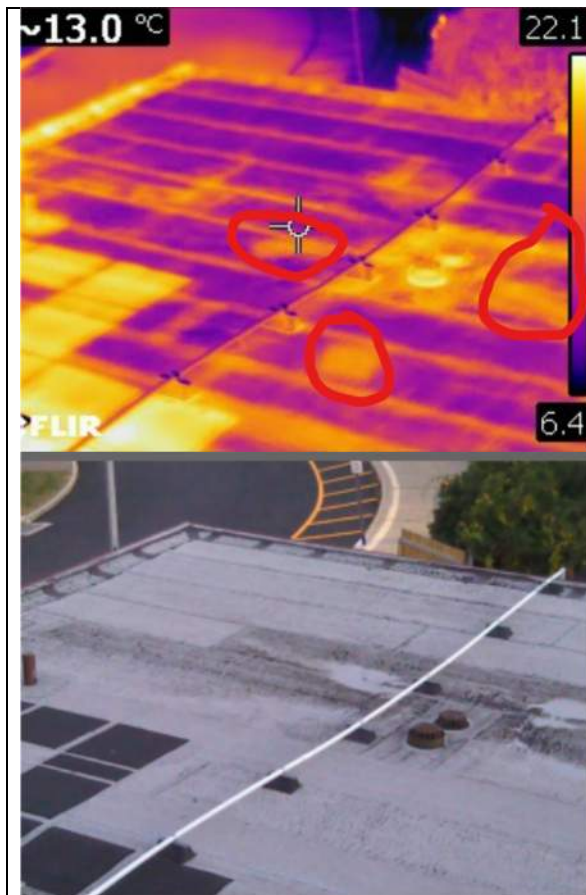
The brighter colors are thermal patterns consistent with wet insulation below the roof membrane.

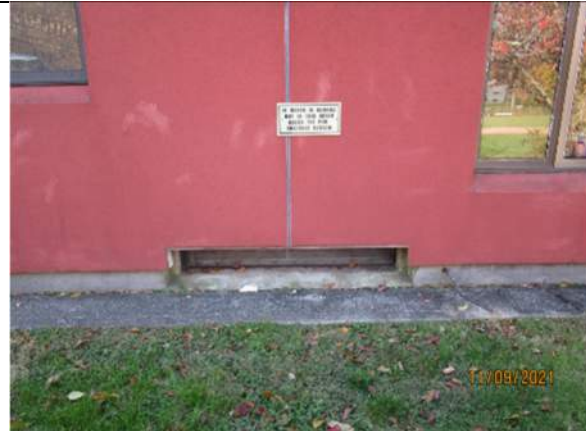
The openings and the clogged dampers allow moisture into the building – snow blows through the ventilators.

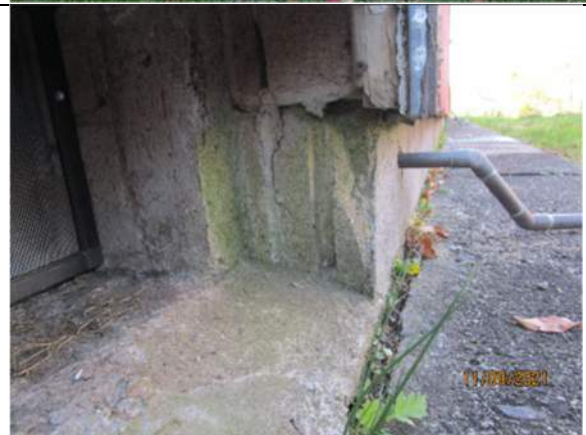
Water observed withing the backside of the External Finish System that poured out of the wall assembly when the unit ventilator was removed. This is an indication that water is trapped behind the finish system reducing the effectiveness of the insulation and causing issues associated with water trapped in a wall system. This was in the 200-wing building.

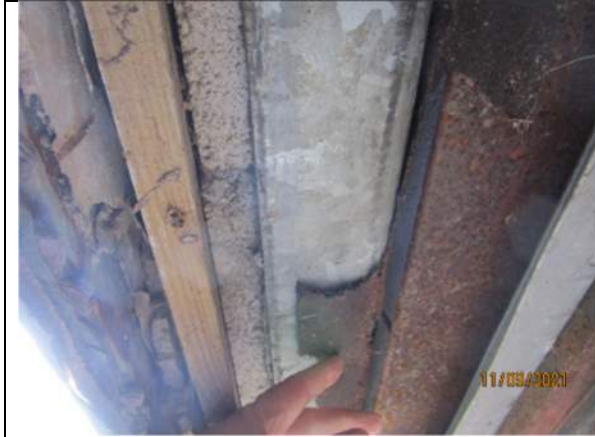
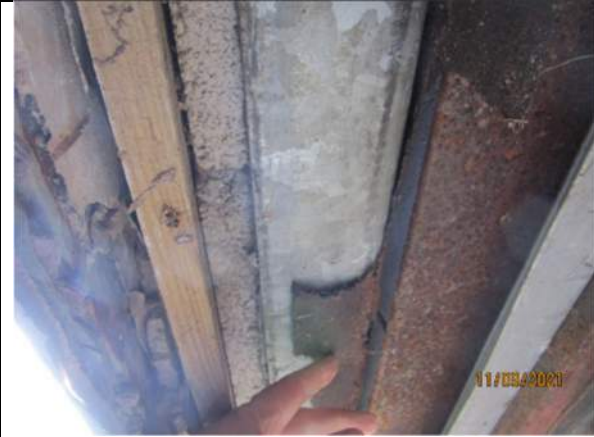
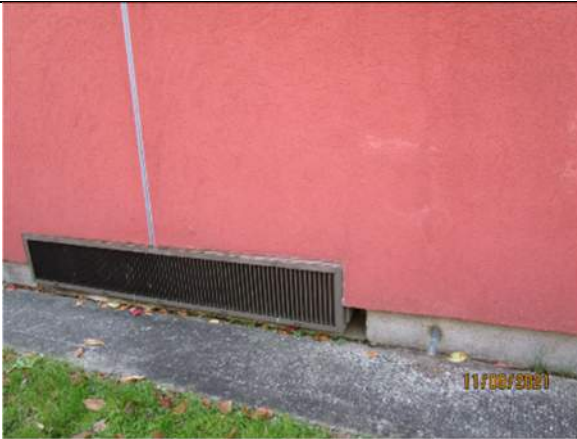
Unit ventilator in place at ground level. Cold air and surface water have an open pathway into the building.

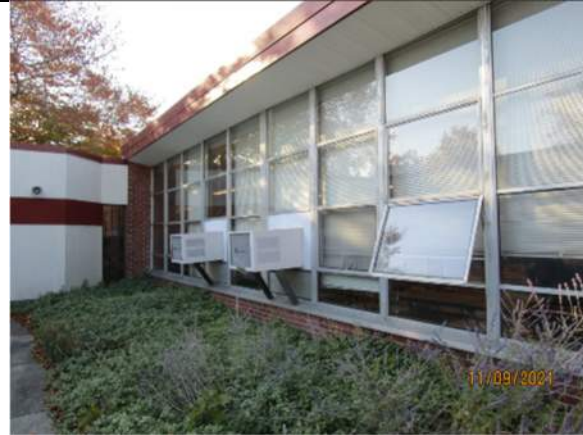
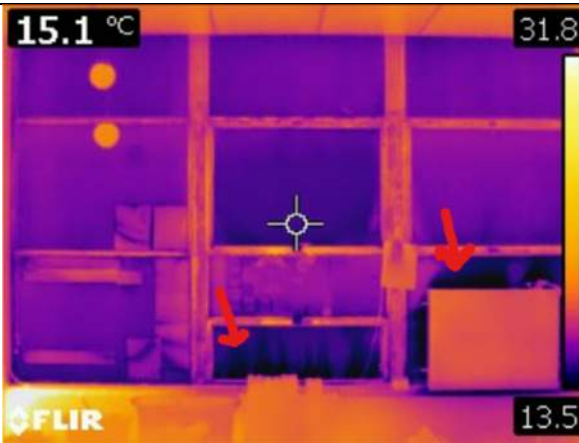
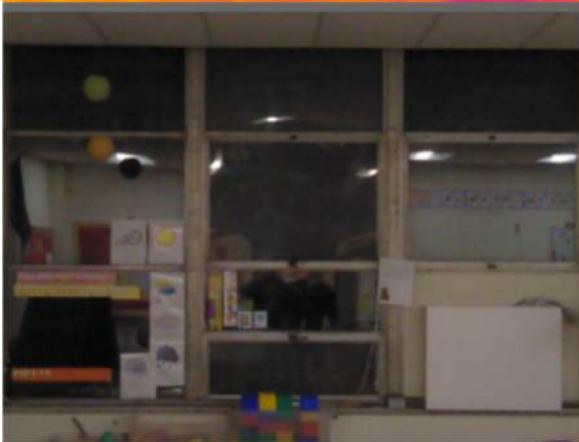
The wisps of black seen at the hopper window and around the air conditioner are cold air drafts into the building.

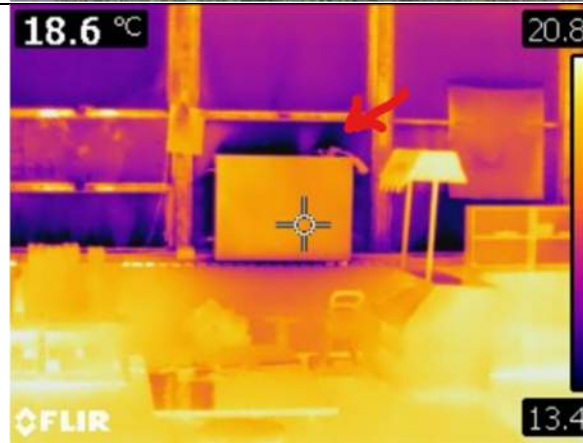
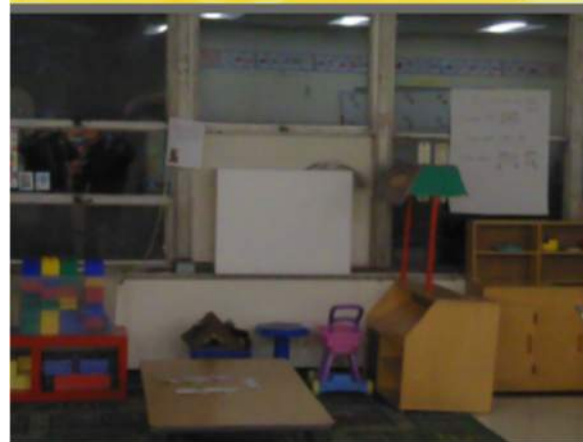
The cold air draft around the air conditioner cover can be clearly seen by the dark colors around the unit.

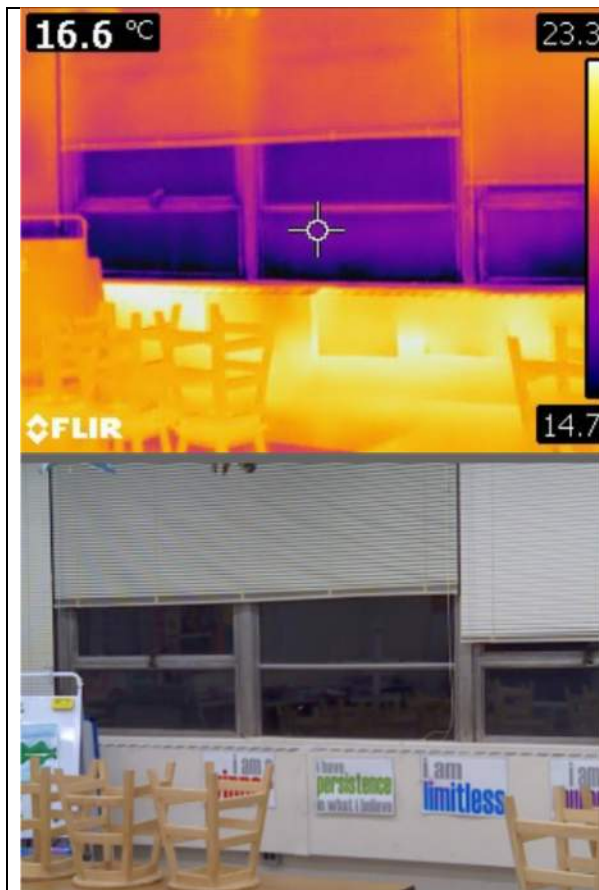
The bright colors are the warm surfaces, and the dark wispy colors are the cold air infiltration drafts. Normally these surfaces would be a consistent color. There is a significant amount of thermal bridging heat loss through the window frames and significant air infiltration.

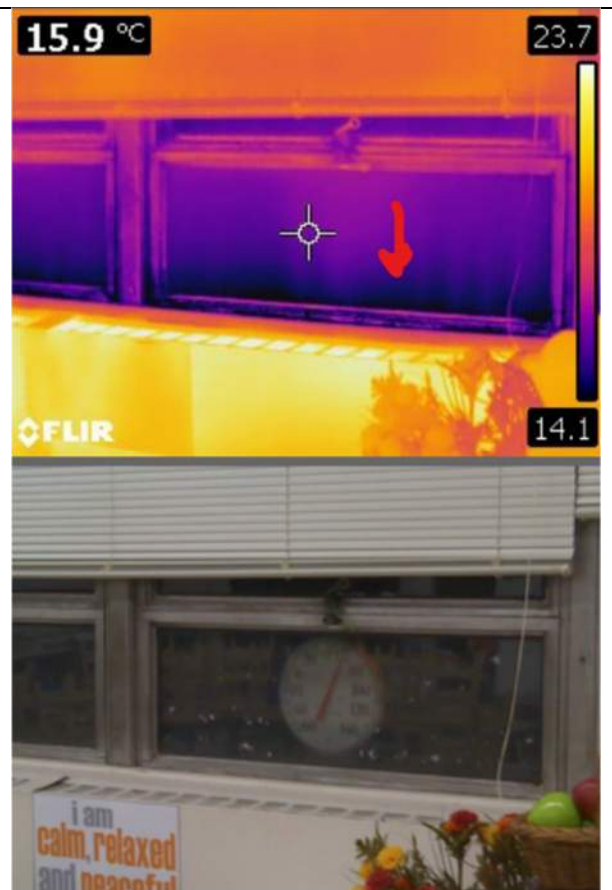
The bright colors are the warm surfaces, and the dark wispy colors are the cold air infiltration drafts. Normally these surfaces would be a consistent color. There is a significant amount of thermal bridging heat loss through the window frames and significant air infiltration.

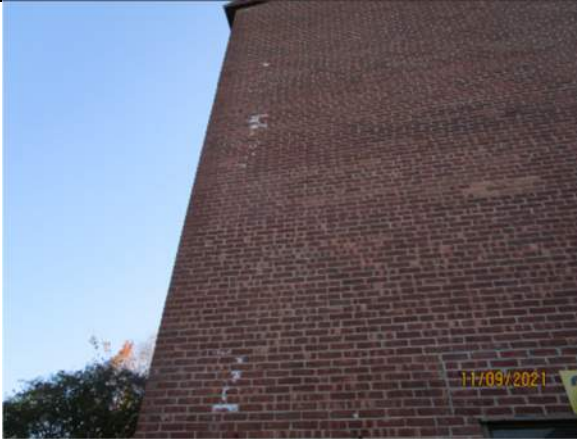
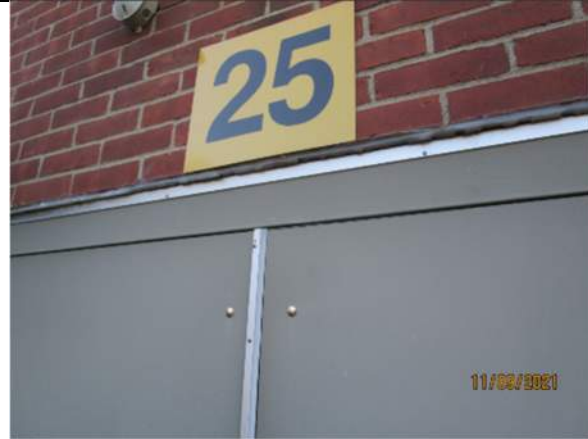
Extensive sealant has been applied to the door lintel. The water infiltration is likely coming from the brick wall cavity from a source higher on the wall or at the roof flashing.

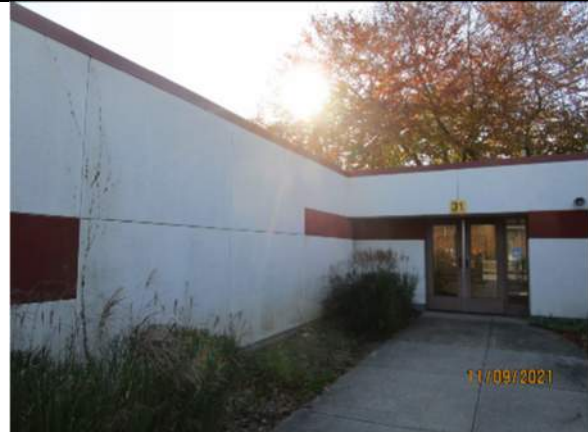
Organics appear to be growing on the surface of the finish system. Water being trapped behind the system has been observed at the unit ventilators and the base of the finished system walls.

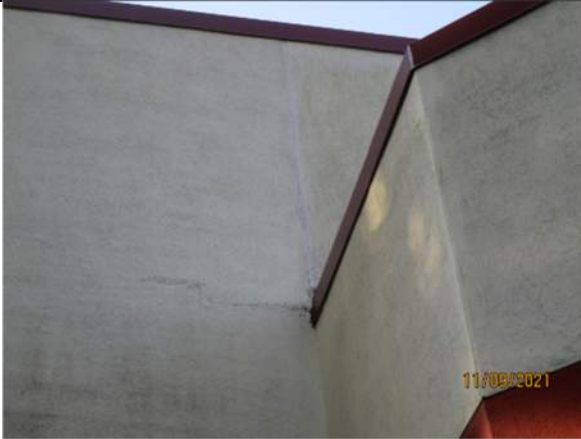
Cracks in the finish system have been sealed to try to prevent water infiltration.

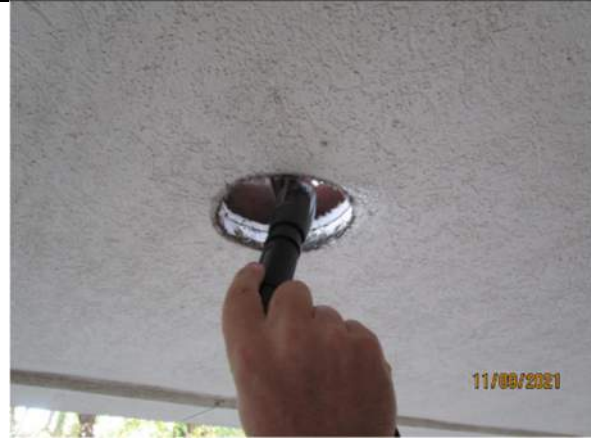
Vent into finish system soffit.

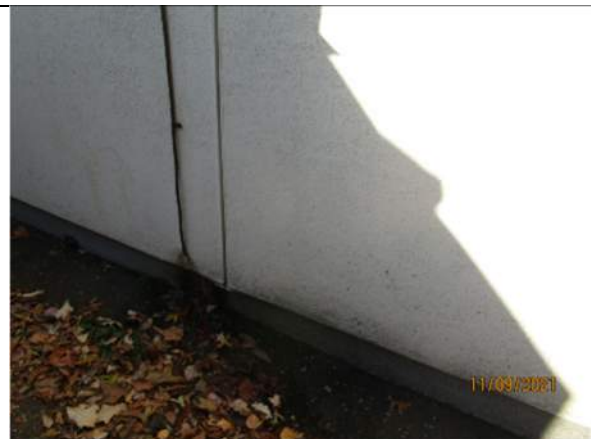
All the base trim and control joints appear to have expansion damage from water exfiltrating the system and expanding when leaving the system.

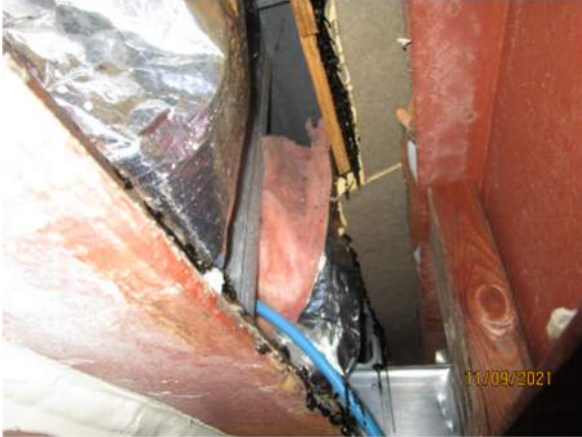
Insulation in the exterior walls is not properly installed. The vapor barrier should be overlapped and sealed from each section of insulation. Without the continuous vapor barrier airflow is free to infiltrate and exfiltrate the building.

A damp patch on a wall is usually much cooler than the surrounding surface and when moisture-laden air meets a colder surface, it causes condensation. Several areas with thermal images with a temperature variation that are consistent with condensation have been identified. Condensation damp areas can lead to microbial growth. If condensation is not dealt with it will go on to cause mold growth.

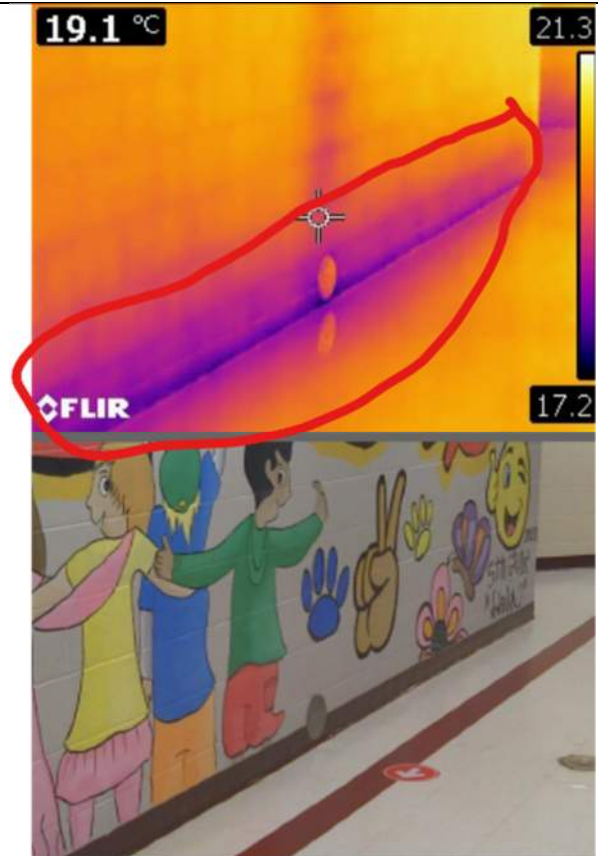
The foundation has no thermal break between the exterior foundation and the floor slab inside of the building causing a cold spot on the walls and floor that can lead to condensation.

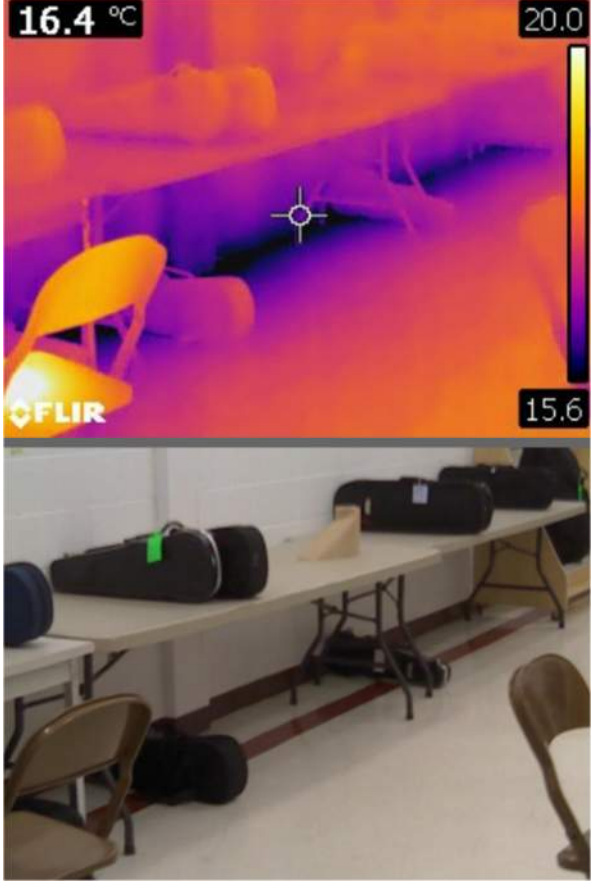
<p>Cold thermal bridge at the exterior walls.</p>

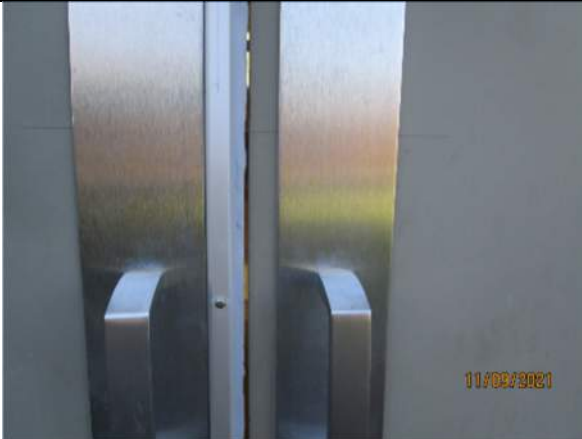
Visible gaps in the weather stripping at the doors observed.

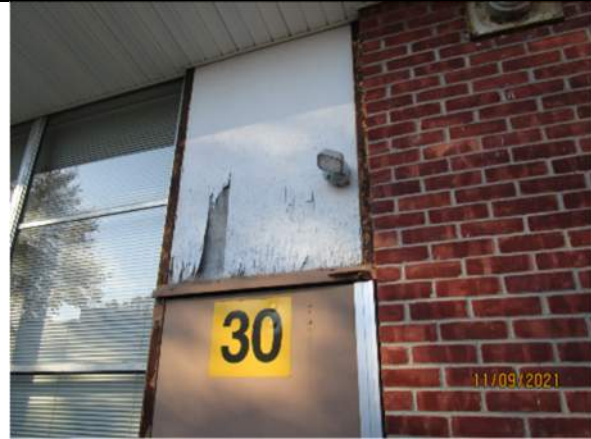
Deteriorated exterior walls systems observed.

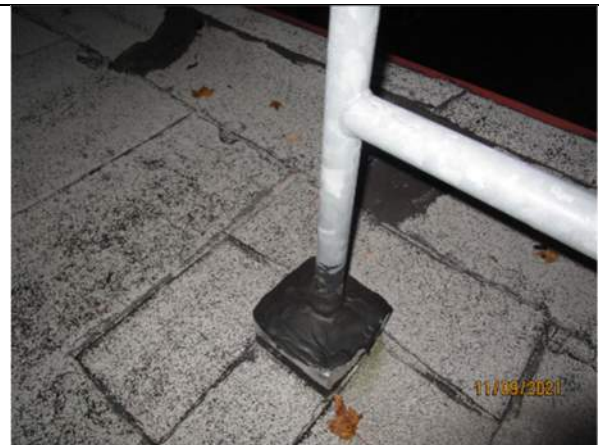
Pitch box at the guardrail has been refreshed.

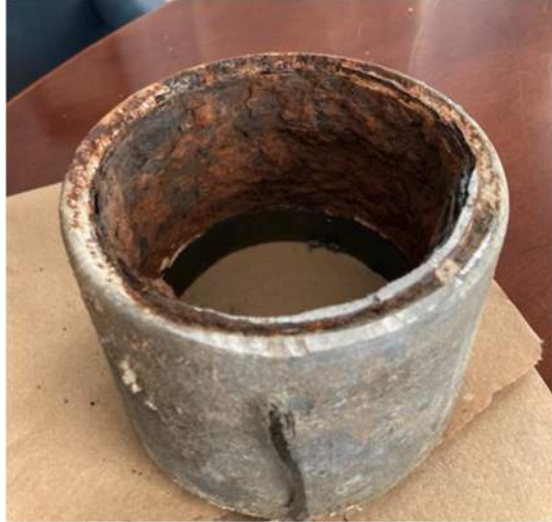
A roof drain body and piping that had been replaced was observed in the office. There was a hole in the pipe indicating that the roof drain system has exceeded its lifespan.

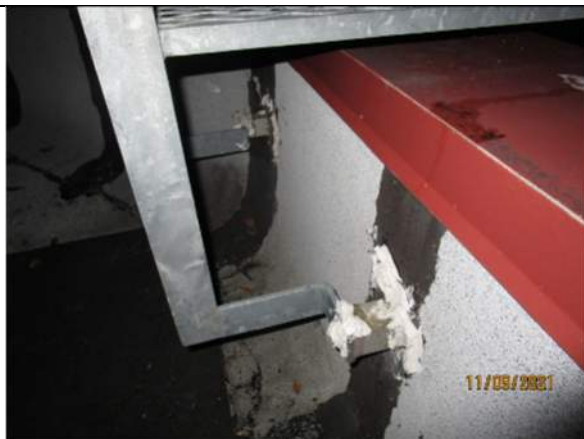
The access ladders on the roof levels have failed anchoring systems. The anchors have pulled out of the building and as a result the ladders are very loose. This is causing a potential water infiltration issue at both ladders.

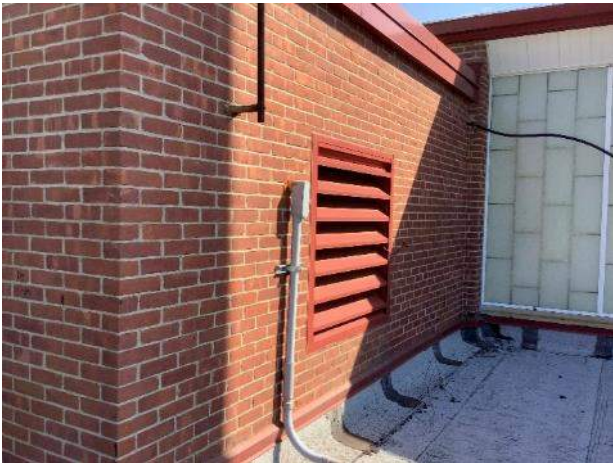
OA louvers on the exterior of wall of the building as observed from the roof.
