INFRARED ROOF INSPECTION

PERFORMED FOR: WESTPORT BOE TED HUNYADI

LOCATION: STAPLES HIGH SCHOOL 70 NORTH AVE WESTPORT CT 06880

This report summarizes the findings of our Infrared Roof Moisture Analysis of the roof at Staples High School, Westport, CT, performed on November 7, 2020.

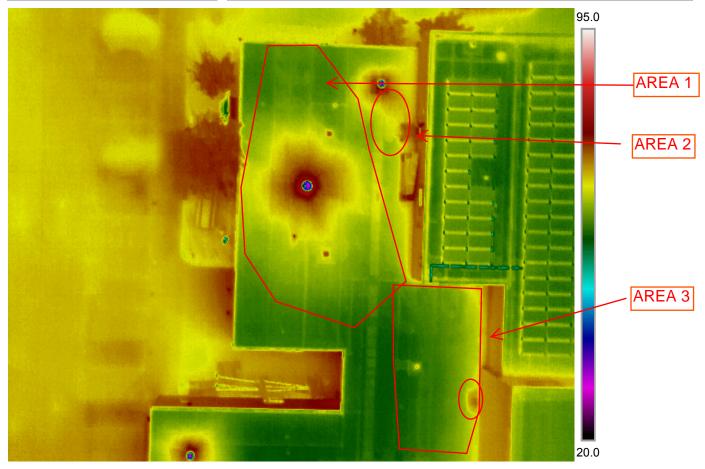
Area 1 ~ 1751 sqft. This area appears to have a significant amount of possible standing water or residue near and around the drain.

Area 2 \sim 97 sqft. There appears to be heat coming from a patch near the walk way pads as well as residual standing water around the drain and wall.

Area 3 ~ 916 sqft. The area along the Eastern wall and over to the walk way pads shows traces of heat and possible moisture.

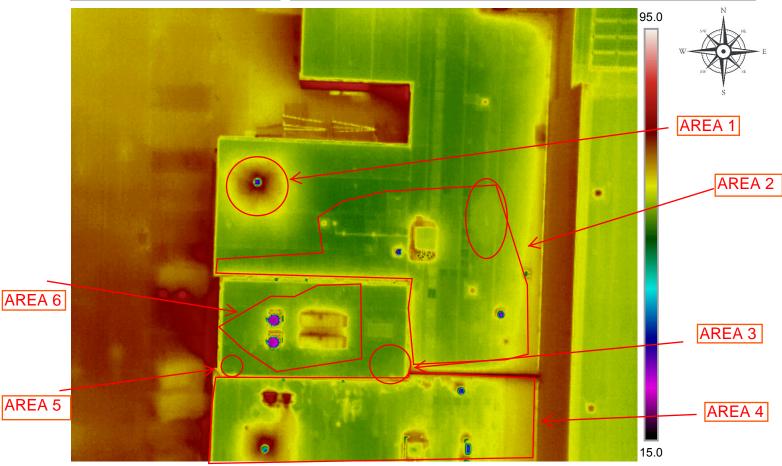
Roof C

AREA 1 \sim 200 sqft. Area revolves around a possible drain or unit which will emit heat. Appears there may be some ponding water or residual moisture left.

Area 2 \sim 2126 sqft. Large area including the areas around the unit, stretching from the edge of the south, east and west portions of the area. Also the large oval shaped area East of the walk pads is called out.

Area 3 ~ 42 sqft. Small south eastern corner of this section Area 4 ~ 2422 sqft. Large area. Almost the entire portion of this section appears to have some sort of heat/possible moisture showing between many small sections and some larger areas. Area $5 \sim 30$ sqft. Small SW corner.

Area 6 \sim 581 sqft. The majority of the area surrounding the 4 units on this roof appears to have heat and possible moisture present.

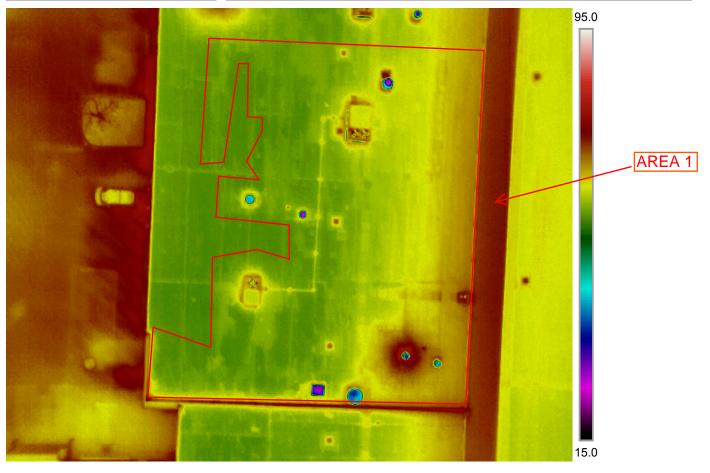
AREA 1 ~ 7111 sqft. A large area that has traces of heat/possible moisture almost entirely covering the section. It cannot be definitely determined whether these areas are standing water or wet insulation etc. However the presence of heat and possible moisture is abundant in this area of the roof.

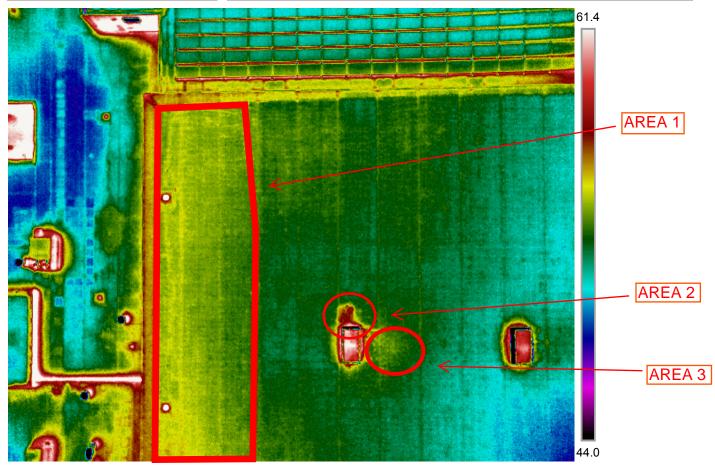
Roof A

Area 1 ~ 2539 sqft. Area that runs along the W edge of this section appears to have heat/possible moisture.

Area 2 \sim 30 sqft. Small area N of the closest unit to the marked location

Area 3 \sim 30 sqft. Small area E of the closest unit to the marked location

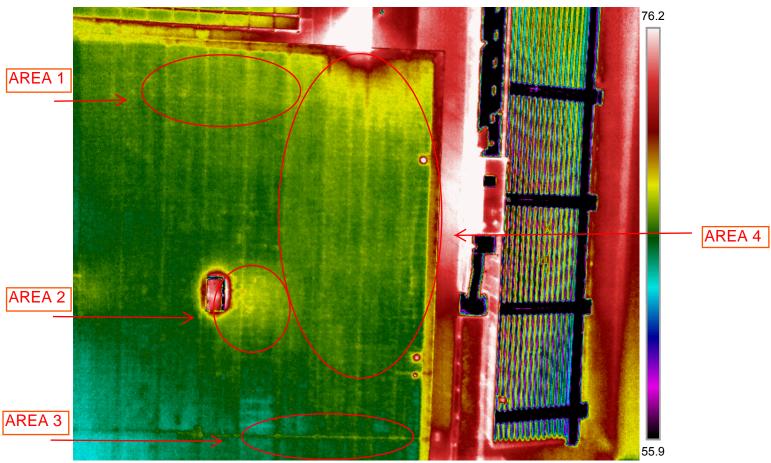
Area 1 ~ 684 sqft. Area along the N edge of the roof. Appears to be standing water marks or possible heat/moisture. Area 2 ~ 113 sqft. Small area E of the closest unit. Area 3 ~ 40 ft. Area that runs along a seam from E to W. Area 4 ~ 2881 sqft. Large area along the E and NE part of the roof edge. Appears to be possible standing water marks or heat/moisture underlying.

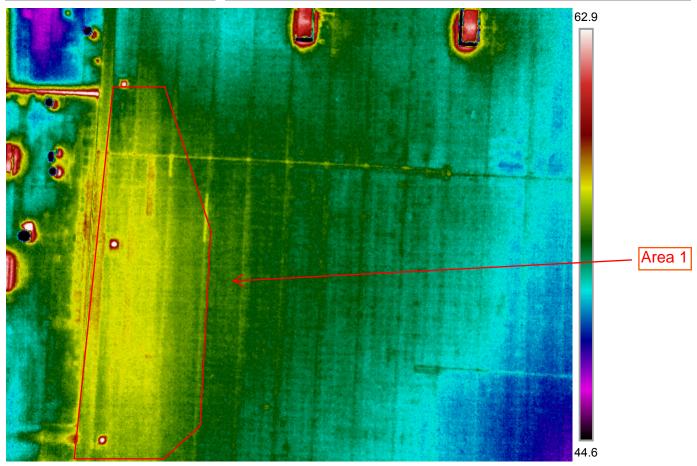
Area 1 \sim 2525 sqft. Area that runs along the W edge of this roof area.

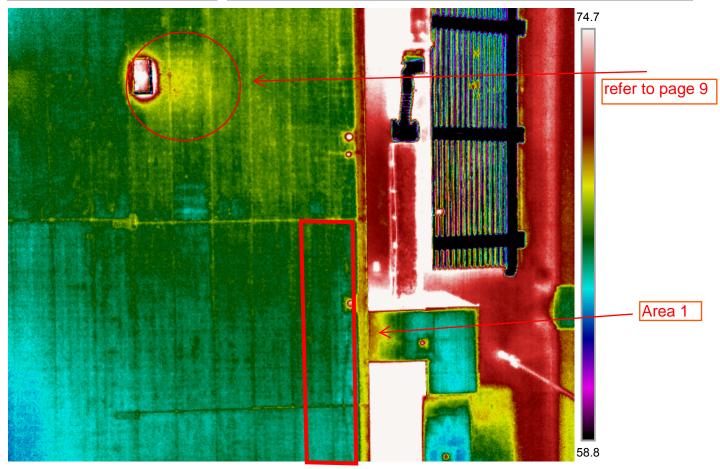
Area 1 ~ 272 sqft. Area that runs beneath the seam, along the E wall. Appears to be standing water spots or possible heat/ moisture spots.

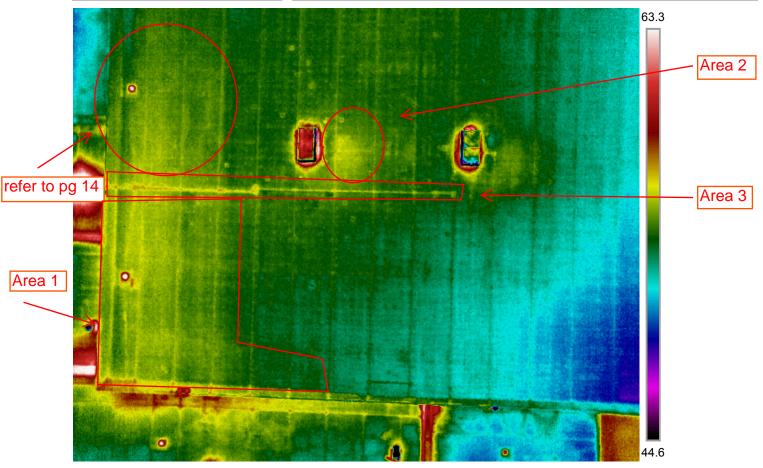
Area 1 ~ 2111 sqft. Area that runs along the W and S edge of the roof section and extends towards the middle of the roof. Area 2 ~ 40 sqft. Small area on the E side of the closest unit to the marked location

Area 3 \sim 81 ft. Seam running from W to E below the two units in the middle of the roof.

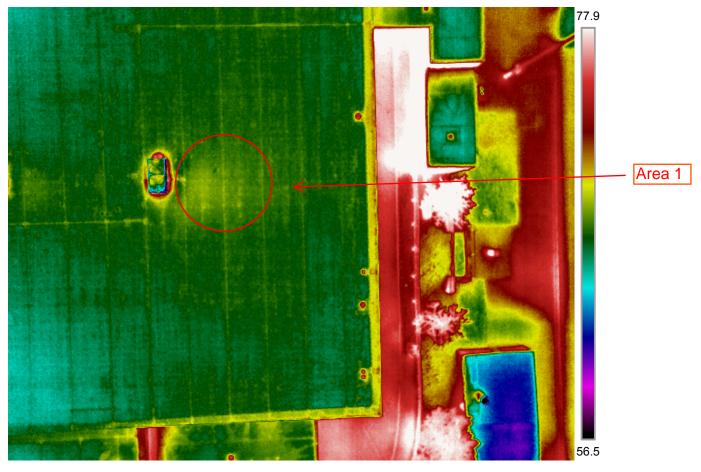
Area 1 \sim 50 sqft. Small area to the E of the closest unit

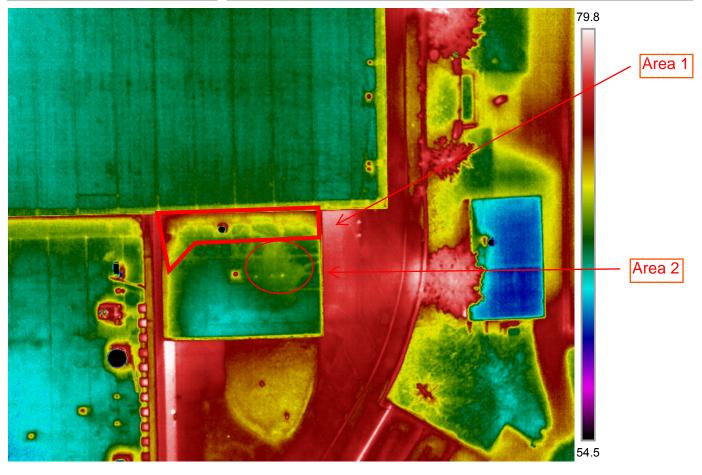
NOLE			
Roof F

Area 1 ~ 270 sqft. Along the N portion of this roof that runs against the wall leading up to Roof A.

Area 2 ~ 251 sqft. Area to the E of the drain in the center of the roof.

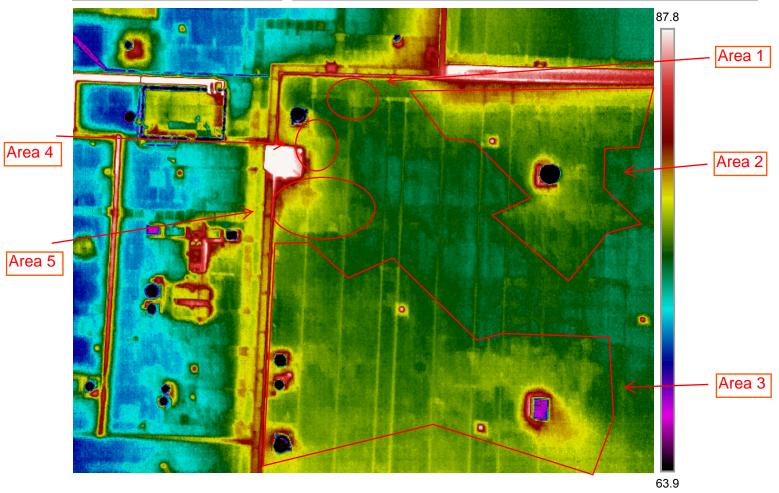
Roof I

Area 1 \sim 33 sqft. Small area along the N edge of the roof section. Appears to be on or next to a former roof patch.

Area 2 ~ 1927 sqft. Large area surrounding the curb/unit in this marked area extending to the N edge of the roof section which goes up to Roof A. Appears to be an abundance of residual water/ponding or heat/moisture.

Area 3 \sim 3177 sqft. Large area extening almost the entire S area of this roof section. Large thermal spots which could be standing water or heat/moisture underneath.

Area 4 \sim 35 sqft. Small area next to the unit and seems to be on the SW corner of a roof patch

Area 5 ~ 240 sqft. Area Just SE of the closest roof unit.

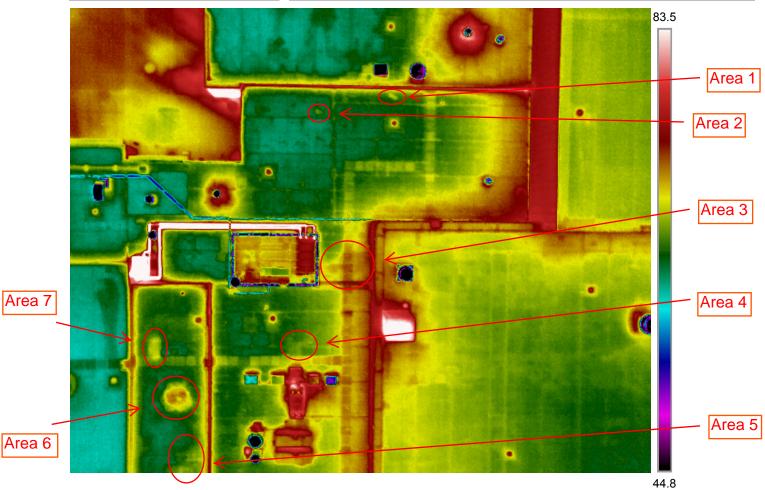
Area 1 ~ 8 sqft. Small area along the N edge of this roof section Area 2 ~ 8 sqft. Small area also along the N edge of this roof section Area 3 ~ 74 sqft. Area in between unit and E edge of adjacent wall mostly around the walkpads

Area 4 \sim 43 sqft. Area of possible standing water/moisture/heat just N of the walkpads and unit.

Area $5/6/7 \sim$ This section of the roof appears to be have lots of residual moisture spots or possible heat. The 3 main spots are pointed out.

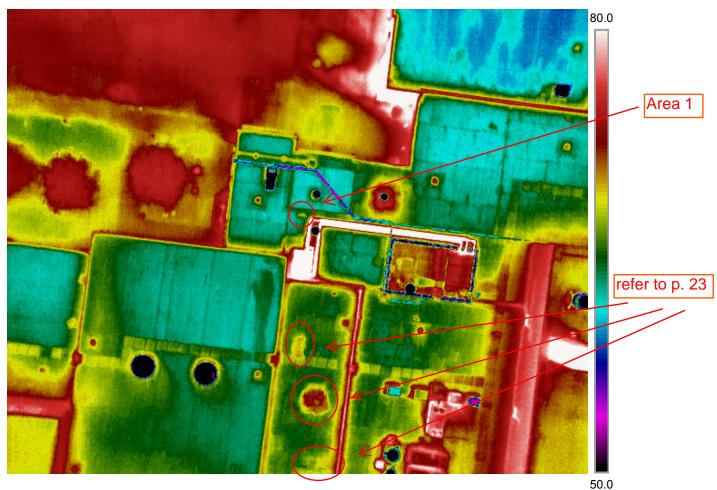
Area 1 ~ 6 sqft. Small area in between roof vent/unit and pipe just S of what appears to be a roof patch.

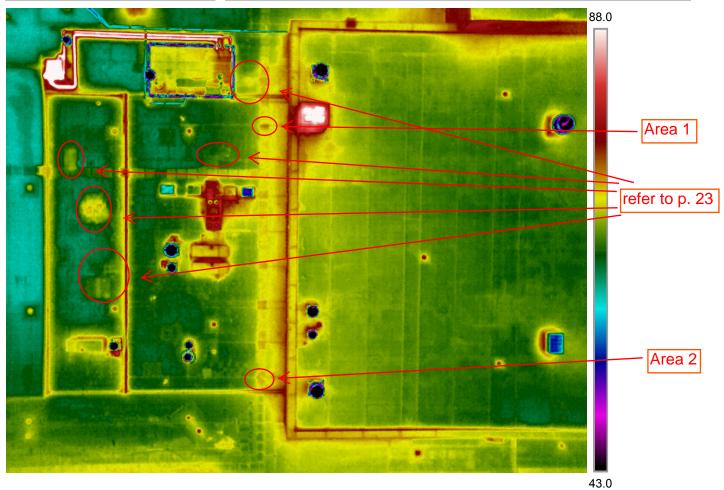
NOLE			
Roof J

Area 1 \sim 8 sqft. Small area of heat/possible moisture along the walk pads near the E edge of this roof section

Area 2 \sim 8 sqft. Small area of heat/possible moisture along the walk pads near the SE edge of this roof section.

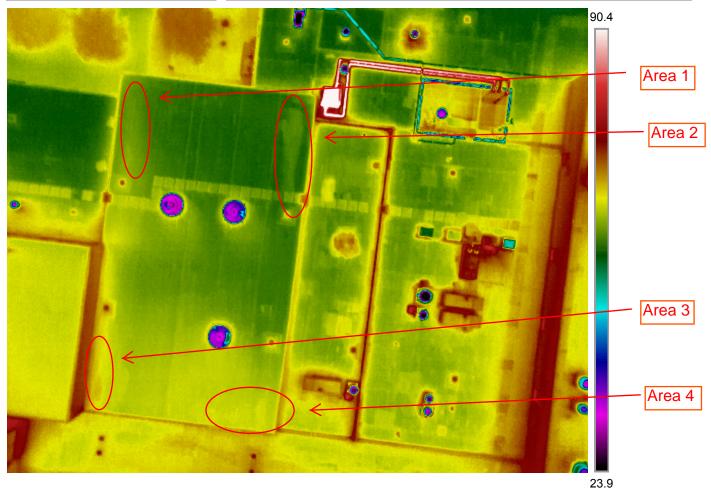
Roof K

Area 1 \sim 105 sqft. Area along the W edge of this roof section. Potential standing water residue or heat/moisture.

Area 2 ~ 117 sqft. Area along E edge of this roof section extending to the walk pads. Potentially standing water or heat/moisture presence.

Area 3 ~ 33 sqft. Small area in the SW corner.

Area 4 \sim 45 sqft. SE corner of this roof section. Possible standing water or heat/ moisture.

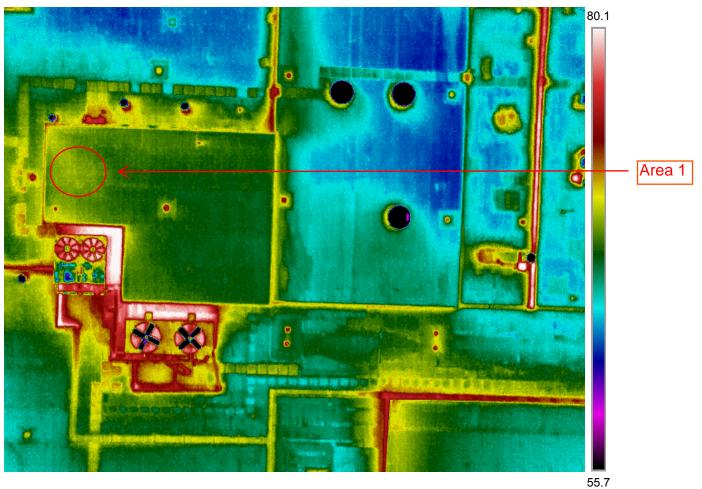
Area 1 \sim 89 sqft. Possible area of standing water staining or heat/moisture.

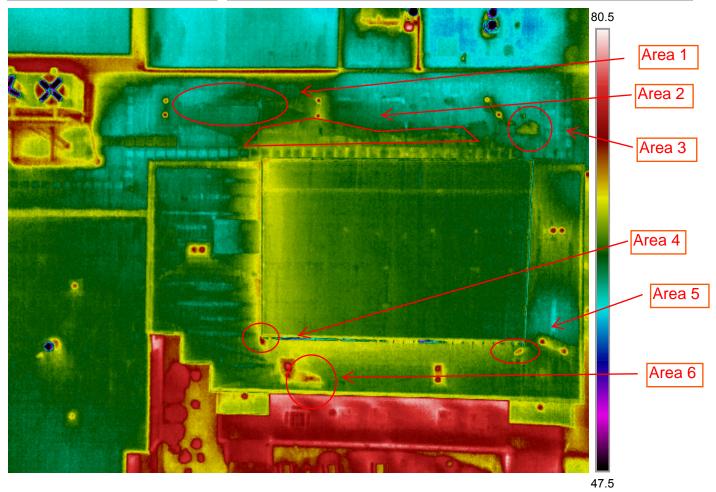
Roof M

Area 1 \sim 295 sqft. Possible standing water residue or heat/moisture. Runs along the NW section of this roof area

Area 2 \sim 305 sqft. Long area stretching along the N side of the walk pads. Appears to be standing water residue or heat/moisture.

Area 3 ~ 15 sqft. Small area in the NE area of this roof section.

Area $4 \sim 6$ sqft. Small area at the bottom of the wall that touches the SW corner of the upper roof.

Area 5 \sim Small area on the bottom of the wall at the SE corner of the wall to the upper roof.

Area 6 ~ 25 sqft. Area to the E of the unit closest to this marked area.

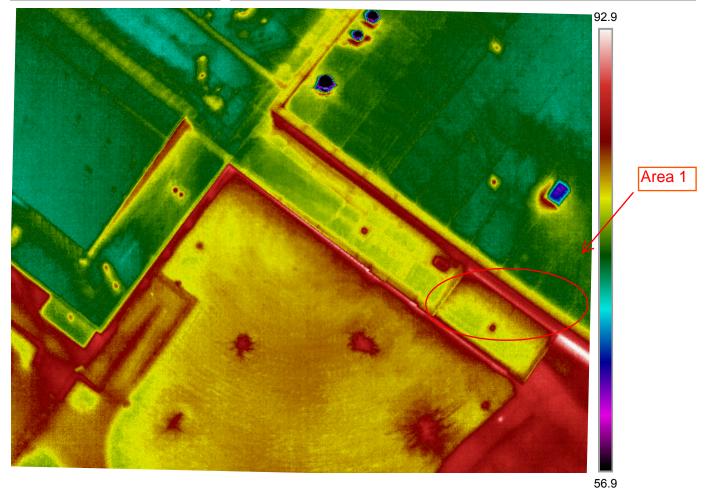
Area 1 \sim 95 sqft. Area that runs along the base of the wall to Roof i.

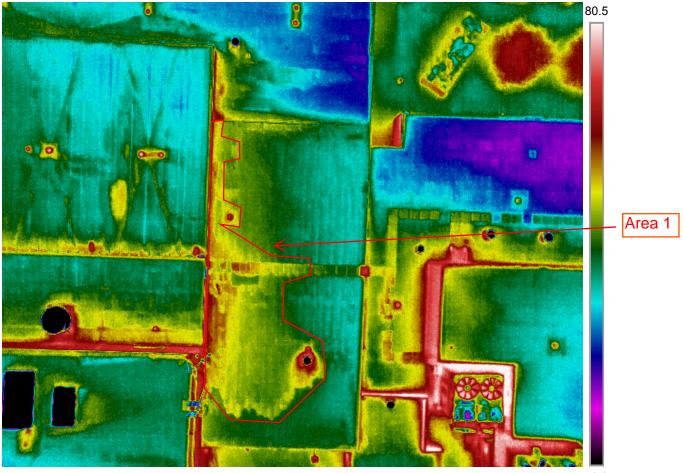
Roof N			
NOIC

Area 1 ~ 1228 sqft. Large area that encompasses almost the entire W edge of this roof section stretching in to the middle. Could be standing water residue or heat/moisture.

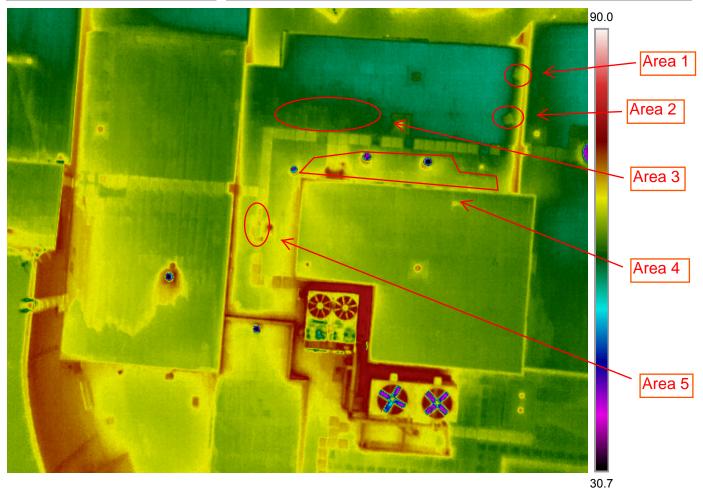
Note Roof O

Area 1 ~ 7 sqft. Small area in the NE corner of this roof section Area 2 ~ 8 sqft. Small area in the NE corner of this roof section.

Area 3 ~ 127 sqft. Area along the N side of the walk pads appears to have possible standing water residue or heat/moisture.

Area 4 ~ 350 sqft. Along the base of the wall to Roof Area L including the ladder and units. Possible stains from standing water or heat/moisture.

Area 5 ~ Small area along the W edge of this section along walk pads.

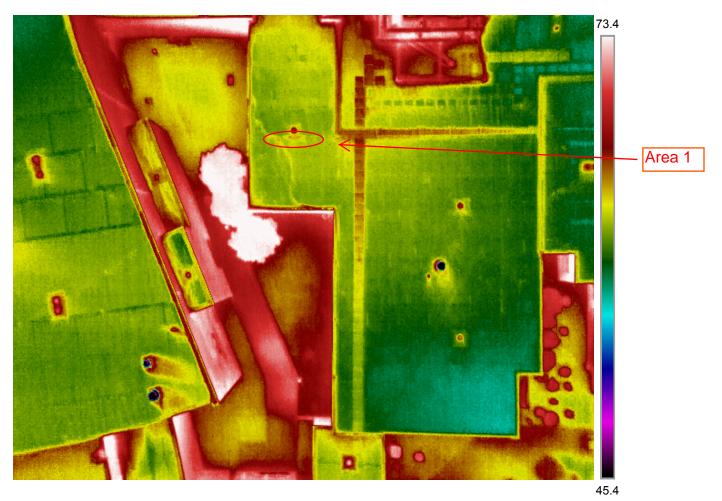
Area 1 \sim 5 sqft. Small area on the S of the unit nearest the marked location.

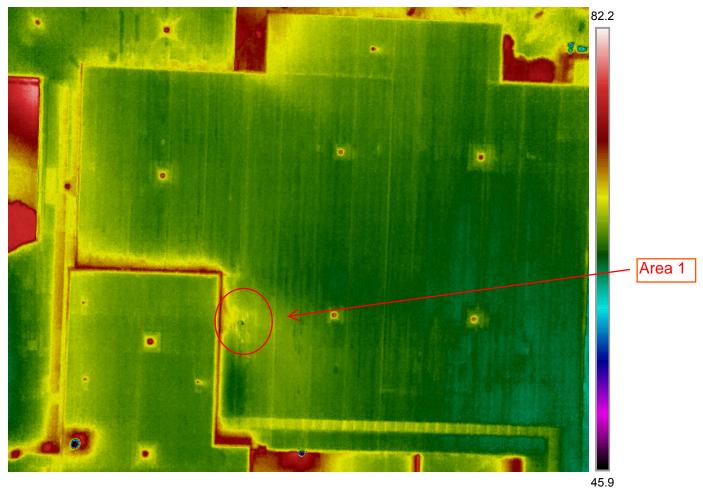
Area 1 \sim 57 sqft. Small area near the base of the wall adjacent to roof area Q.

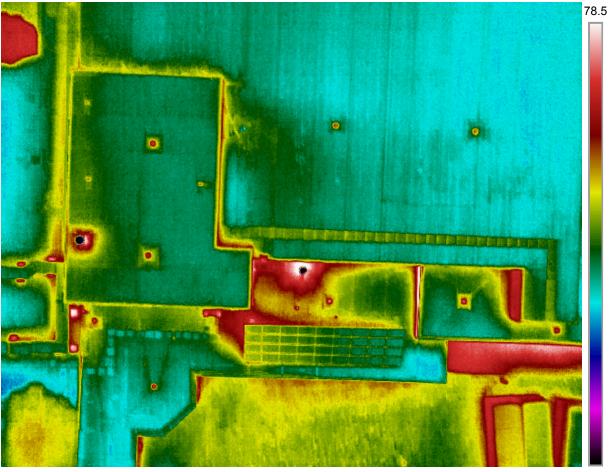
Roof Q

No major issues or concerns

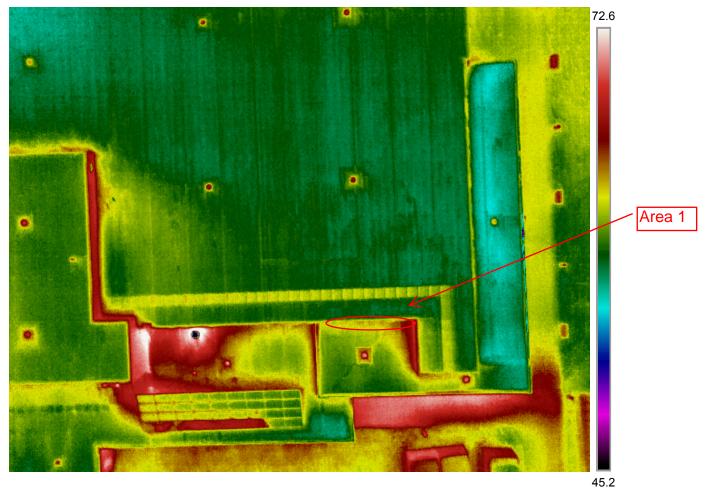
Area 1 \sim 25 sqft. Small section at the base of the wall. Possible standing water or residue.

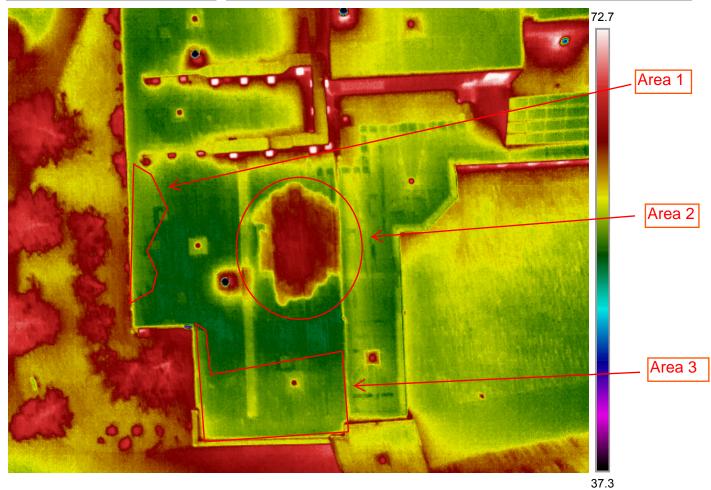
Note Roof S

Area 1 \sim 225 sqft. Area along the W edge of this roof section. Appears to be possible standing water stain or heat/moisture.

Area 2 ~ 623 sqft. Large area of concern. Appears to be significant heat/ moisture in this location.

Area 3 \sim 710 sqft. Area along the S edge of this roof section. Likely due to stain from standing water or light moisture/heat.

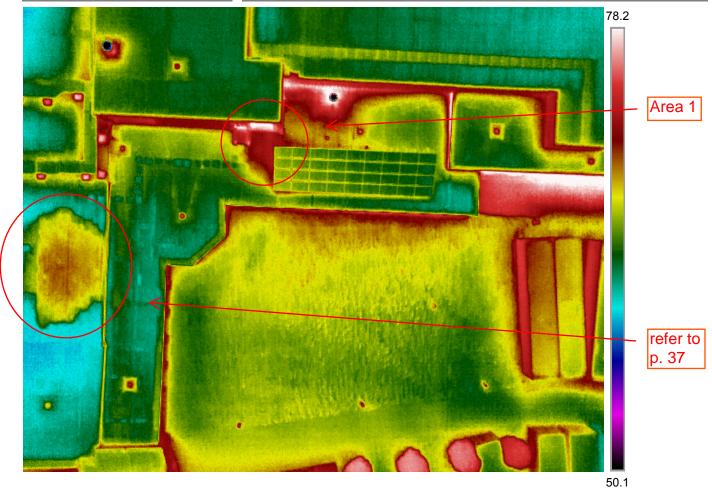
Area 1 \sim 164 sqft. Area in between solar panels and corner of roof Q.

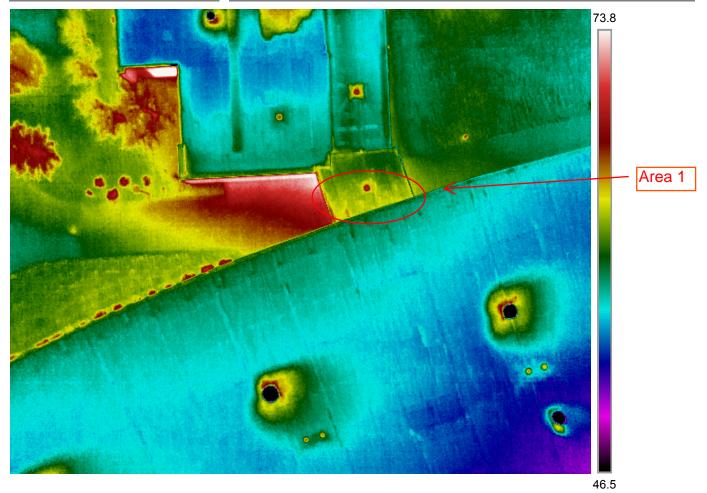
Area 1 $\sim~125$ sqft. Small area along the south portion of this roof area.

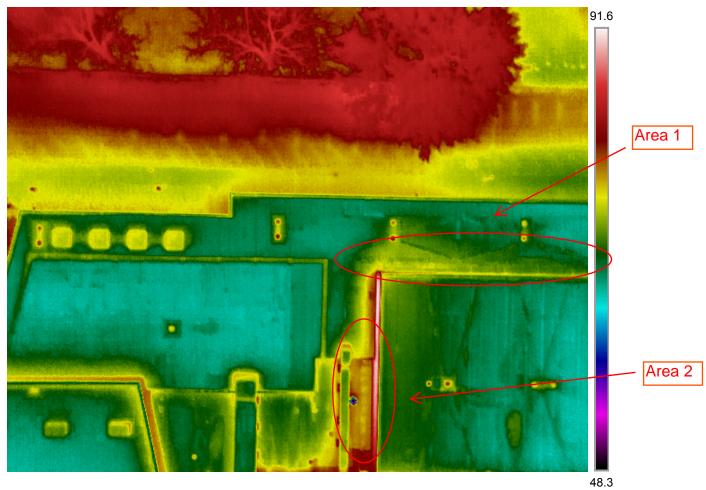
Note Roof U

Area 1 ~ 269 sqft. Area along the wall that is adjacent to Roof Area V.

Area 2 \sim 199 sqft. Area in between hvac and Roof Area V.

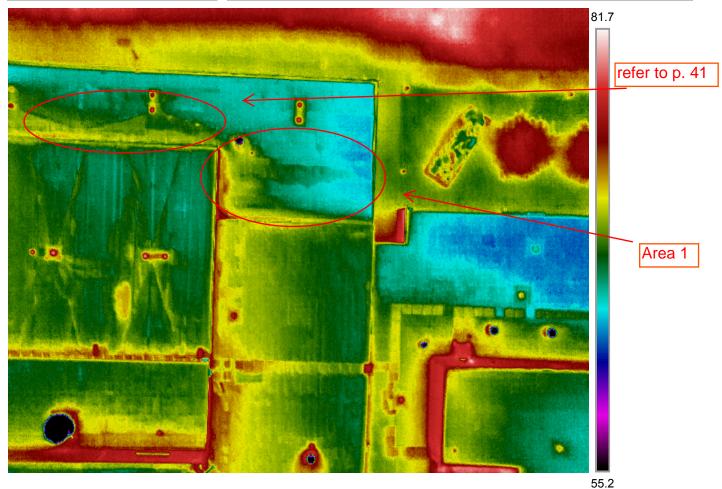
Area 1 ~ 306 sqft. Area along the wall that is adjacent to Roof Area V. Could be presence of standing water or stains.

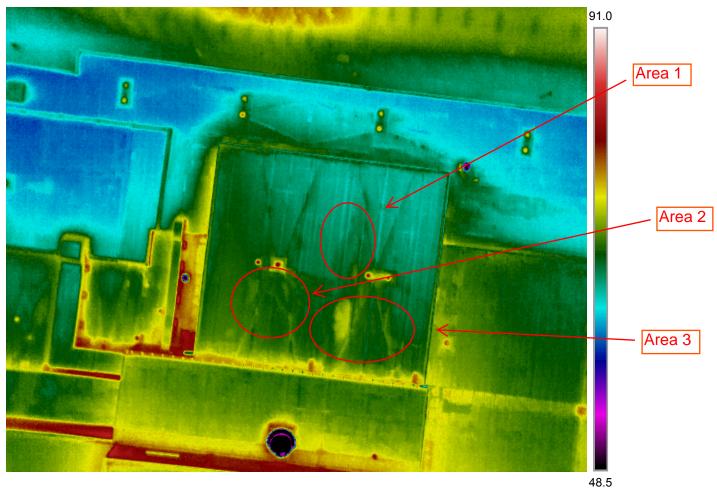
Note Roof V

Area 1 ~ 95 sqft. N of Area 3. Looks like possible standing water or staining resulting from crickets underneath. Area 2 ~ 115 sqft. Area just S of the drain. Appears to be standing water or stains.

Area 3 ~ 361 sqft. SE corner of this roof section. Appears to be a combination of some standing water/stains and a large spot of moisture/heat.

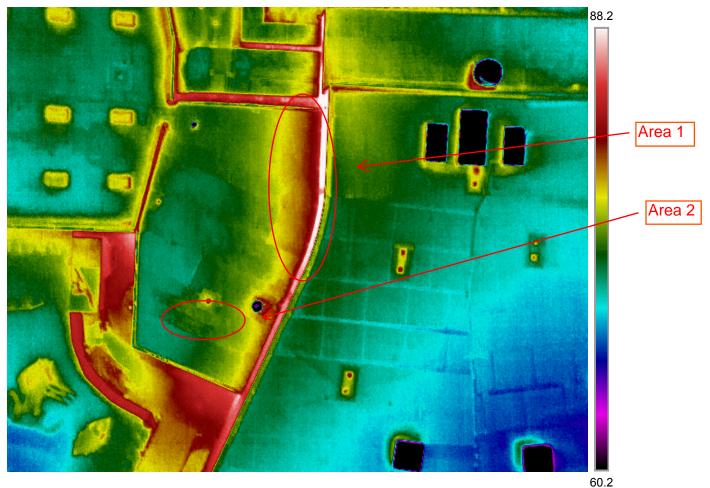
Roof W

Area 1 \sim 250 sqft. Area along the E edge of this roof section where possible water stains/moisture come from the higher roof.

Area 2 ~ 52 sqft/ Small area S of the drain closest to the marked area. Appears to be residue from standing water or possible heat/moisture.

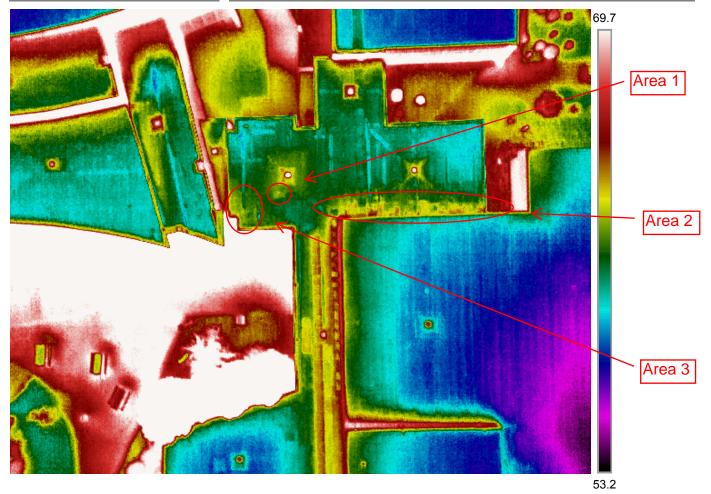
Roof X

Area 1 ~ 12 sqft. Small marked area S of roof drain.

Area $2 \sim 185$ sqft. Roof section along the base of the Roof P wall. Likely standing water or stains. Possible moisture/heat from water coming from above.

Area 3 \sim 43 sqft. Corner section along the base of the SW corner of this roof area.

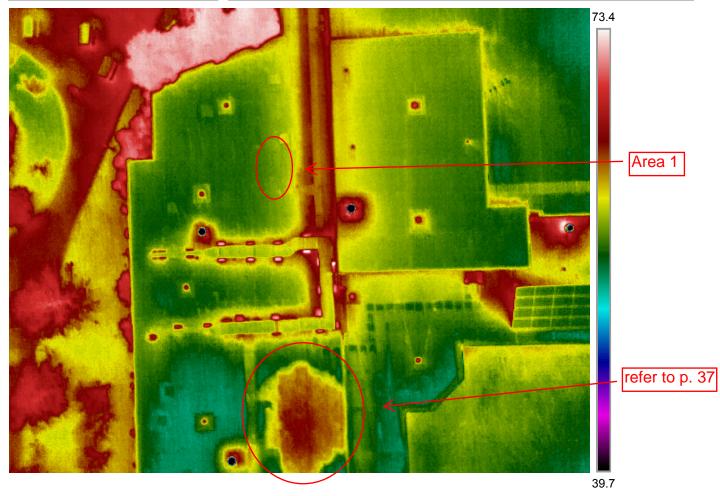
Area 1 \sim 45 sqft. Area along the W edge of the walk pads that appears to have standing water or water staining. Possible moisture/heat.

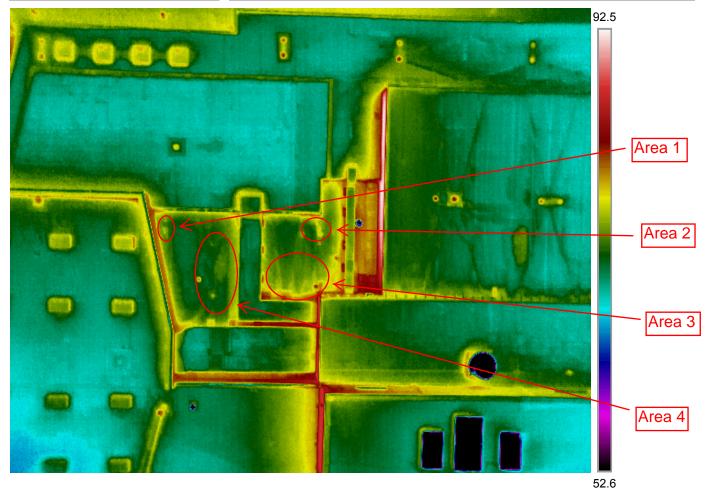
Note Roof Y

Area 1 ~ 6 sqft. Small spot in the NW corner of this roof section Area 2 ~ 25 sqft. Small area in the NE corner of this roof section Area 3 ~ 45 sqft. Area along the edge of the vent/ductwork. Area 4 ~ 65 sqft. Appears to be standing water or staining. Possible moisture/heat.

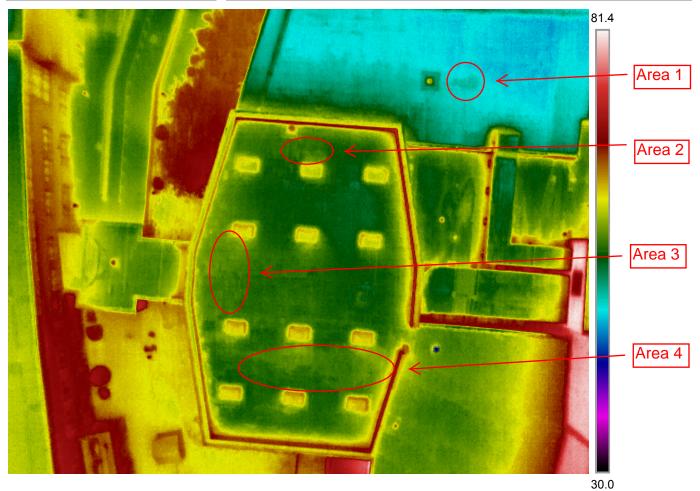
Roof Z

Area 1 \sim 42 sqft. E side of the drain on the upper portion of this roof section.

Area 2 \sim 38 sqft. N side of the closest unit to the marked area. Potential standing water/staining or heat/moisture.

Area 3 \sim 105 sqft. Appears to be standing water or staining. Possible moisture/heat.

Area 4 \sim 125 sqft. Appears to be standing water or staining. Possible moisture/heat.
