**Westport Public Schools**  
**Coleytown Elementary School – 23-008-RFP**  
***Request for Proposal for Renovation Status Evaluation***

**5.0 Existing Facility Survey**  
Master Plan Facility Study for Westport Public Schools  
**COLEYTOWN ELEMENTARY SCHOOL**  
**5.1.1 Architectural Conditions Analysis**

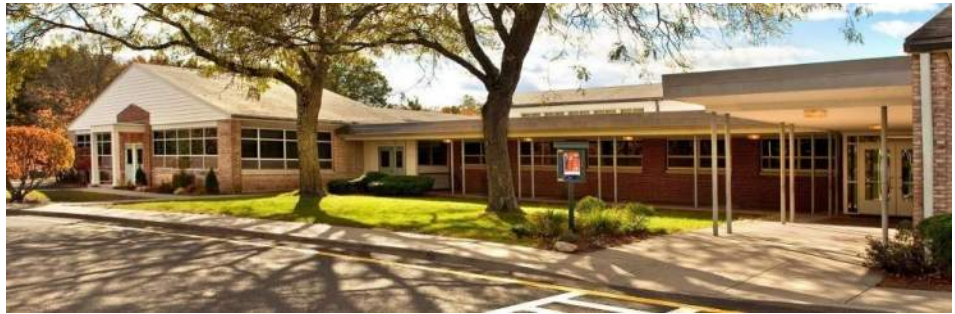
Overall, there were no obvious cracks in the brick veneer, and it appears to be in good condition. There are several locations of minor damage to masonry, mostly located at building corners and at window jambs.

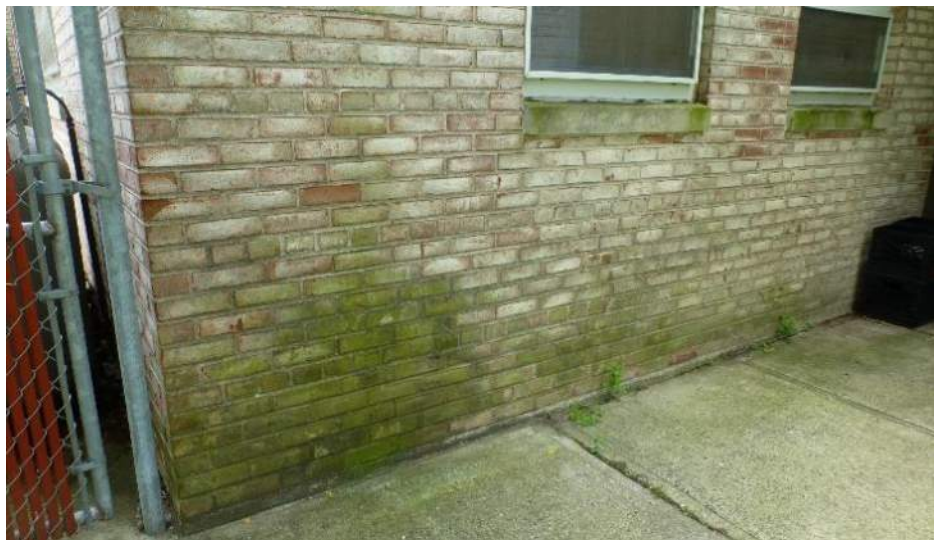
As indicated in the picture below, there are multiple locations of masonry veneer and precast sills that are in need of cleaning due to moss / mildew / mold. These areas need to be cleaned and treated, and this needs to be kept up regularly. Typically, these locations tend to be in areas that receive little sunlight and also at downspouts and downspout nozzles.

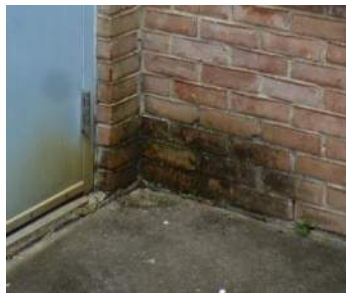
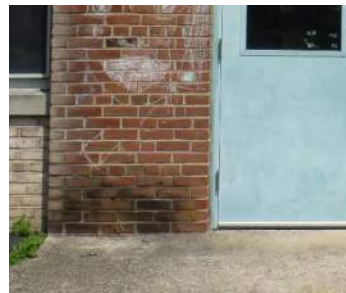
There are several areas about the perimeter of the structure that show signs of black staining. These areas should be investigated to determine the source of the issue, repaired and cleaned. Examples of this can be found near Doors 7, 26, 34, and 62.

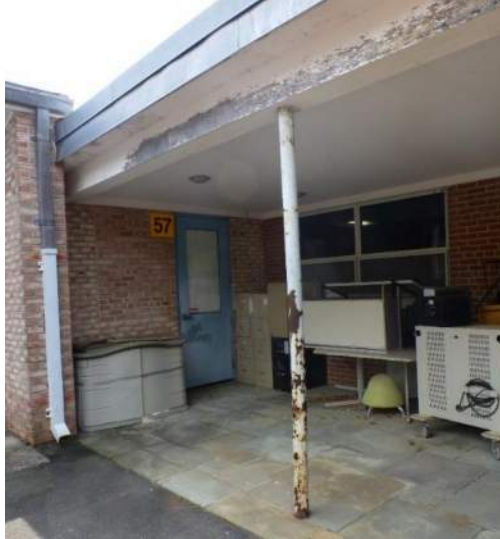
Structural steel columns, fascias, and metal trim work / louvers are in need of scraping, priming, and repainting.

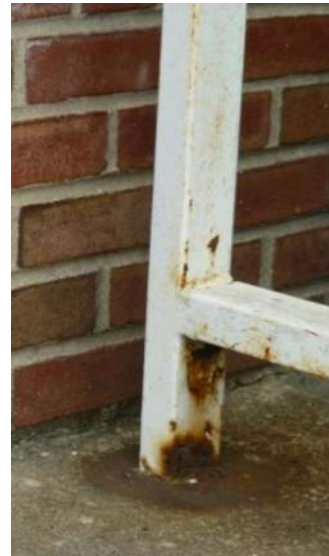
There are multiple areas of rust that are in need of scraping, priming, and repainting. Evidence of rust can be found at the grille vents near Doors #3 and #7 and also at the handrails at these locations. Steel lintels at many window openings are in need of the same treatment, as are some of the gutter leaders.

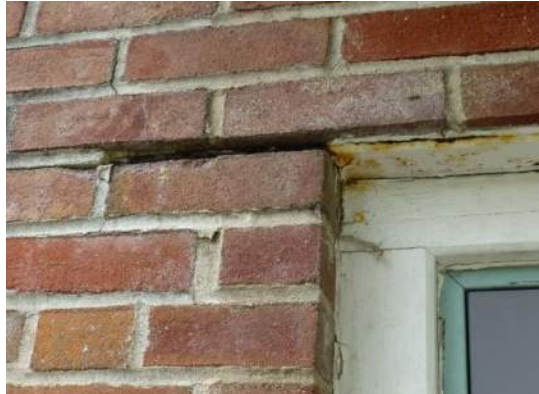
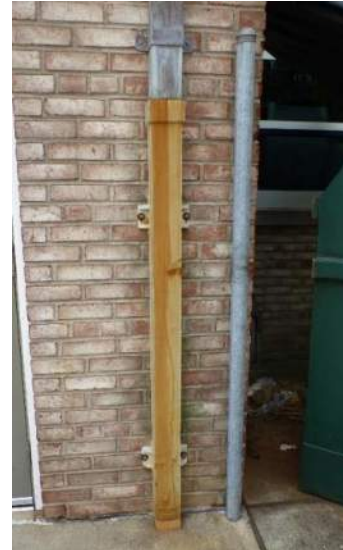
Many of the exterior doors to the classrooms of the older portions of the school still have wood trim. There is evidence that repair work has been done in the past to repair rotting wood at the base of the side jamb by splicing in new pieces. Some doors have not yet received this repair-work. It is recommended that the wood trim be removed entirely and replaced with new PVC trim.

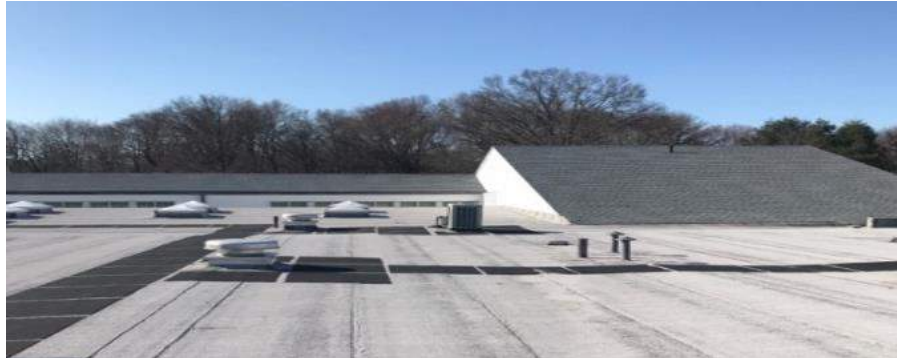
The school roof consists of two distinct types: asphalt shingles at the gabled roofs and built-up asphalt at the flat roofs. Both roof systems appear to be in fairly good condition. The warranty expirations are unknown at this time.

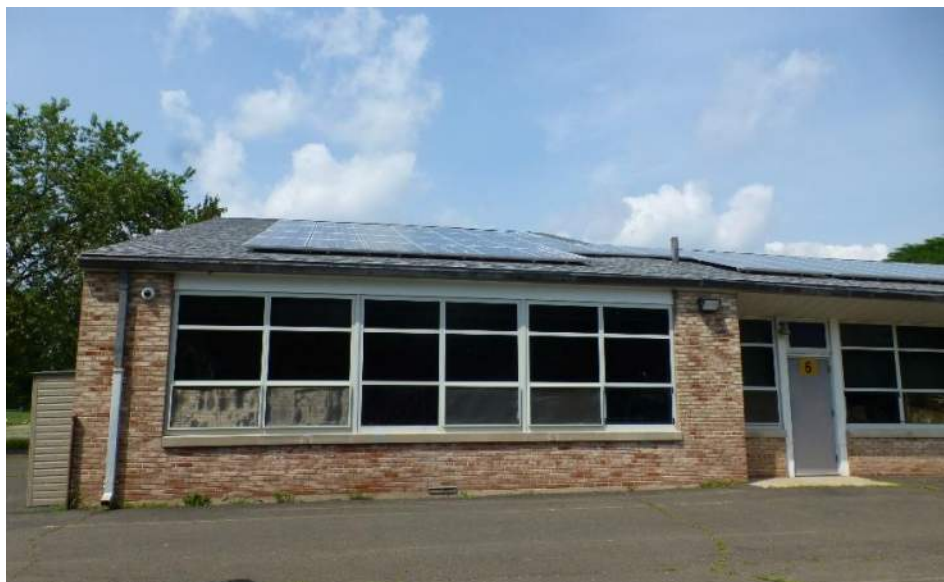
As shown in the following picture, solar panels have been installed on the western roof of the 1993/97 Addition. Monitor all penetrations for leaks.

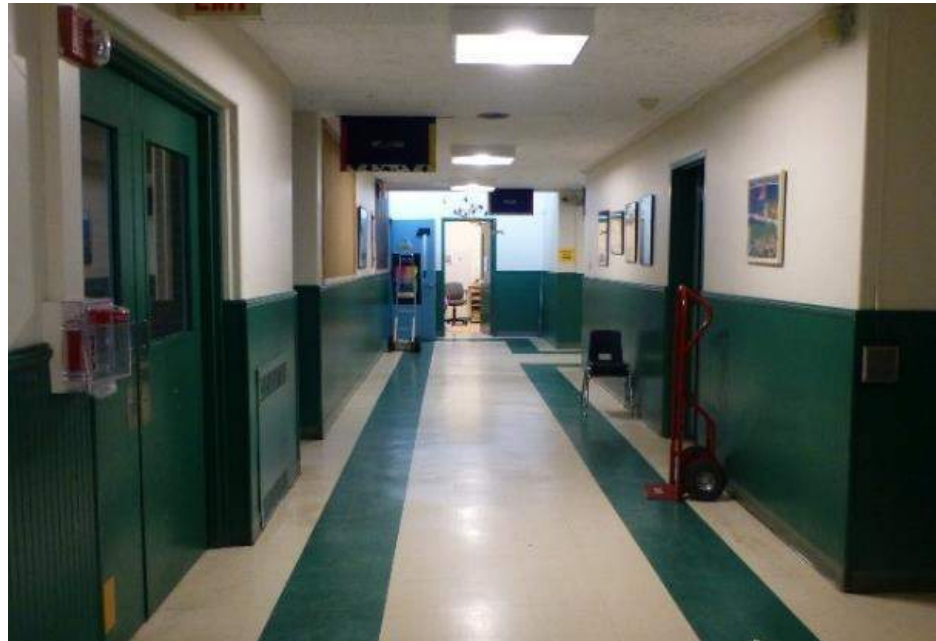
The VCT flooring in the corridors of the original building is older but generally in good condition. Several cracks spanning the width of the corridor were noted.

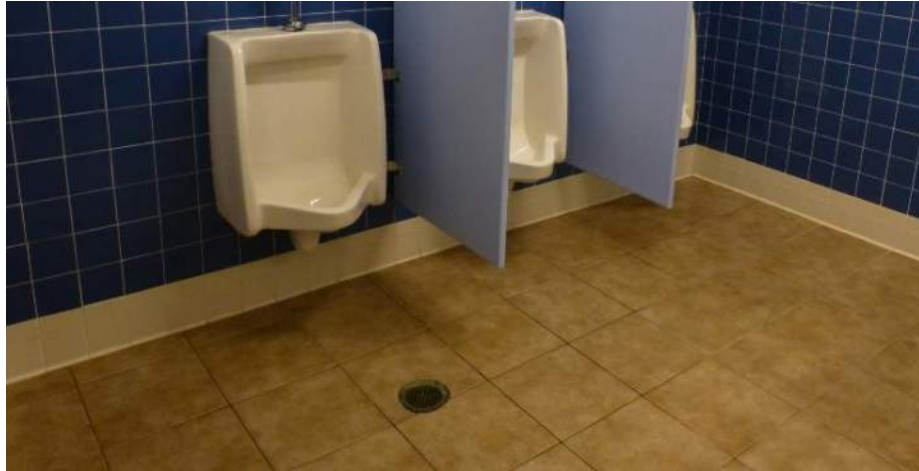
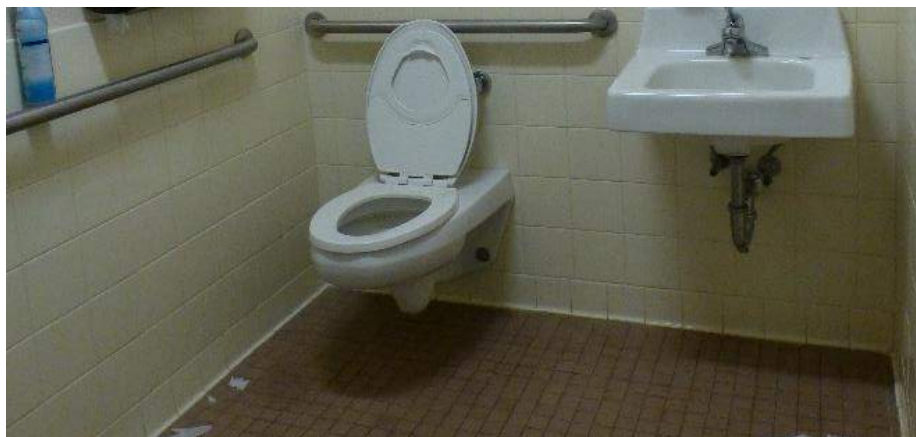
Flooring in the toilet rooms varies from the larger porcelain tile in the more recently renovated toilet rooms to the smaller dated look in the toilet rooms in the 1990's additions. The tile in both locations are in fair to good condition.

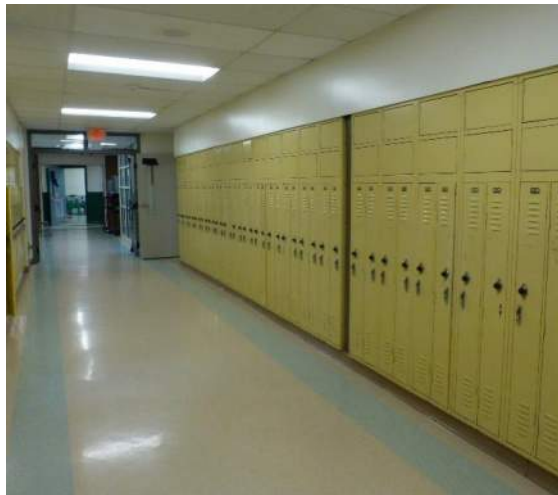
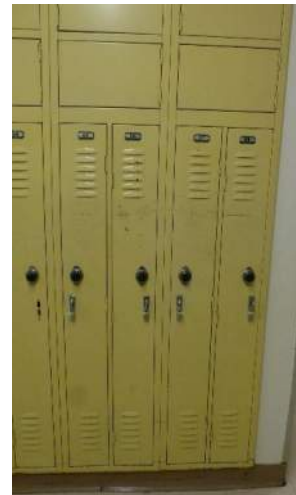
There are lockers located in the northeast corridor leading from the original school to the northern addition built in the 70's. These lockers are older with many scratches and dings that need touch up.

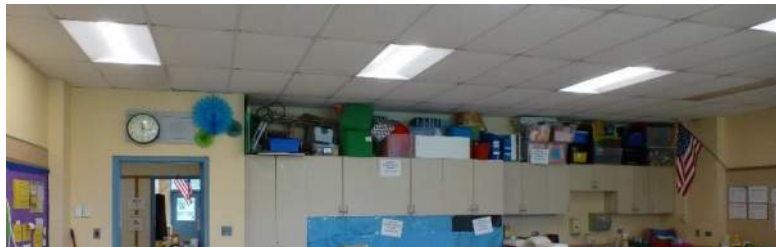
No major deficiencies were observed in the 24"x48" ACT ceilings overall except water stains in a few classrooms and ceiling tile sagging observed in some locations. The sagging is most likely due to age; tiles should be replaced throughout. A smaller tile of 24"x24" would have less chance of drooping over time.

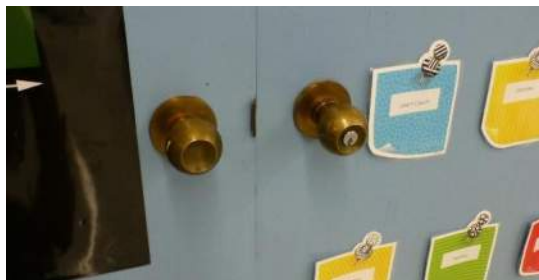
It was noted that closets in the older classrooms have standard knobs which do not comply with current accessibility codes.

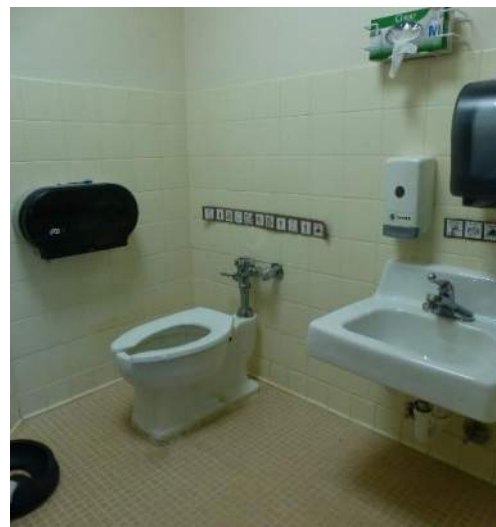
As stated earlier in the Toilet Rooms section, some of the classrooms are provided with individual restrooms. These toilet rooms are designed with children in mind, but are not furnished with accessible grab bars.

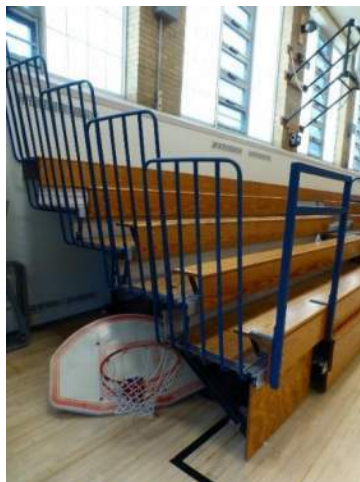
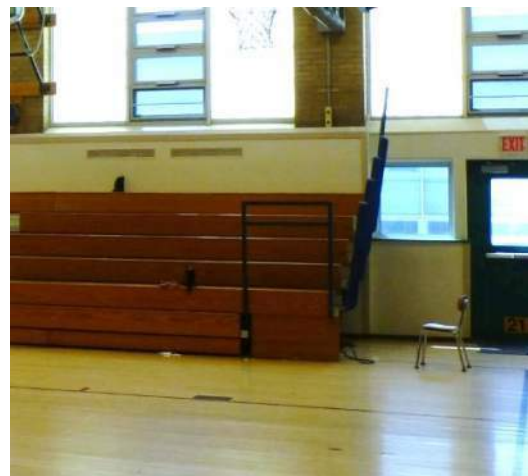
The retractable bleachers located on the western wall, when fully opened, overlap onto the basketball court. Alternative means of seating should be investigated so that the court can be used at full size. Bleachers do not appear to include accessible and companion seating.

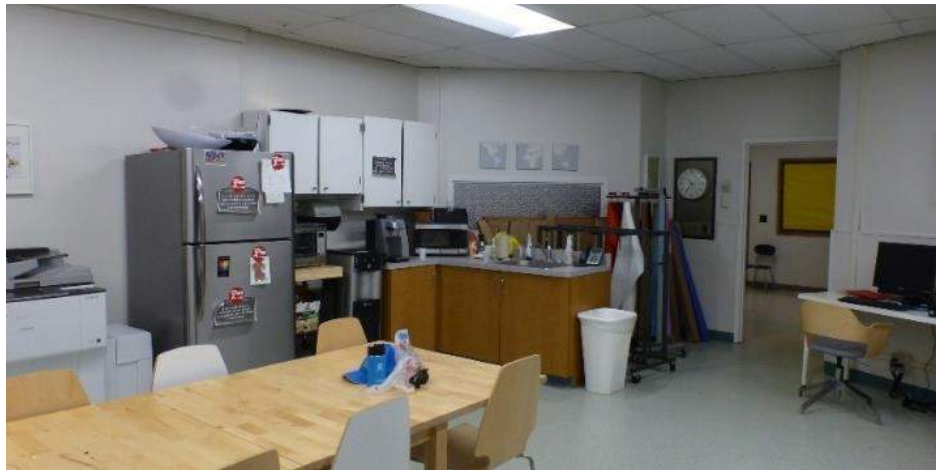
The Staff Lounge is located in the northeast corner of the 1970's Addition and is equipped with a small kitchenette. The Lounge is in good condition although it should be noted that the kitchenette is not accessible.

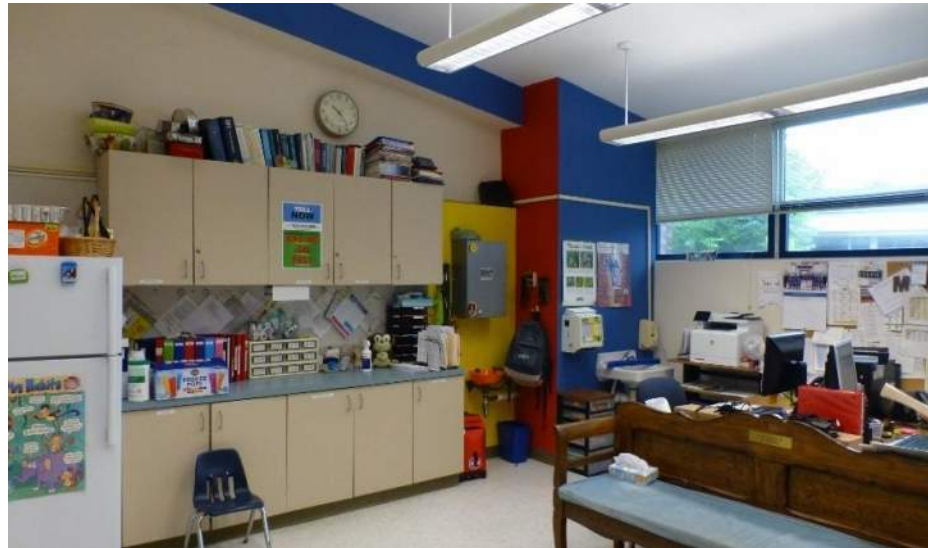
###### Building Interior – Nurse’s Station

The Nurse’s Station is located off the Main Corridor across the hall from the Administrative Offices. The Station is equipped with two (2) beds and its own individual toilet room. Generally, the Station is in good condition.

1. Nurses' station appears to be of insufficient size to accommodate more than a student or two. One patient station is currently occupied by a desk.
2. Eventually update aging interior finishes throughout the school.

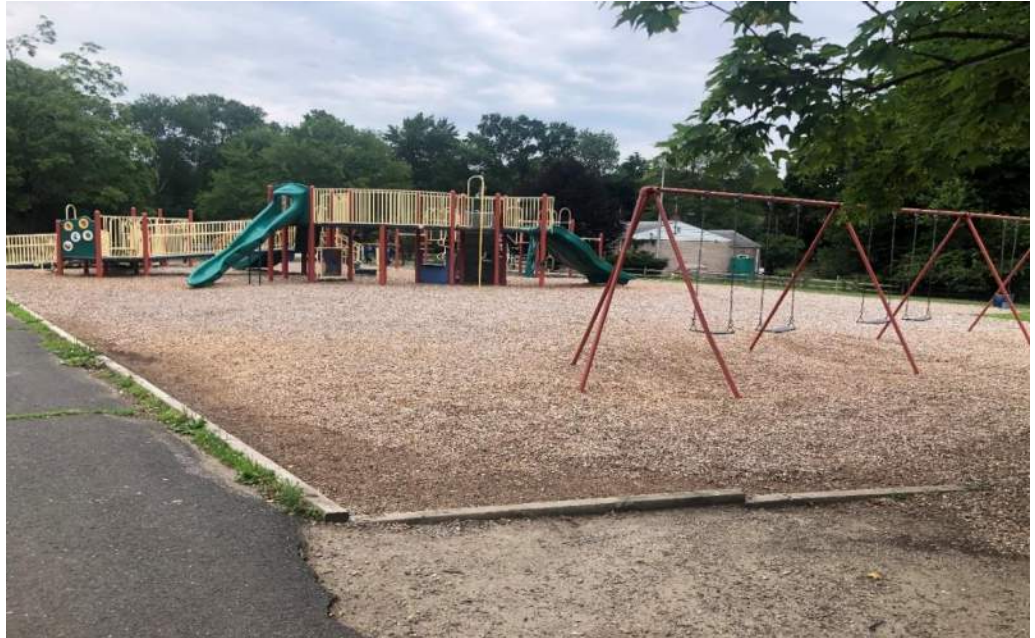
PHOTO #5:

Playscapes in working order. Potential for future improvements 5+ years.

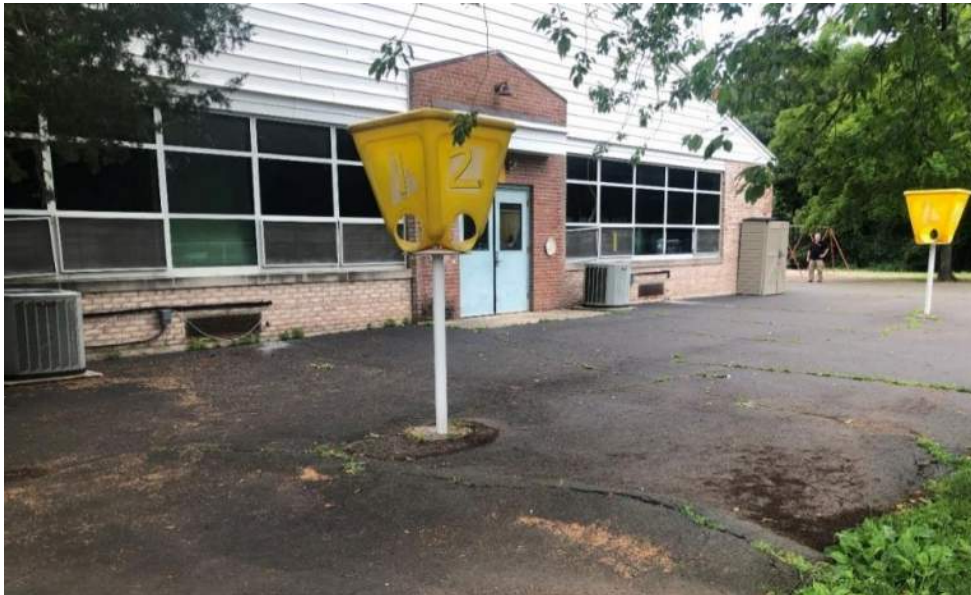
PHOTO #8

Improve playscape area. At discretion of town. No immediate concern but could be a simple update.

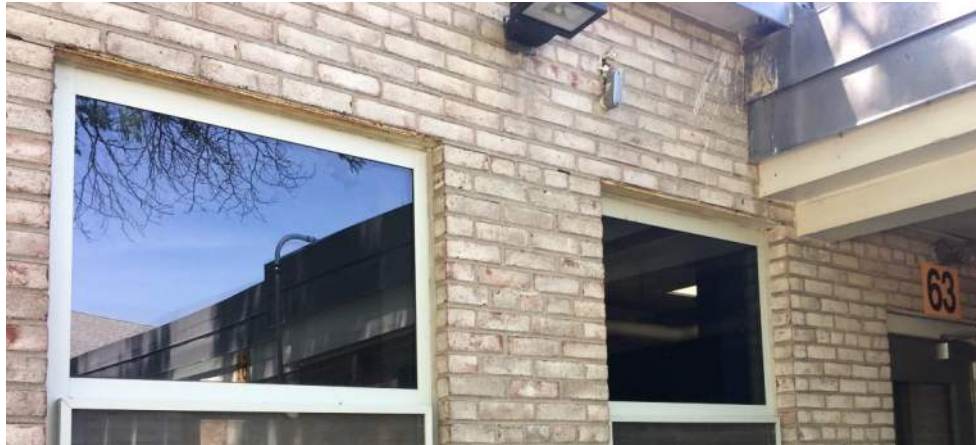
**Exhibit CES-I**

Steel lintels are present above the typical window openings. Minor surface corrosion of the steel is occurring in some locations. Please refer to Photograph Exhibits CES-1, CES-2 and CES-3 as representative examples. These lintels should be stripped to bare metal where exposed and recoated with a galvanizing compound and painted approved by the Architect. The brick veneer should then be repaired accordingly.

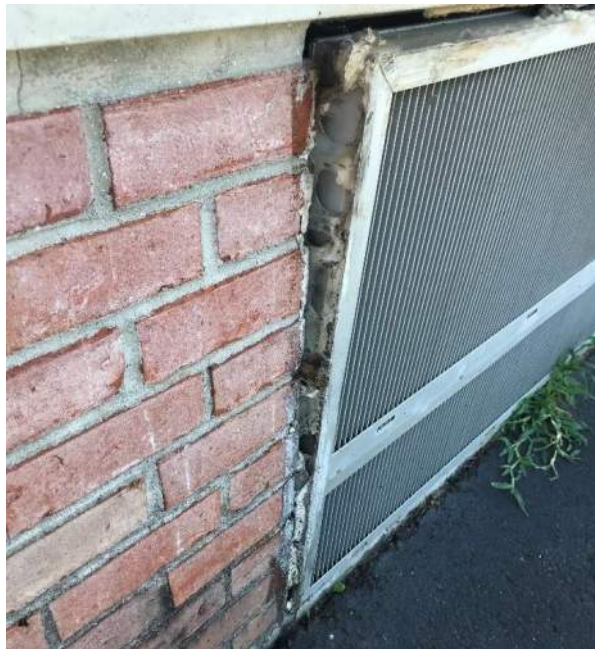
**Exhibit CES-4**

1997 Addition – West Side: the fan coil unit is partially displaced from the face of the exterior wall, refer to Photograph CES-4. This condition can lead to water infiltration around the unit.

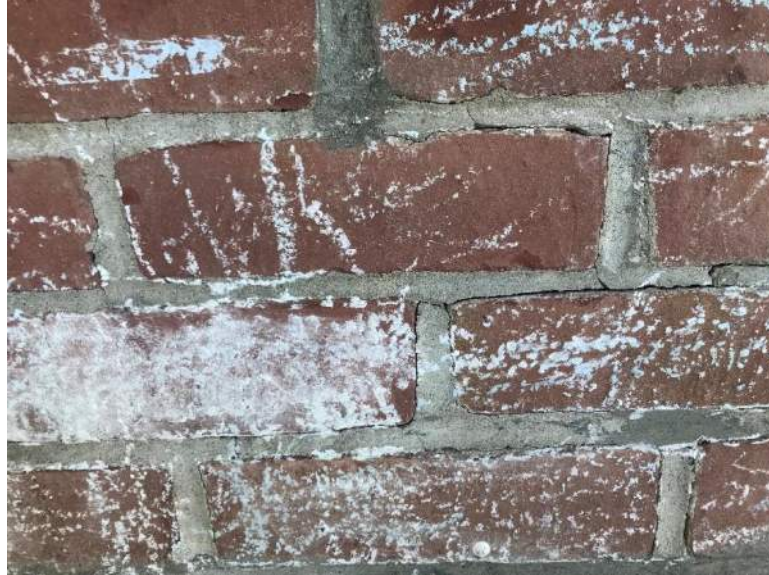
**Exhibit CES-5**

South 1974 Addition – East Side: at Door 14 there are cracks in the brick below the sill of the adjacent window, refer to Photograph Exhibit CES-5.

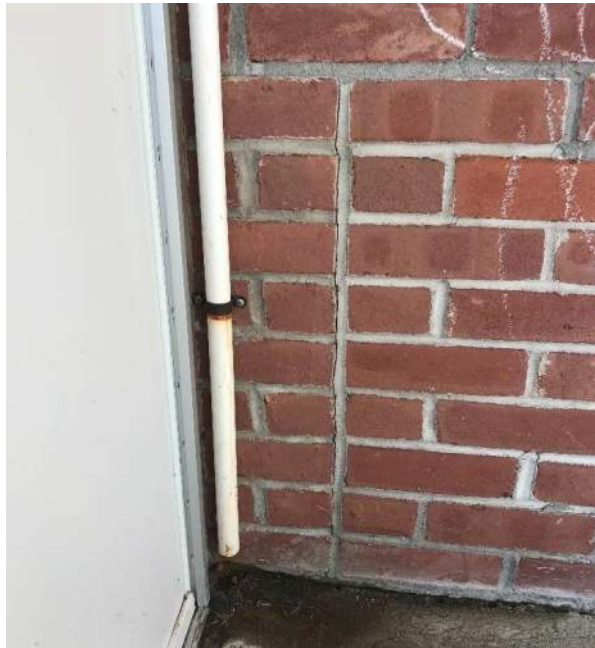
**Exhibit CES-6**

South 1974 Addition – East Side: at Door 12 there are cracks in the brick adjacent to the door, refer to Photograph CES-6.

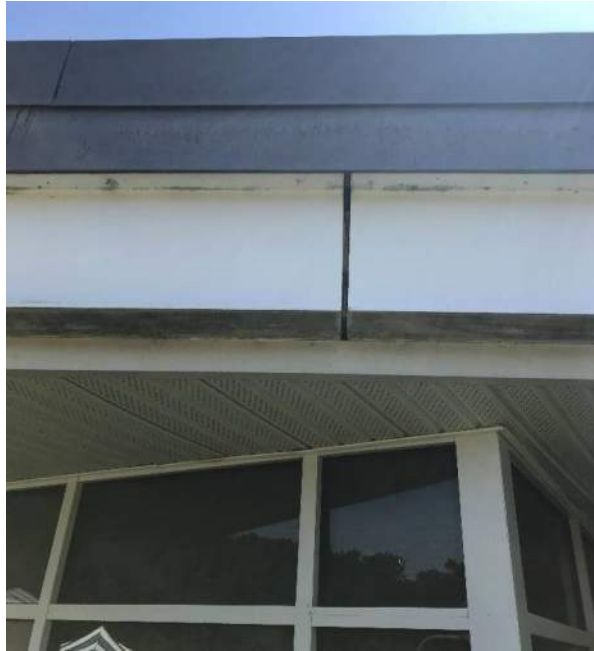
**Exhibit CES-7**

1974 Additions: Typical at perimeter roof steel, the continuous roof spandrel has a gap between the ends of the beams that is open to water infiltration. We could not determine how the wall is flashed behind the steel to prevent the water infiltration into the building, refer to Photograph Exhibit CES-7.

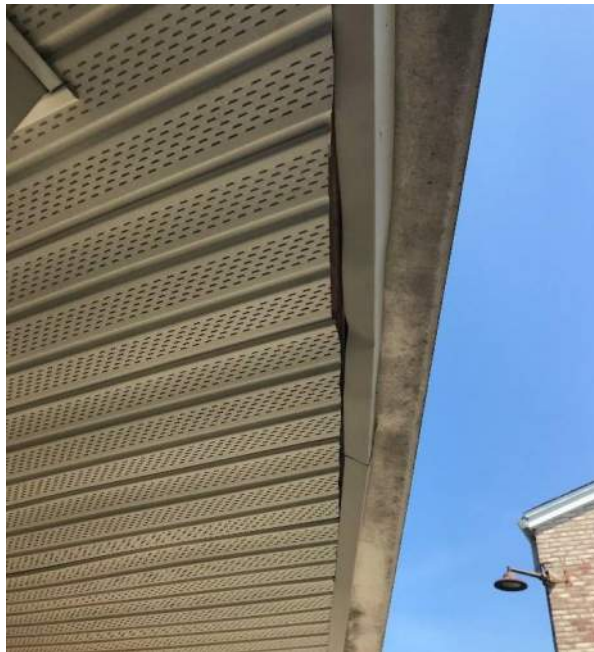
**Exhibit CES-8**

South 1974 Addition – East Side: Between Doors 12 and 13, the roof soffit is loose and not engaged with the break metal fascia, refer to Photograph Exhibit CES-8.

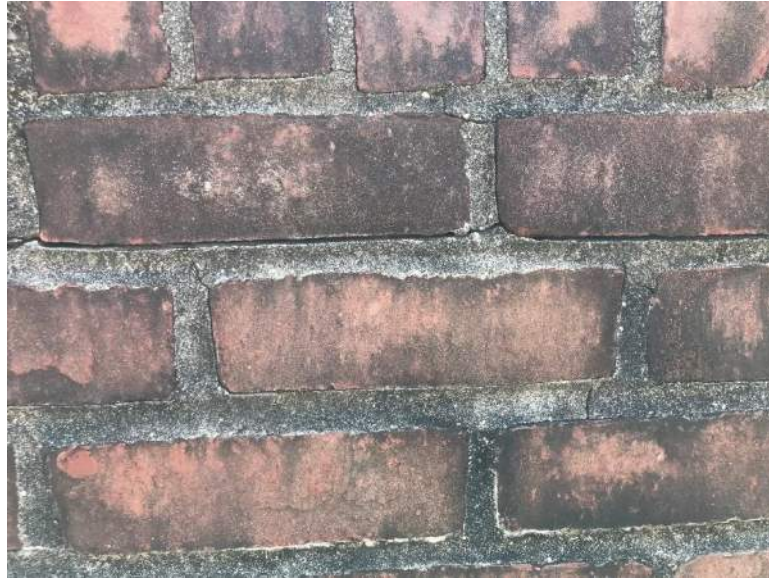
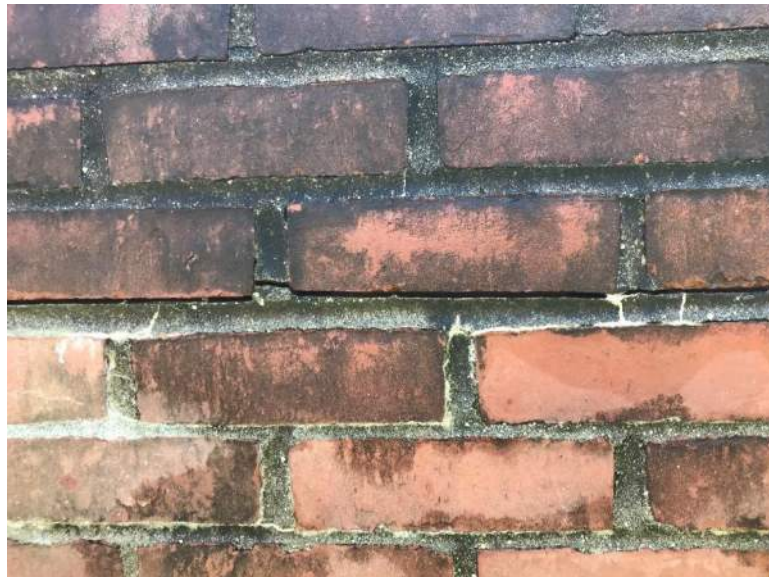
South 1974 Addition – West Side: Site Brick Masonry Wall, the mortar joints at the top of the wall are opening up. These joints will be subjected to water infiltration and detrimental effects of freeze-thaw action, refer to Photograph Exhibits CES-9 and CES-10.

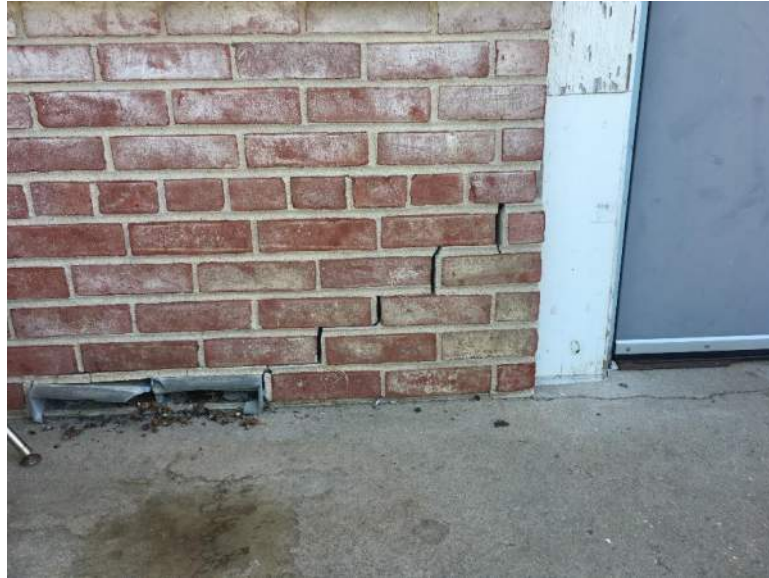
**Exhibit CES-11**

Original Building: In the northwest corner, the brick veneer is cracking at the base of the wall adjacent to Door #44. Please refer to Photograph Exhibit CES-11.

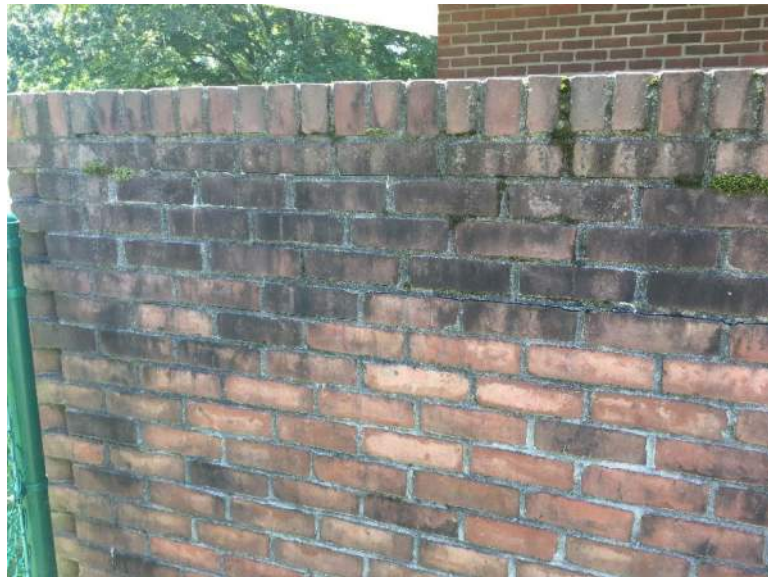
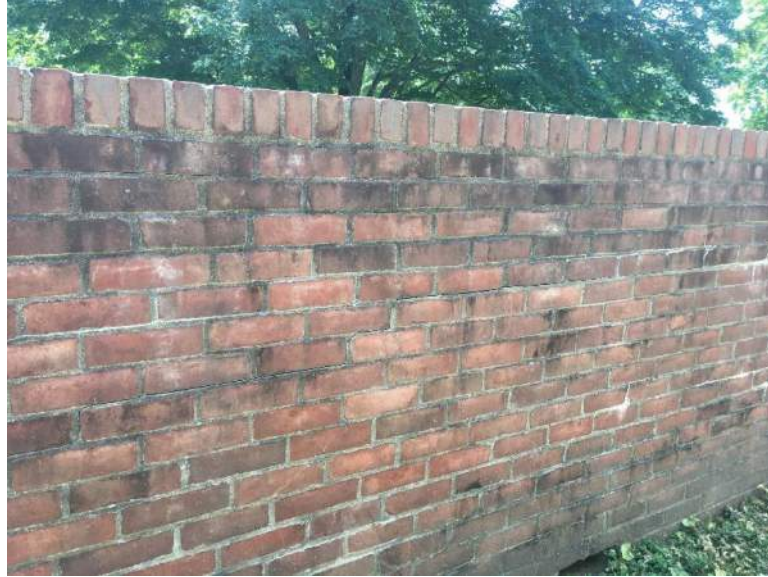
Cracking was observed in the upper portion of the brick site wall at the northeast corner of the school. Please refer to Photograph Exhibits CES-12 and CES-13.

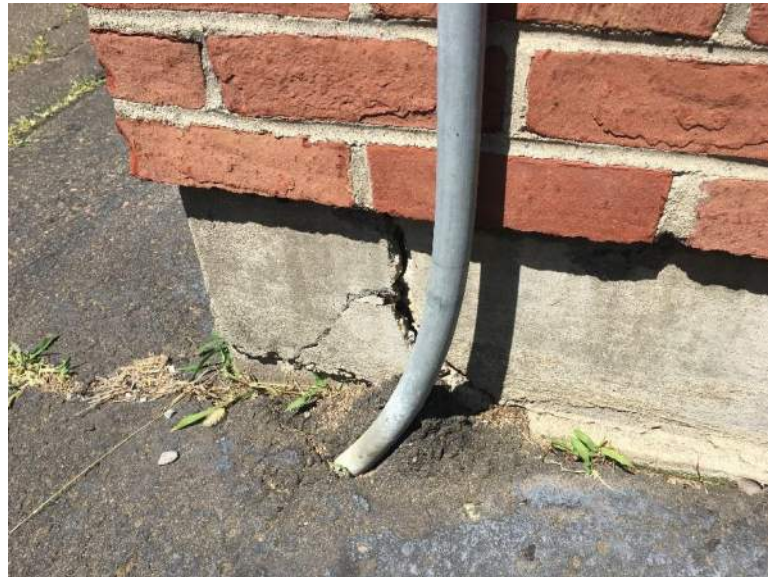
**Exhibit CES-14**

North 1974 Addition: The corner of the cast-in-place concrete foundation wall is significantly cracked to the south of Door #53. Please refer to Photograph Exhibit CES-14. Continuing west into the alleyway to the next building corner, an additional crack was observed in the foundation wall. Please refer to Photograph Exhibit CES-15. The cracks should be repaired and sealed to prevent water infiltration and further damage to the concrete.

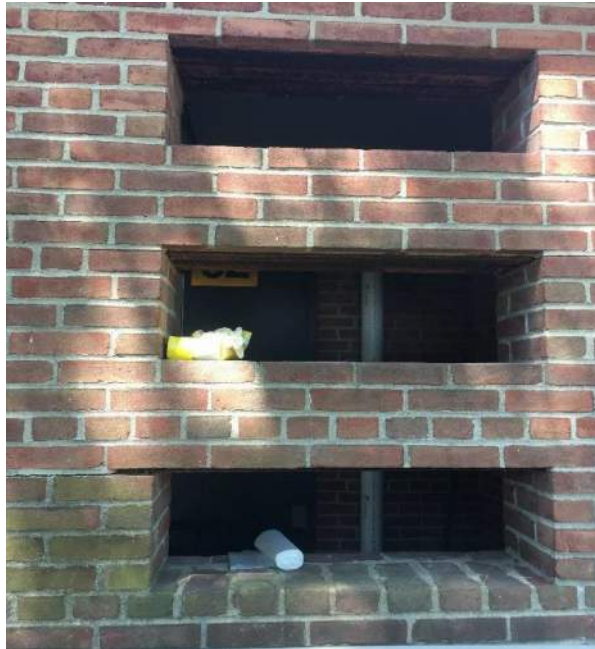
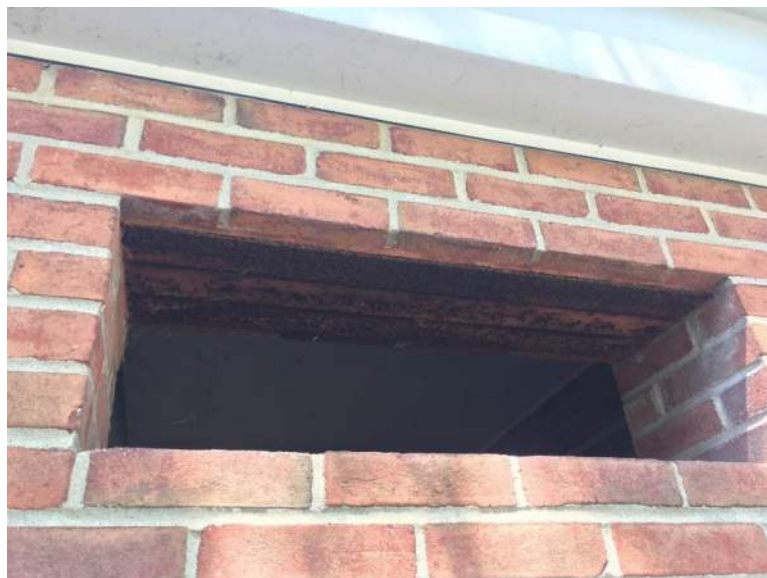
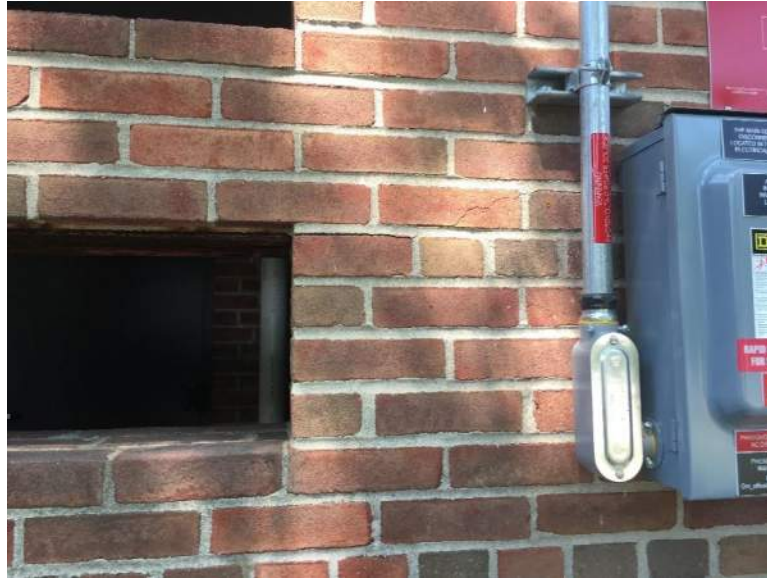
Adjacent to the Kitchen service entrance at the Original Building, there are three openings thru the brick wall to the north. Please refer to Photograph Exhibit CES-17. The lintels are corroded and the brick joints have cracked at the lintel bearings. A crack in the brick was also observed extending to the adjacent electrical service box. Please refer to Photograph Exhibits CES-18 and CES-19.

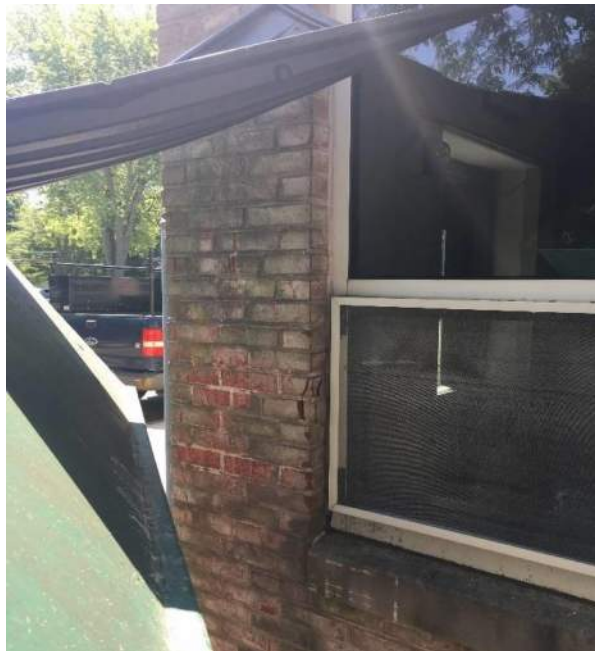
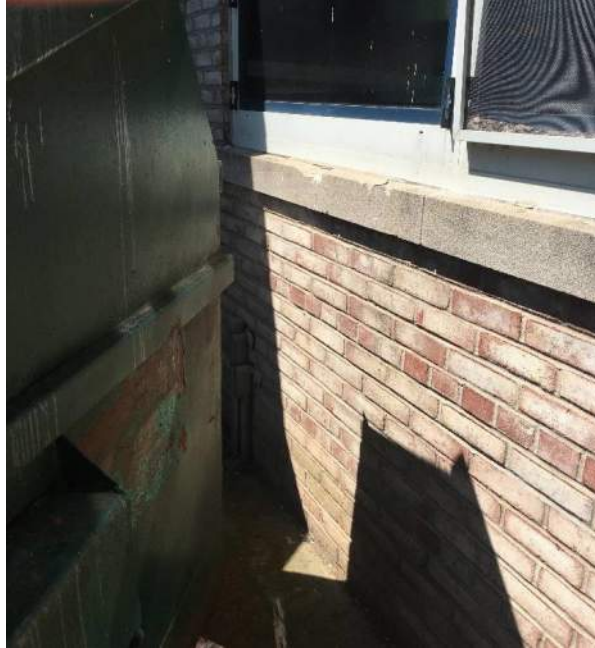
The brick veneer of the exterior wall located behind the dumpster has been damaged from the dumpster being placed. Please refer to Photograph Exhibits CES-20 and CES-21.

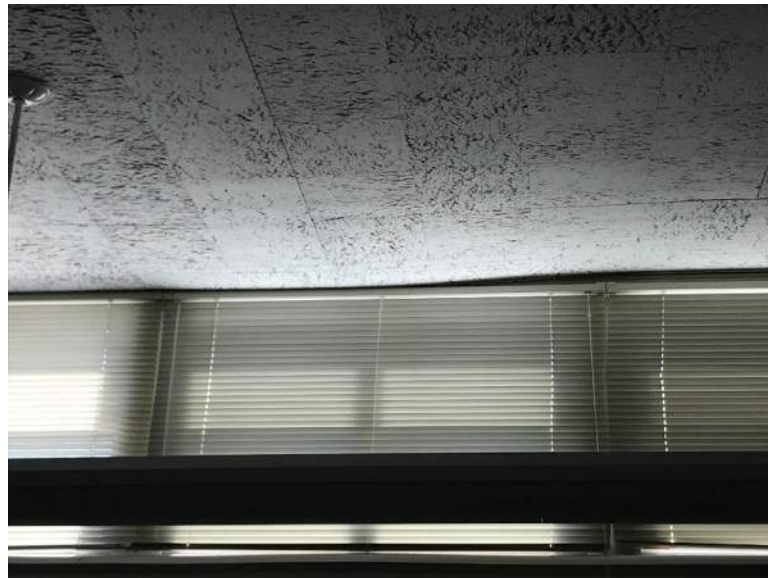
**Exhibit CES-22**

Room 16, the ceiling tile is dropping at the high windows, refer to Photograph Exhibit CES-22. This may be due to the adhesive for the tile failing.

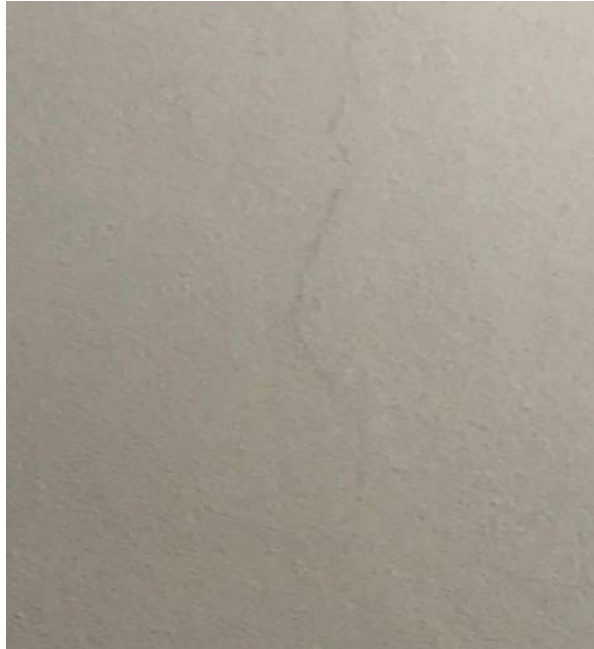
**Exhibit CES-23**

Room 16, there is a crack in the north wall, refer to Photograph Exhibit CES-23.

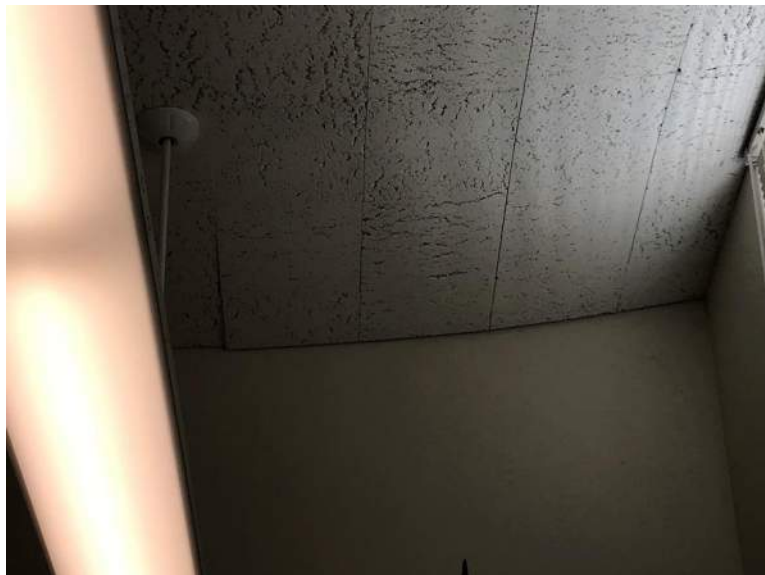
**Exhibit CES-24**

Room 23, the ceiling tile is dropping at the north wall, refer to Photograph Exhibit CES-24. This may be due to the adhesive for the tile failing.
