INFRARED ROOF INSPECTION

PERFORMED FOR: WESTPORT BOE TED HUNYADI

LOCATION: STAPLES HIGH SCHOOL 70 NORTH AVE WESTPORT CT 06880

This report summarizes the findings of our Infrared Roof Moisture Analysis of the roof at Staples High School, Westport, CT, performed on November 7, 2020.

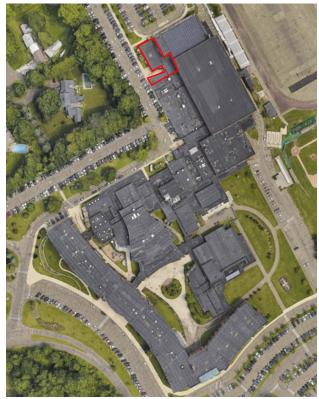
Roof C

AREA 1 \sim 200 sqft. Area revolves around a possible drain or unit which will emit heat. Appears there may be some ponding water or residual moisture left.

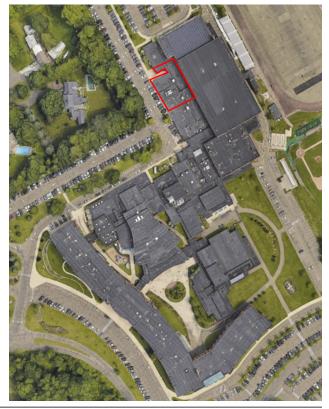
Roof C, D, E

AREA 1 ~ 7111 sqft. A large area that has traces of heat/possible moisture almost entirely covering the section. It cannot be definitely determined whether these areas are standing water or wet insulation etc. However the presence of heat and possible moisture is abundant in this area of the roof.

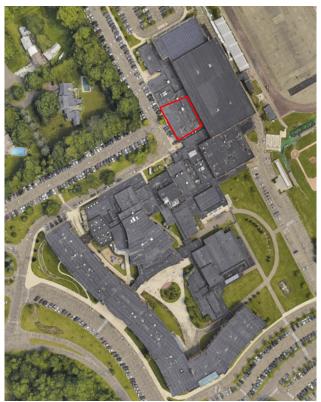
Roof E

Area 1 ~ 2539 sqft. Area that runs along the W edge of this section appears to have heat/possible moisture.

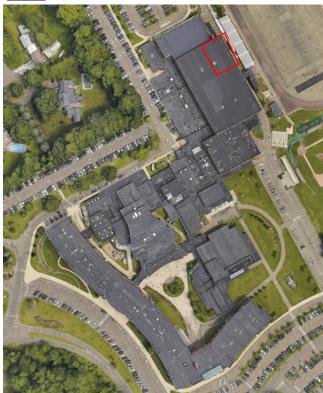
Area 1 \sim 2525 sqft. Area that runs along the W edge of this roof area.

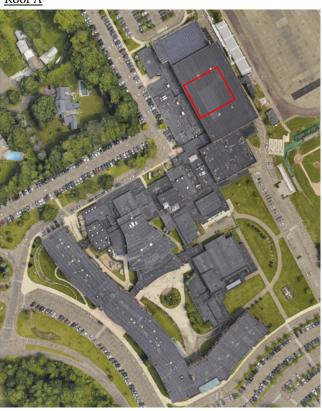
Area 1 ~ 272 sqft. Area that runs beneath the seam, along the E wall. Appears to be standing water spots or possible heat/ moisture spots.

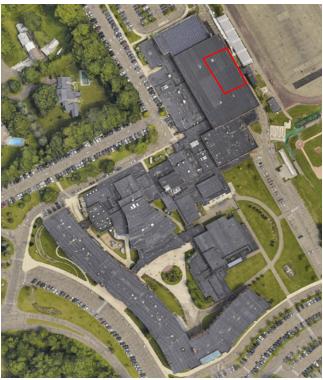
Area 3 \sim 81 ft. Seam running from W to E below the two units in the middle of the roof.

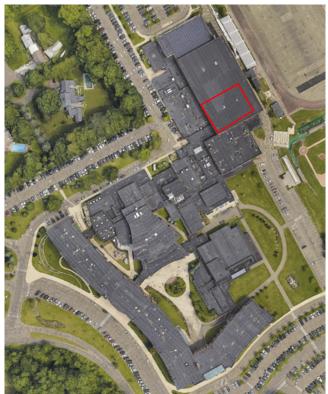
Area 1 \sim 50 sqft. Small area to the E of the closest unit

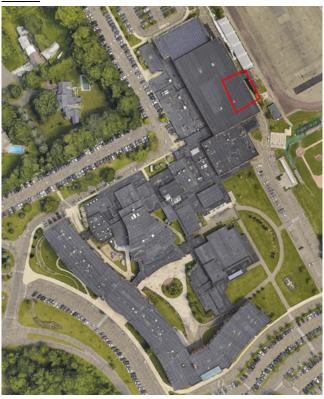
Roof A

Area 1 ~ 270 sqft. Along the N portion of this roof that runs against the wall leading up to Roof A.

Area 2 ~ 251 sqft. Area to the E of the drain in the center of the roof.

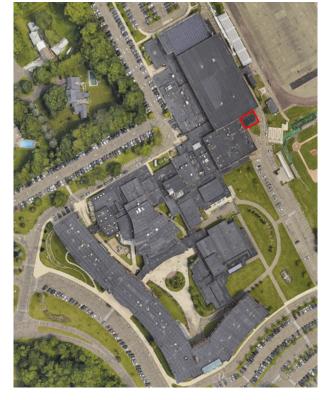
Area 2 ~ 1927 sqft. Large area surrounding the curb/unit in this marked area extending to the N edge of the roof section which goes up to Roof A. Appears to be an abundance of residual water/ponding or heat/moisture.

Area 3 \sim 3177 sqft. Large area extening almost the entire S area of this roof section. Large thermal spots which could be standing water or heat/moisture underneath.

Area 4 \sim 35 sqft. Small area next to the unit and seems to be on the SW corner of a roof patch

Area 5 ~ 240 sqft. Area Just SE of the closest roof unit.

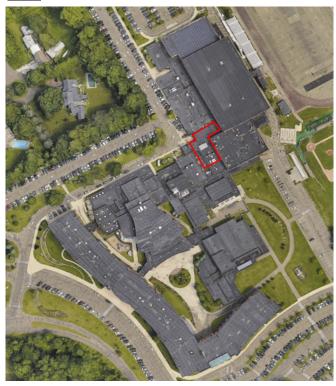
Roof J

Area 1 ~ 6 sqft. Small area in between roof vent/unit and pipe just S of what appears to be a roof patch.

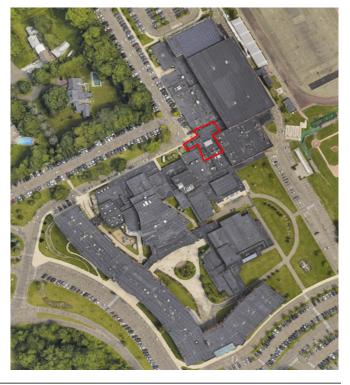
Area 1 \sim 8 sqft. Small area of heat/possible moisture along the walk pads near the E edge of this roof section

Area 2 \sim 8 sqft. Small area of heat/possible moisture along the walk pads near the SE edge of this roof section.

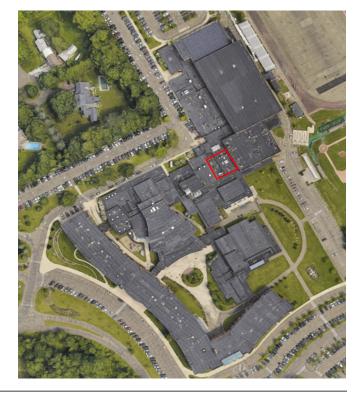
Area 1 \sim 105 sqft. Area along the W edge of this roof section. Potential standing water residue or heat/moisture.

Area 2 ~ 117 sqft. Area along E edge of this roof section extending to the walk pads. Potentially standing water or heat/moisture presence.

Area 4 \sim 45 sqft. SE corner of this roof section. Possible standing water or heat/ moisture.

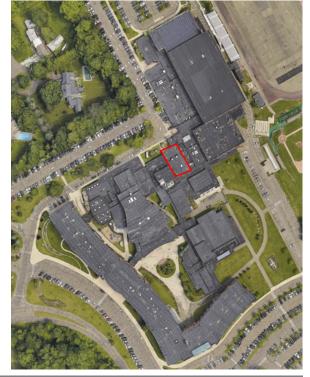
Area 1 \sim 89 sqft. Possible area of standing water staining or heat/moisture.

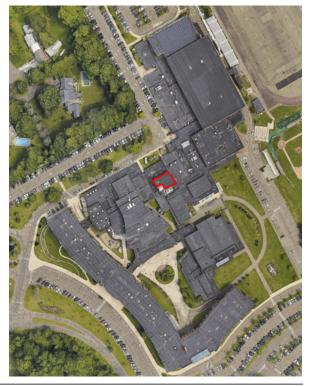
Area 1 \sim 295 sqft. Possible standing water residue or heat/moisture. Runs along the NW section of this roof area

Area 2 \sim 305 sqft. Long area stretching along the N side of the walk pads. Appears to be standing water residue or heat/moisture.

Area 6 ~ 25 sqft. Area to the E of the unit closest to this marked area.

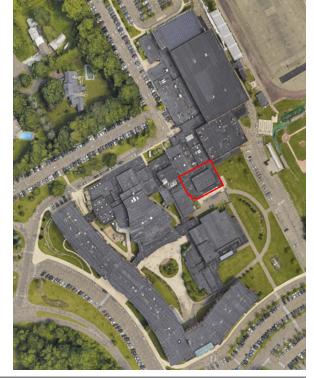
Area 1 \sim 95 sqft. Area that runs along the base of the wall to Roof i.

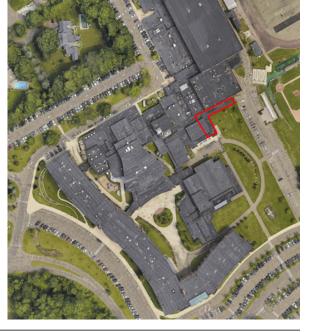
Area 1 ~ 1228 sqft. Large area that encompasses almost the entire W edge of this roof section stretching in to the middle. Could be standing water residue or heat/moisture.

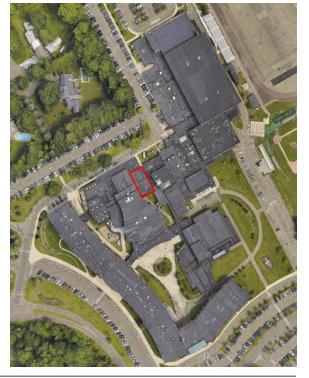
Area 3 ~ 127 sqft. Area along the N side of the walk pads appears to have possible standing water residue or heat/moisture.

Area 4 ~ 350 sqft. Along the base of the wall to Roof Area L including the ladder and units. Possible stains from standing water or heat/moisture.

Area 5 ~ Small area along the W edge of this section along walk pads.

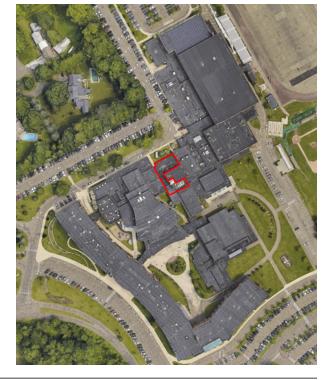
Area 1 \sim 5 sqft. Small area on the S of the unit nearest the marked location.

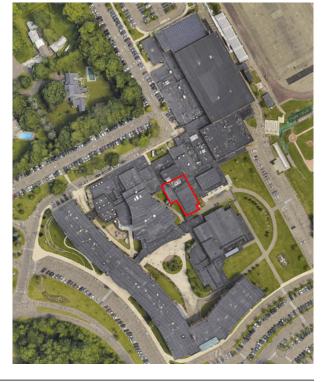
Area 1 \sim 57 sqft. Small area near the base of the wall adjacent to roof area Q.

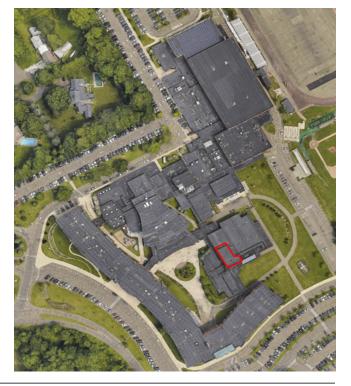
Area 1 \sim 25 sqft. Small section at the base of the wall. Possible standing water or residue.

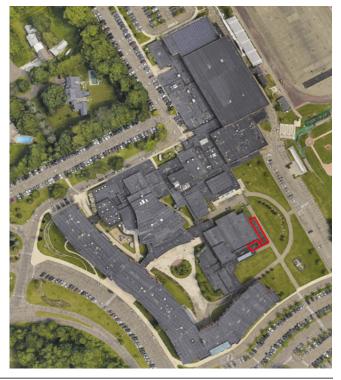
Area 1 \sim 225 sqft. Area along the W edge of this roof section. Appears to be possible standing water stain or heat/moisture.

Area 2 ~ 623 sqft. Large area of concern. Appears to be significant heat/ moisture in this location.

Area 3 \sim 710 sqft. Area along the S edge of this roof section. Likely due to stain from standing water or light moisture/heat.

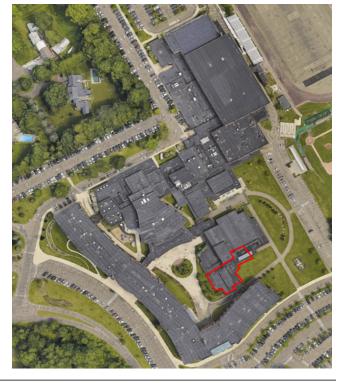
Area 1 \sim 164 sqft. Area in between solar panels and corner of roof Q.

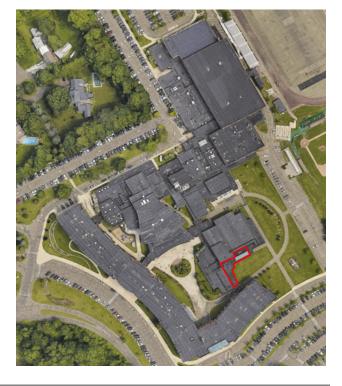
Area 1 $\sim~125$ sqft. Small area along the south portion of this roof area.

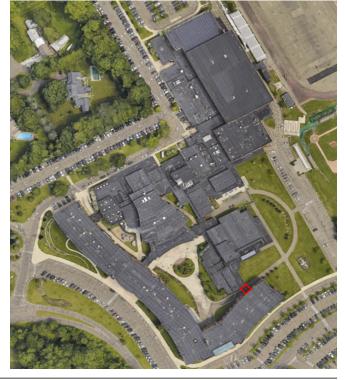
Area 2 \sim 199 sqft. Area in between hvac and Roof Area V.

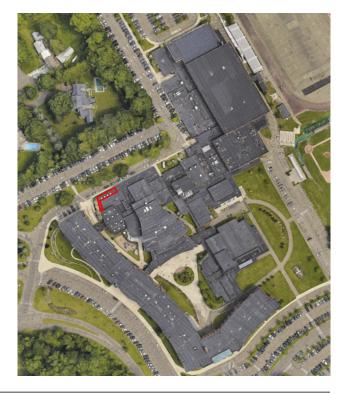
Area 1 ~ 306 sqft. Area along the wall that is adjacent to Roof Area V. Could be presence of standing water or stains.

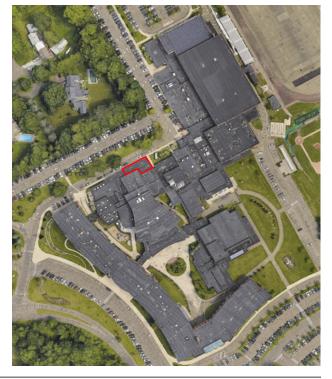
Area 1 ~ 95 sqft. N of Area 3. Looks like possible standing water or staining resulting from crickets underneath. Area 2 ~ 115 sqft. Area just S of the drain. Appears to be standing water or stains.

Area 3 ~ 361 sqft. SE corner of this roof section. Appears to be a combination of some standing water/stains and a large spot of moisture/heat.

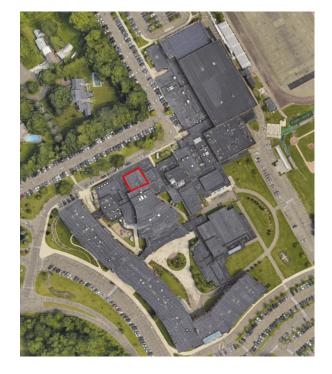
Area 1 \sim 250 sqft. Area along the E edge of this roof section where possible water stains/moisture come from the higher roof.

Area 2 ~ 52 sqft/ Small area S of the drain closest to the marked area. Appears to be residue from standing water or possible heat/moisture.

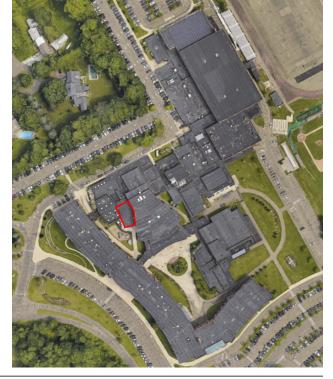
Area $2 \sim 185$ sqft. Roof section along the base of the Roof P wall. Likely standing water or stains. Possible moisture/heat from water coming from above.

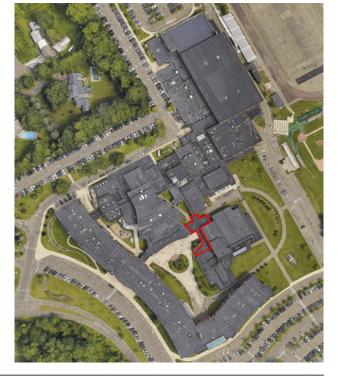
Area 3 \sim 43 sqft. Corner section along the base of the SW corner of this roof area.

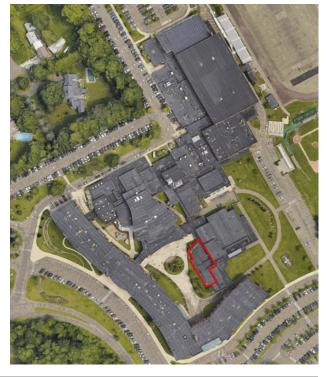
Area 1 \sim 45 sqft. Area along the W edge of the walk pads that appears to have standing water or water staining. Possible moisture/heat.

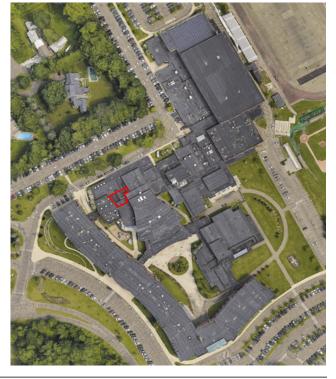
Area 1 ~ 6 sqft. Small spot in the NW corner of this roof section Area 2 ~ 25 sqft. Small area in the NE corner of this roof section Area 3 ~ 45 sqft. Area along the edge of the vent/ductwork. Area 4 ~ 65 sqft. Appears to be standing water or staining. Possible moisture/heat.

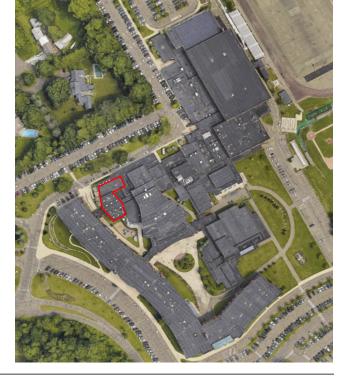
Area 2 \sim 38 sqft. N side of the closest unit to the marked area. Potential standing water/staining or heat/moisture.

Area 3 \sim 105 sqft. Appears to be standing water or staining. Possible moisture/heat.

Area 4 \sim 125 sqft. Appears to be standing water or staining. Possible moisture/heat.
