WESTPORT BOARD OF EDUCATION

Subject: *Recommended 5-year Capital Improvement Plan FY23 through FY27*

PROPERTY CONDITION ASSESSMENT Long Lots Elementary School

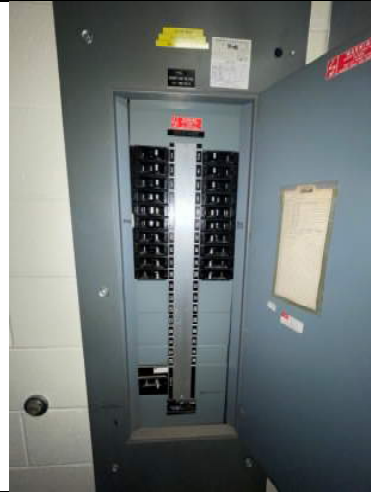
- a) The electrical distribution serving the building consists of a variety of aged panels. Due to the varying age, some of the existing equipment is at the end of its useful life, some is approaching the end of its useful life and some of the existing equipment is in acceptable condition. Some of the older panels are Federal Pacific Electric (FPE) and should be replaced immediately due to known problems with the equipment.

Figure 14: Old FPE panel serving the 200 wing

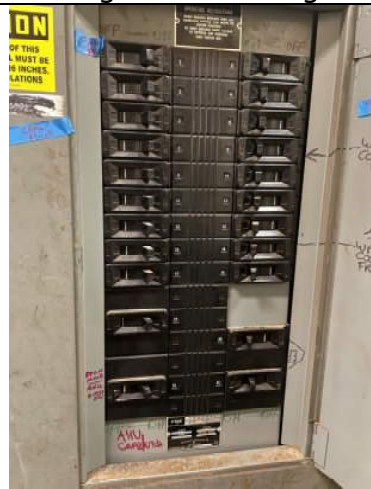
Figure 15: Old FPE panel serving the kitchen area

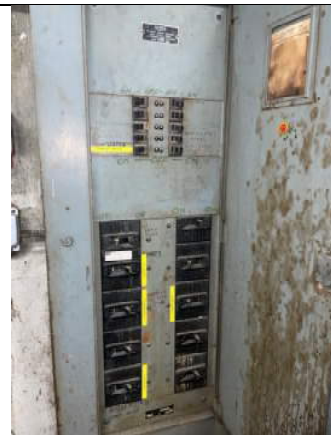
Figure 17: Old FPE panel serving boiler room

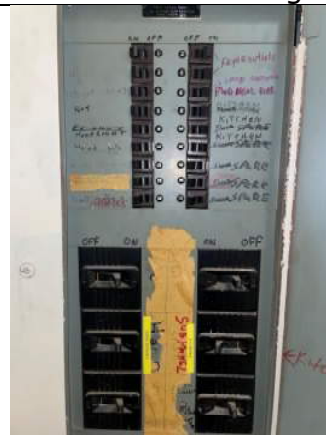
Figure 18: Old FPE panel outside the boiler room

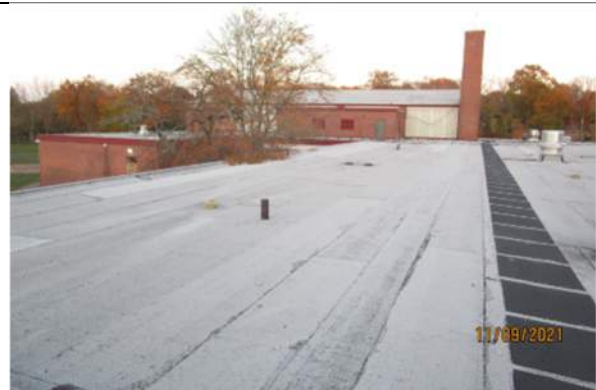
Cracking in the gym masonry wall and heat transfer from the building chimney observed visually and in the thermal scan. These cracks are a major concern both from a structural perspective and a water infiltration concern. These cracks should be evaluated by a structural engineer.

It's not clear if the heat transfer from the chimney is from conduction or if the cracks visible in the gym wall continue into the chimney and this is a direct heat source from the chimney. There are no visible expansion joints at the common wall with the chimney. The building movement against the rigid chimney needs to be evaluated by a structural engineer.

View of the chimney at the gym adjacent to the Kalwall panels.

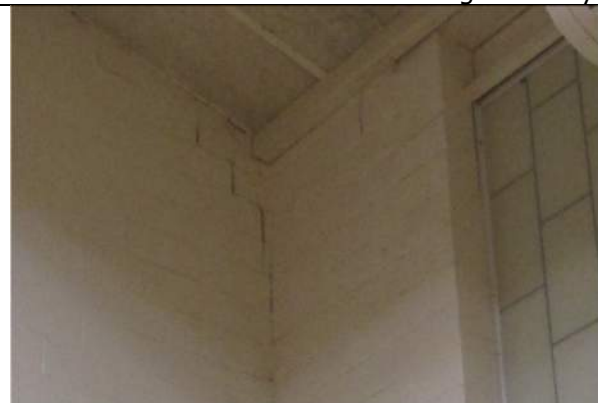
Cracks in the gym wall up to the roof level. Cracking in the masonry wall in the gym at the roof line.

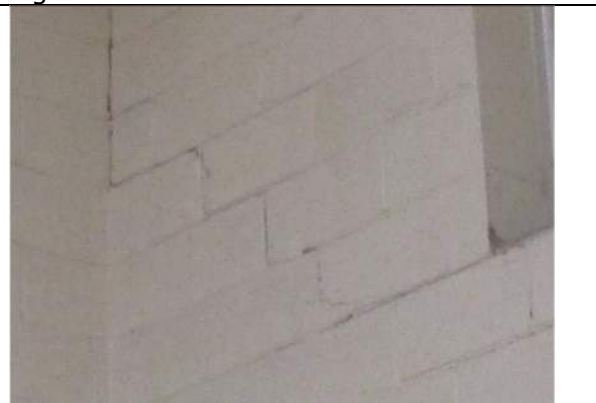
Cracking continues to the opening.

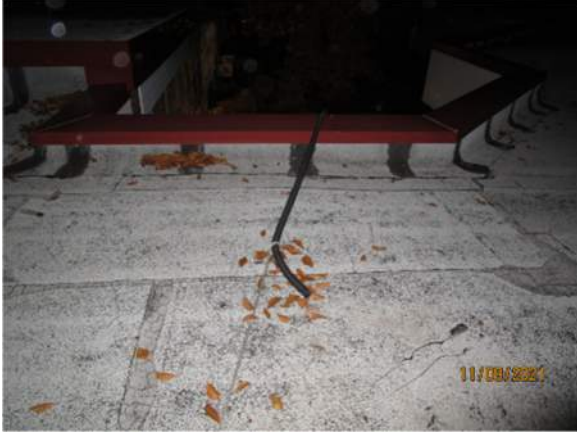
The sump pump discharges onto the roof as there is no drain in the courtyard.

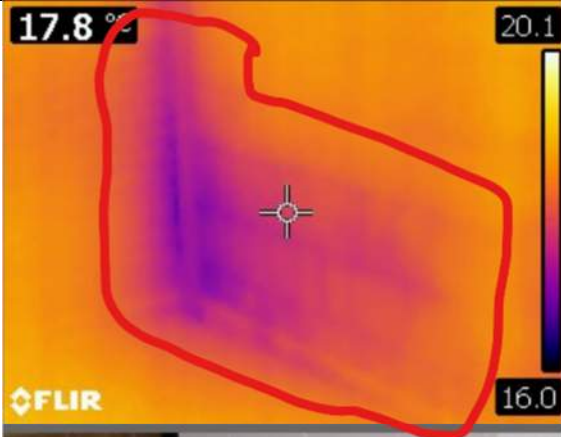
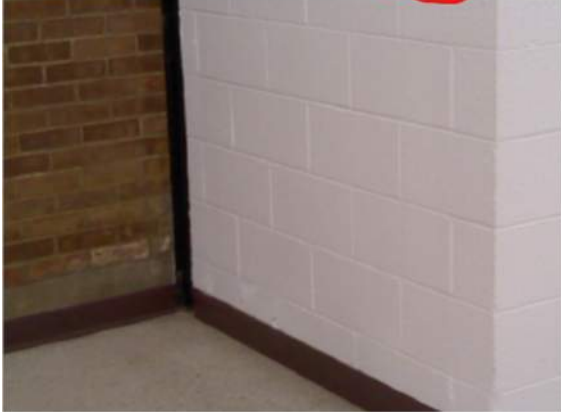
Thermal patterns show cooler temperatures at the foundation wall. This thermal pattern is consistent with missing foundation insulation, wet block, condensation. Efflorescence can be seen on the brick which is an indication of moisture in the masonry wall.

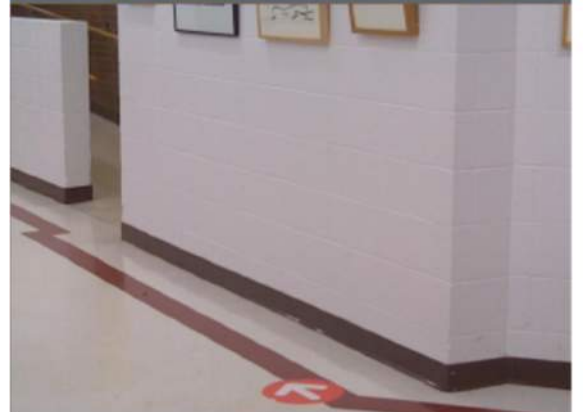
Thermal patterns show cooler temperatures at the foundation wall. This thermal pattern is consistent with missing foundation insulation, wet block, condensation.

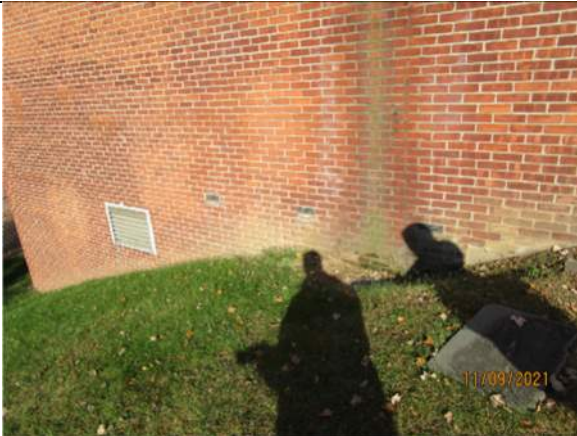
The masonry wall extends below grade with no apparent foundation or waterproofing membrane.

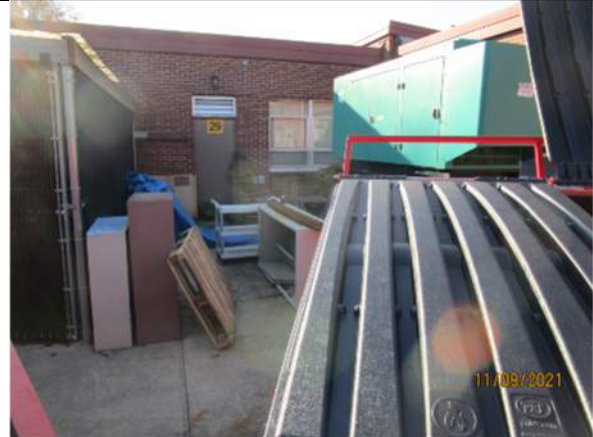
It was reported when the diesel generator is operating the diesel smell is evident in the kitchen. This is a sign of a failed building enclosure and improper balancing of the ventilating system allowing outside air to be pulled into the kitchen. It is reported that the kitchen exhaust hood has no control link between the cooking line hood and makeup air. The kitchen exhaust is likely causing negative air pressure in the kitchen and the poor building enclosure construction is likely allowing these fumes to be drawn into the building through the walls, windows, gaps around the doors and the window air conditioning unit.

The generator exhaust stack should be extended and directed above the roof level. The windows, doors and exterior wall system should be replaced with an airtight building enclosure.

A makeup air unit should be provided to correct the negative air balancing issue in the kitchen.

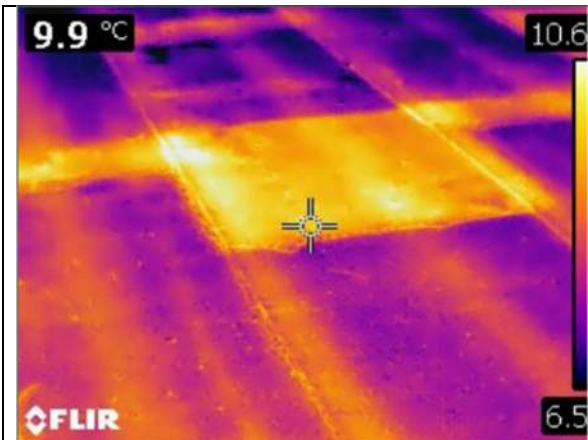
This location appears to be an infilled roof curb roofed over flush to the roof with no insulation.

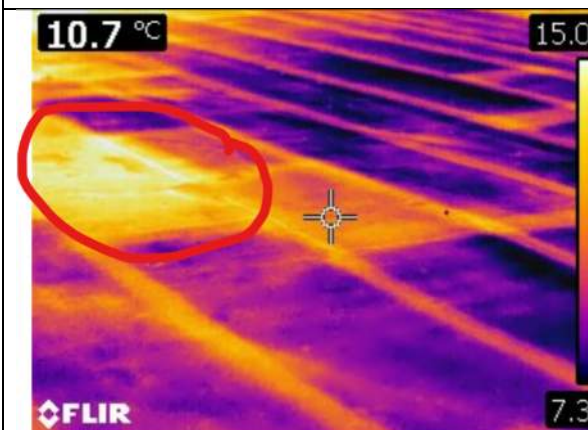
The brighter colors are thermal patterns consistent with wet insulation below the roof membrane.

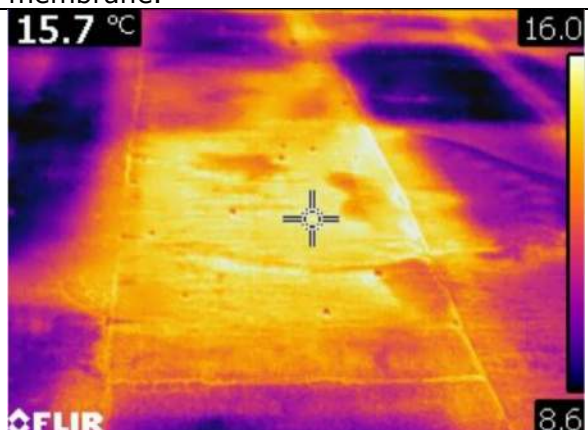
The brighter colors are thermal patterns consistent with wet insulation below the roof membrane.

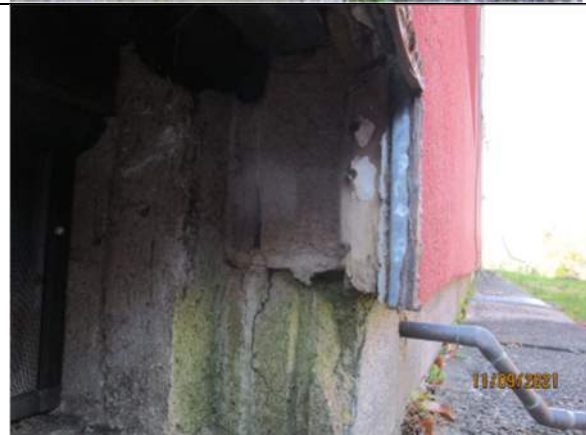
Unit ventilator in place at ground level. Cold air and surface water have an open pathway into the building.

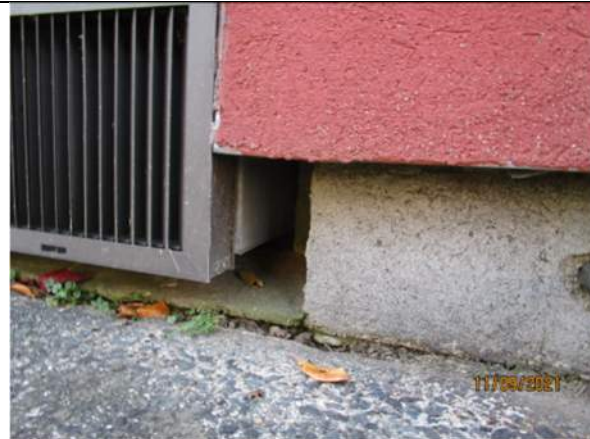
Wide open-air gap at the unit ventilator into the building.

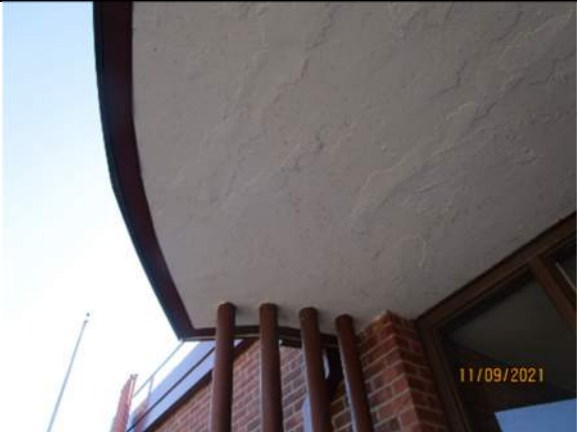
Entry soffit does not have any venting resulting in likely condensation building up in the ceiling cavity. The moisture shows signs of suspect materials on the ceiling surface.

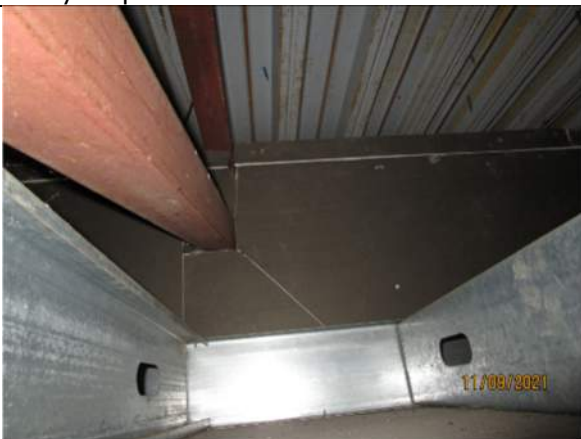
View inside the finish system soffit reveals that the gypsum sheathing on the exterior wall has no vapor barrier allowing drafts of outside air into the building.

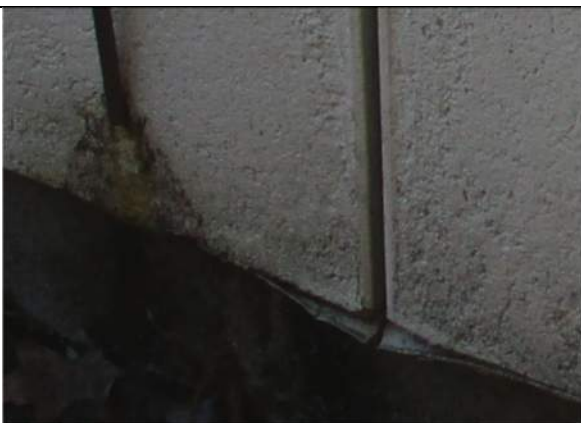
Ice damage at base trim and control joint.

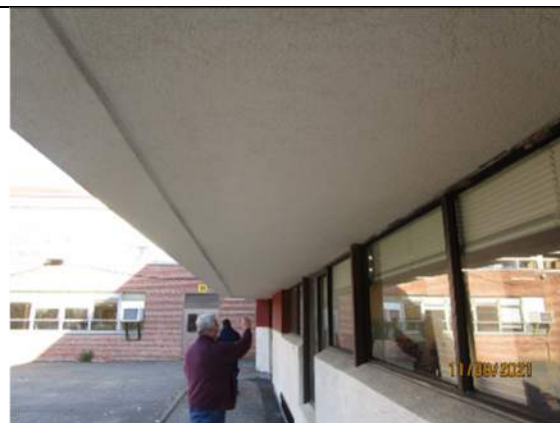
Little to no ventilation in the soffits.

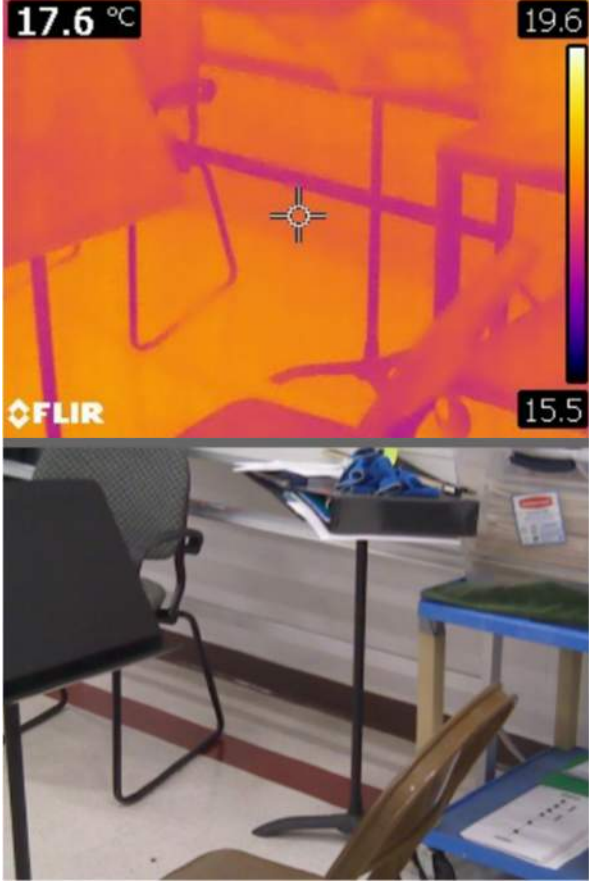
<p>Interior walls thermal pattern as an example of a wall to floor slab with no thermal bridge to the exterior.</p>
--	---

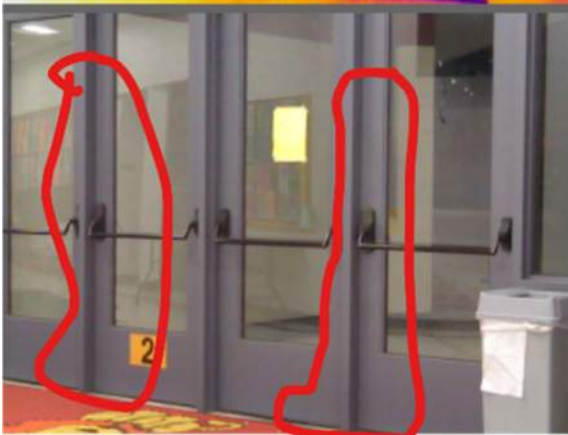
Thermal image consistent with air infiltration observed around all the entry doors.

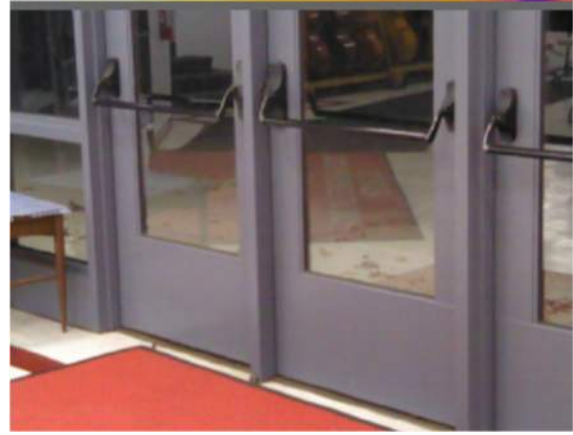
Thermal image consistent with air infiltration observed around all the entry doors.

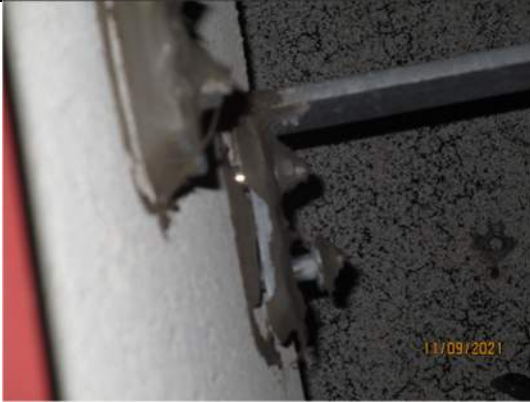
Roof ladder pulling away from the building causing the sealant around the anchors to tear allowing water into the wall.

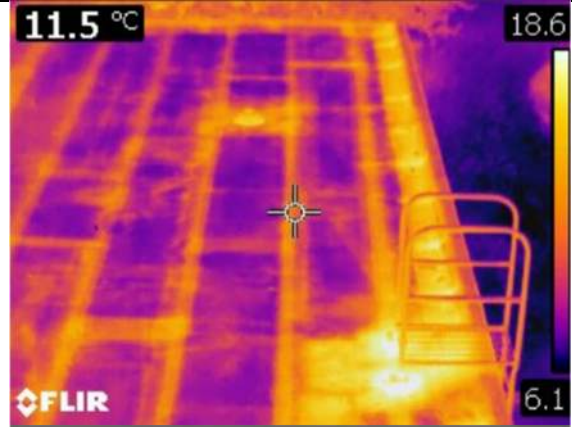
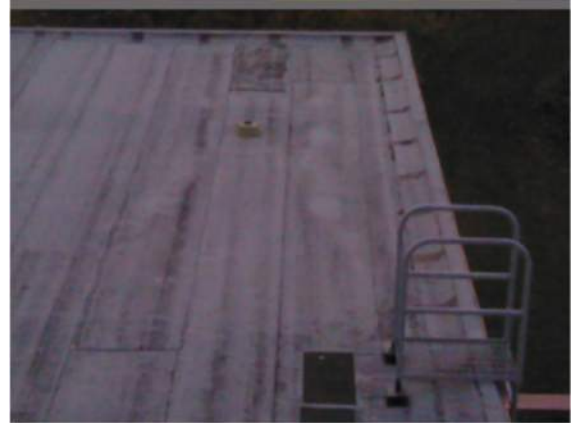
Thermal pattern consistent with water infiltration at the roof ladder possibly caused by the movement of the ladder due to the loose anchors.

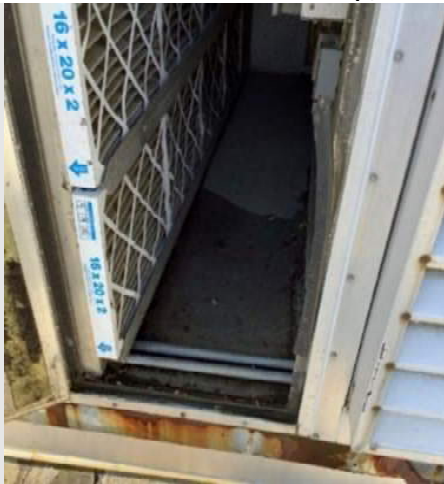
RTU-MZ-2 filters

1. HV units are located on the bulkhead above the gymnasium.
2. The chiller and the constant volume chilled water pump operates continuously when the OA temp goes above 67°F. Only one chiller runs at a time, and the chillers are rotated every 168 hours (approximately 1 week).
3. All units' filters are MERV 8 and have been replaced on 04/21. RTU MZ-2 filters were observed to be dirty, and stalled water was observed at the base of the unit.

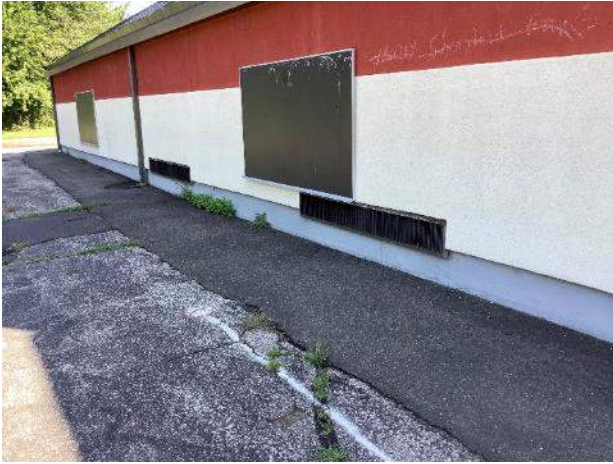
OA grills on the outside wall for fan coil unit ventilation.
